Cross beam replacement

Rocker Replacement Ohio tower

Painting

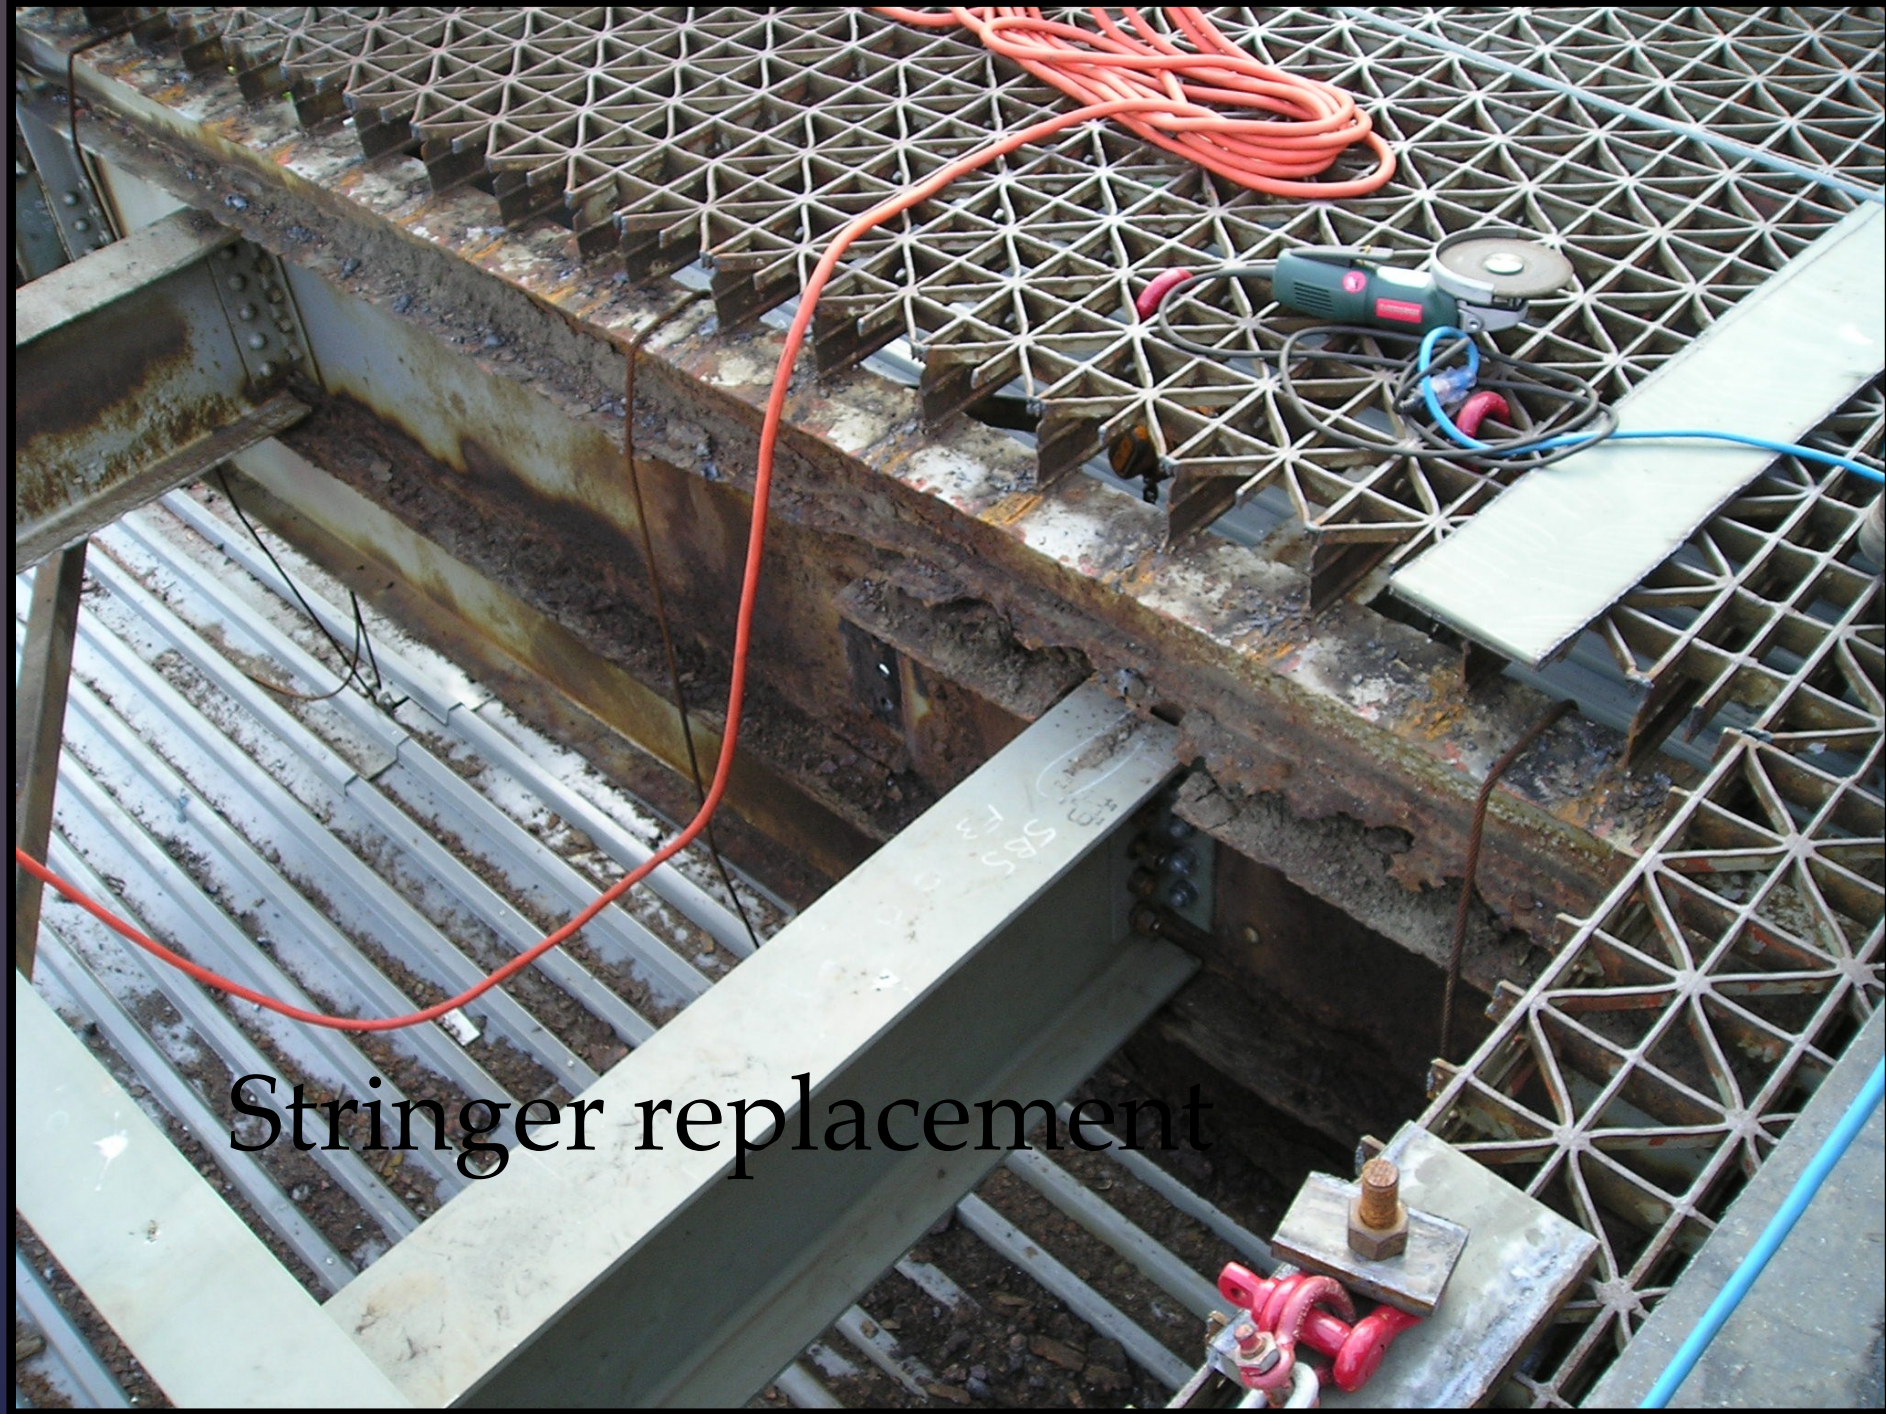
Stringer replacement

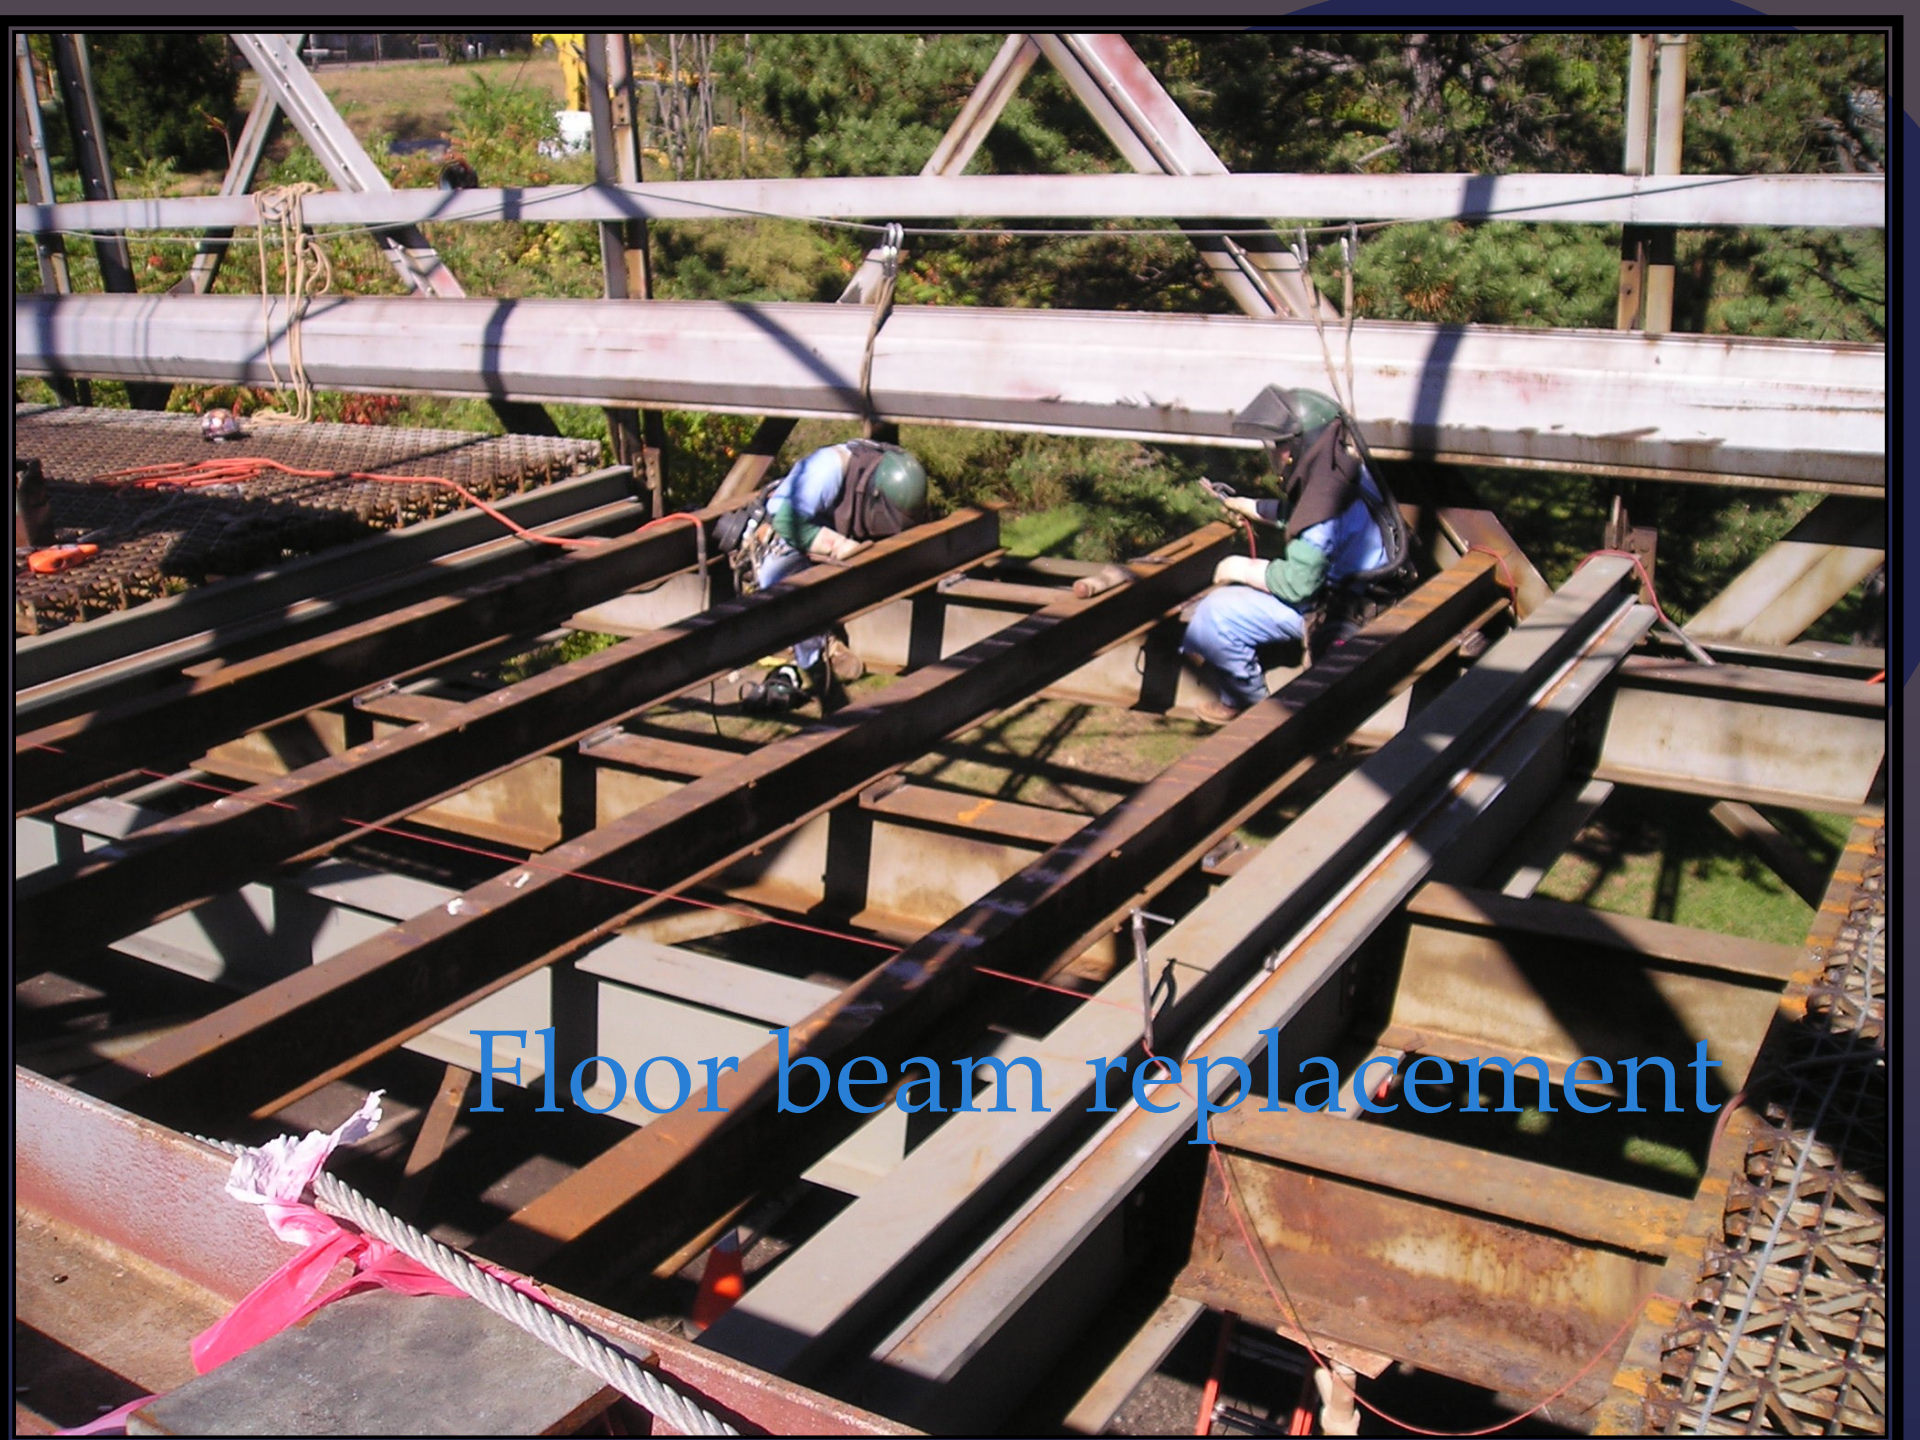
Floor beam replacement

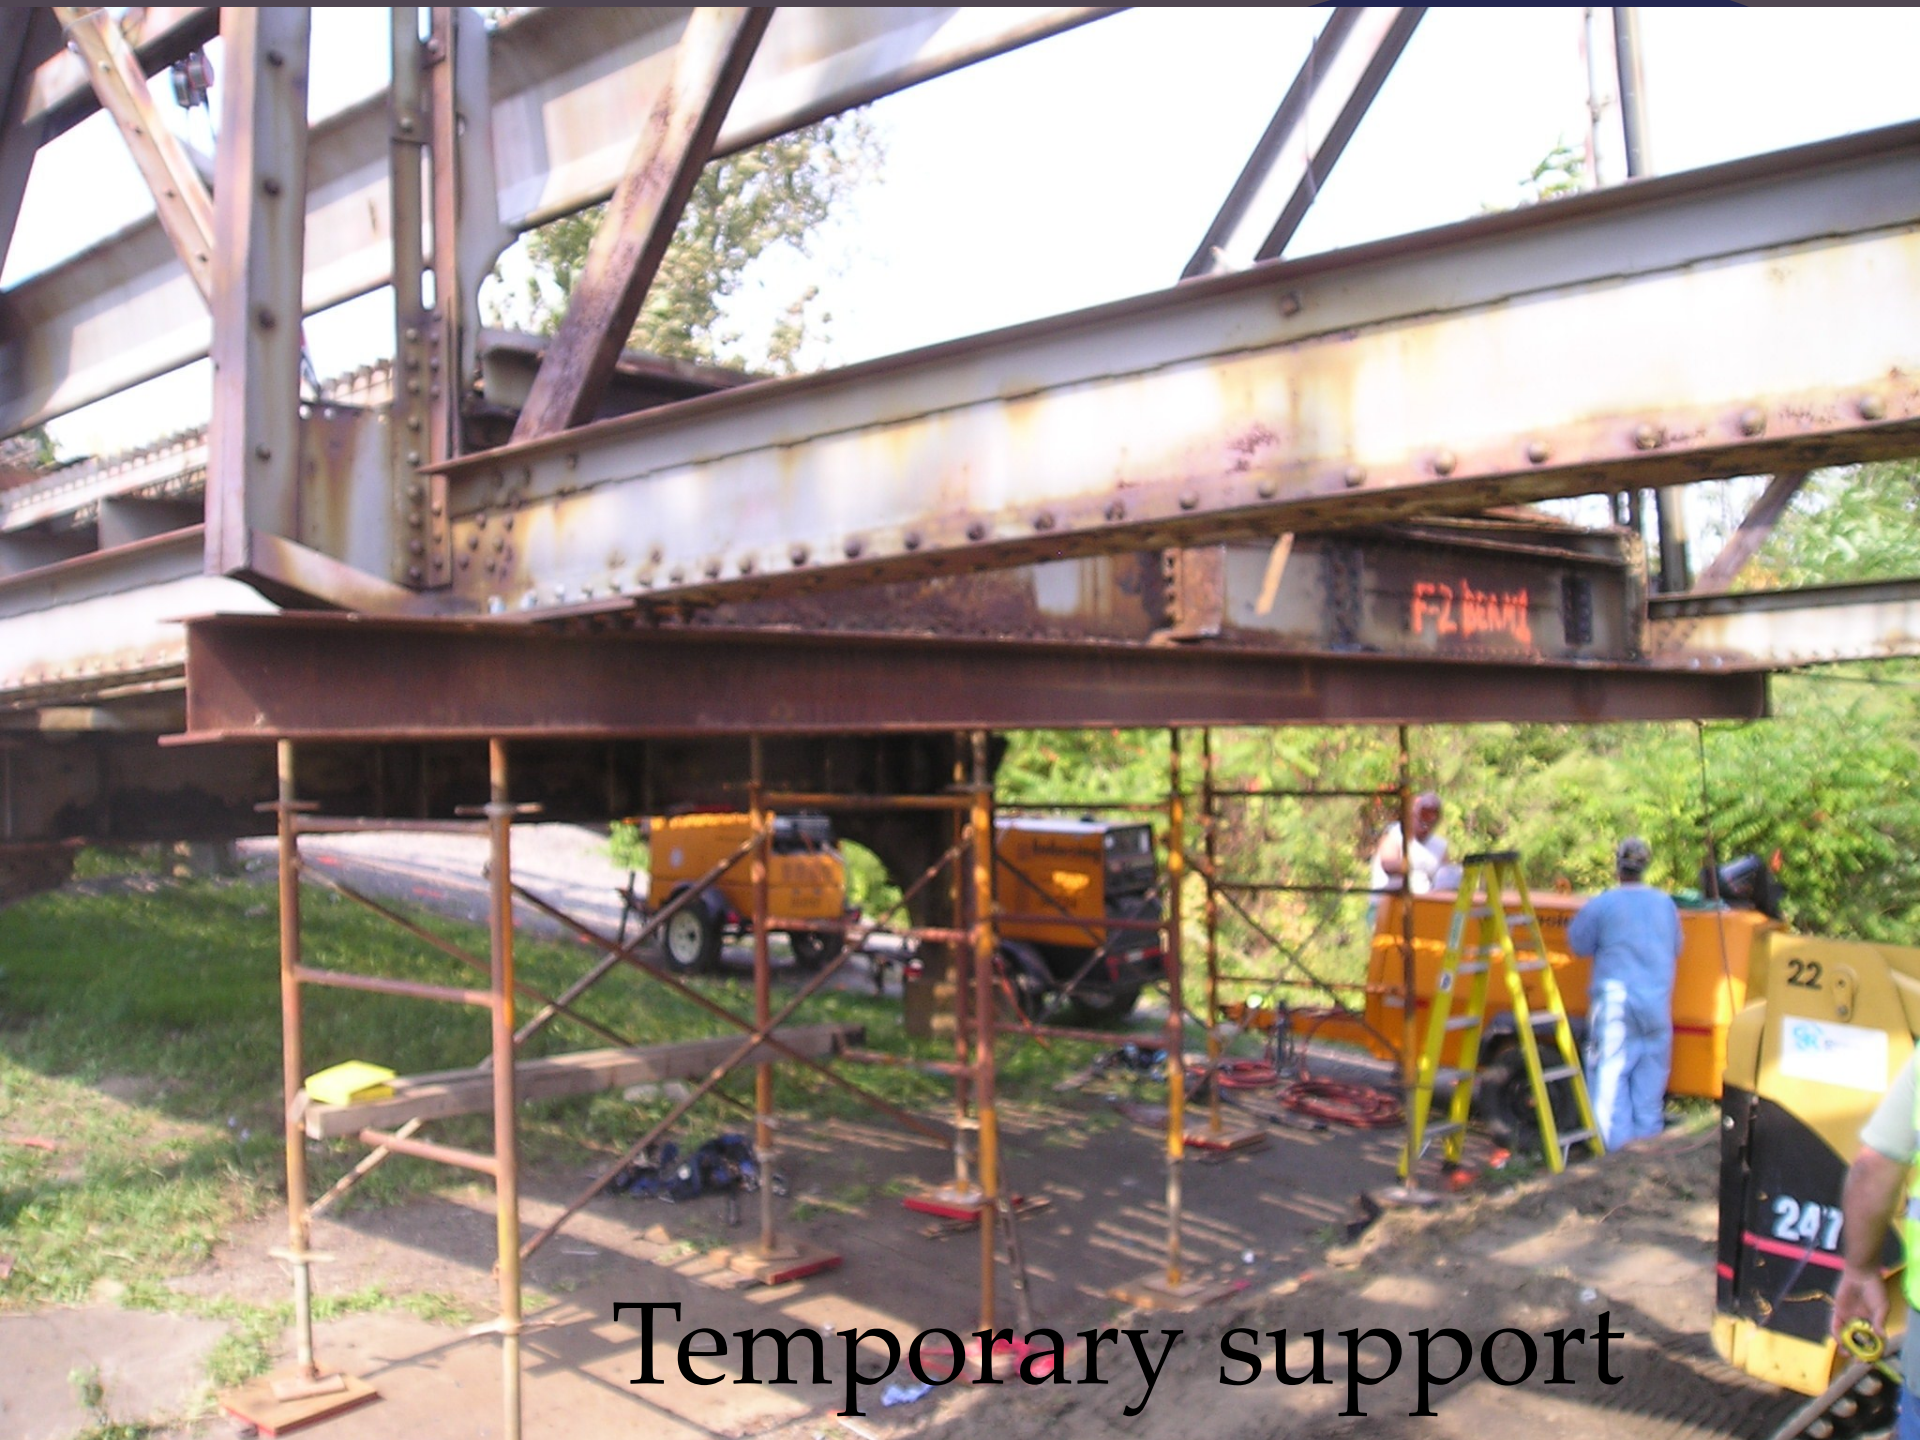
Temporary support

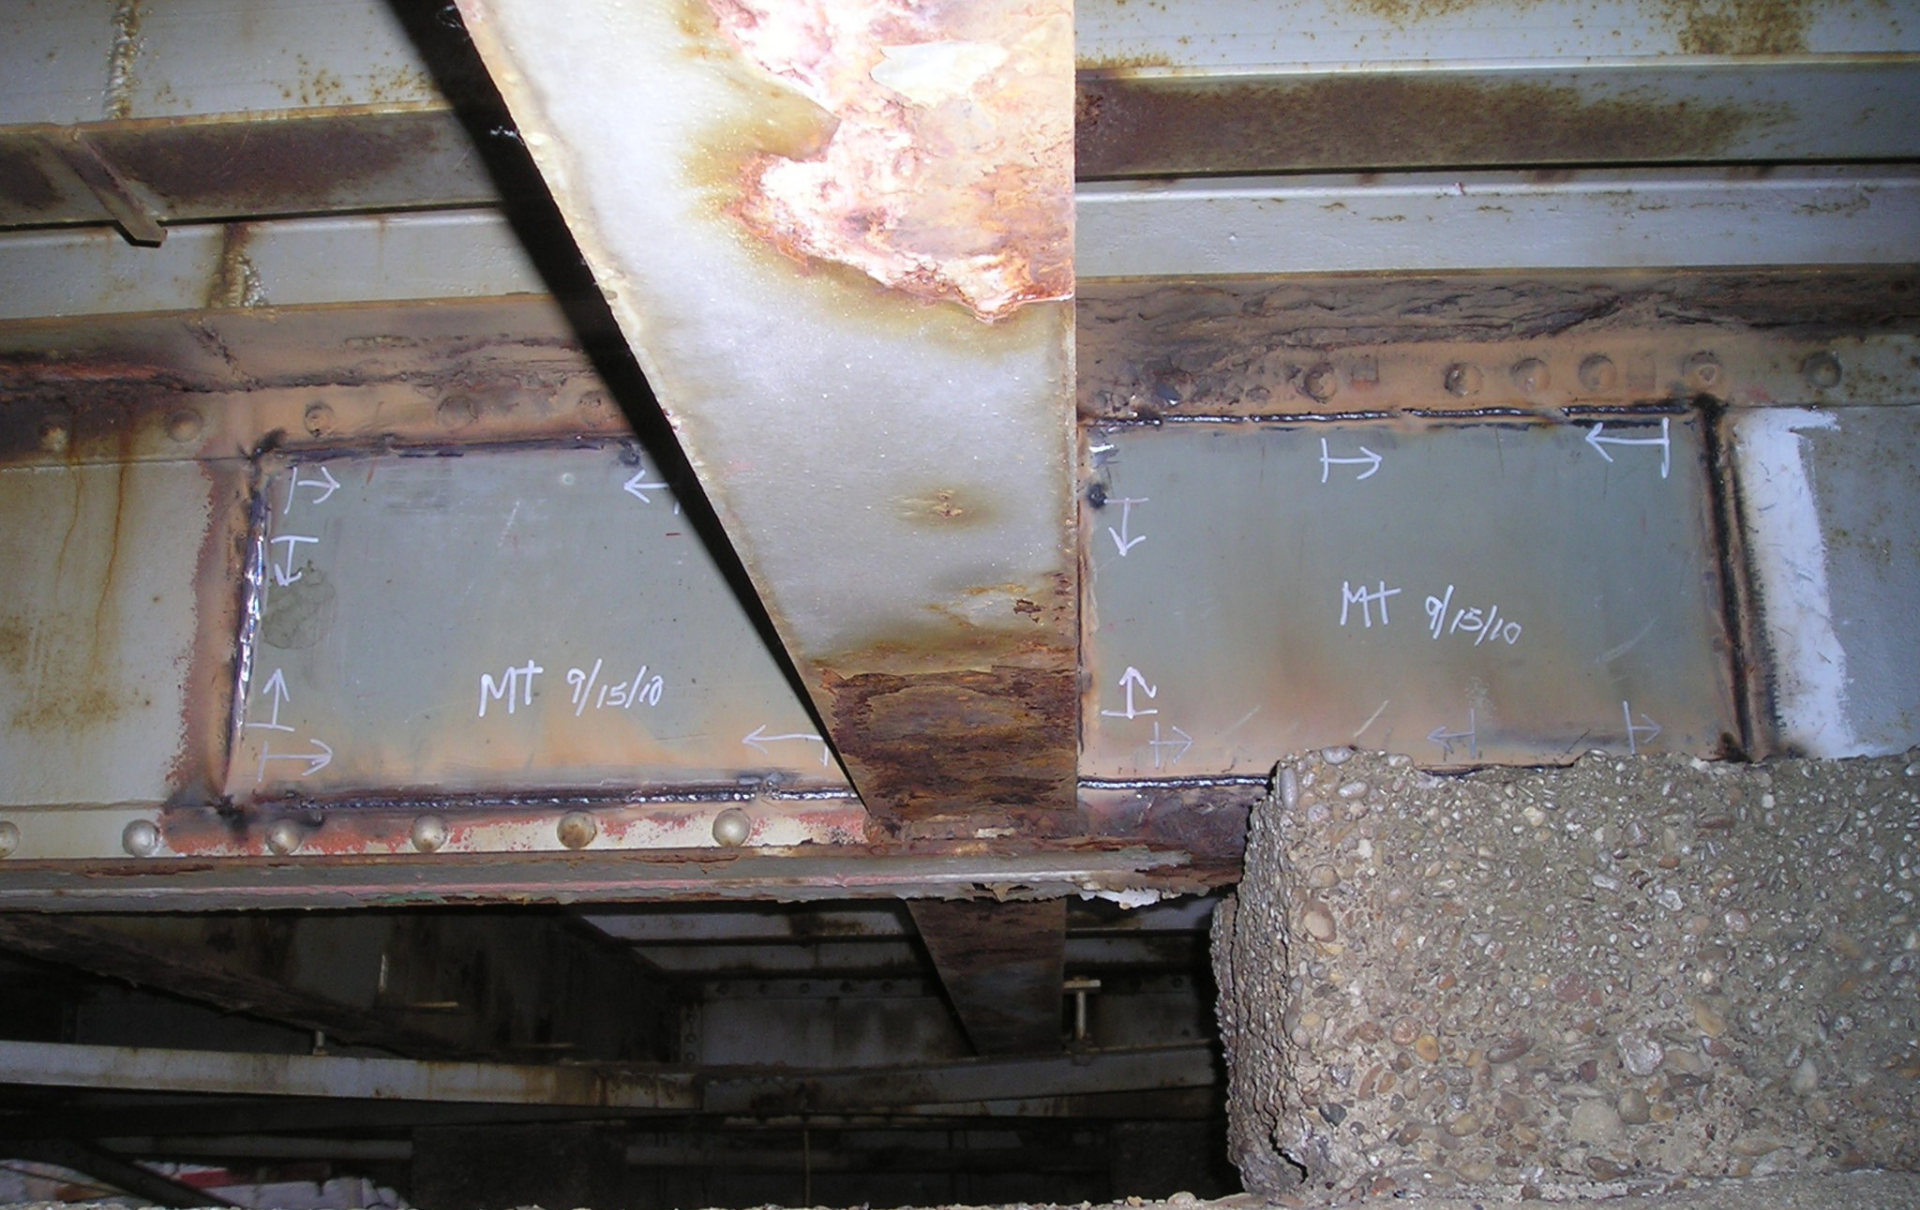
Patches to the floor beams

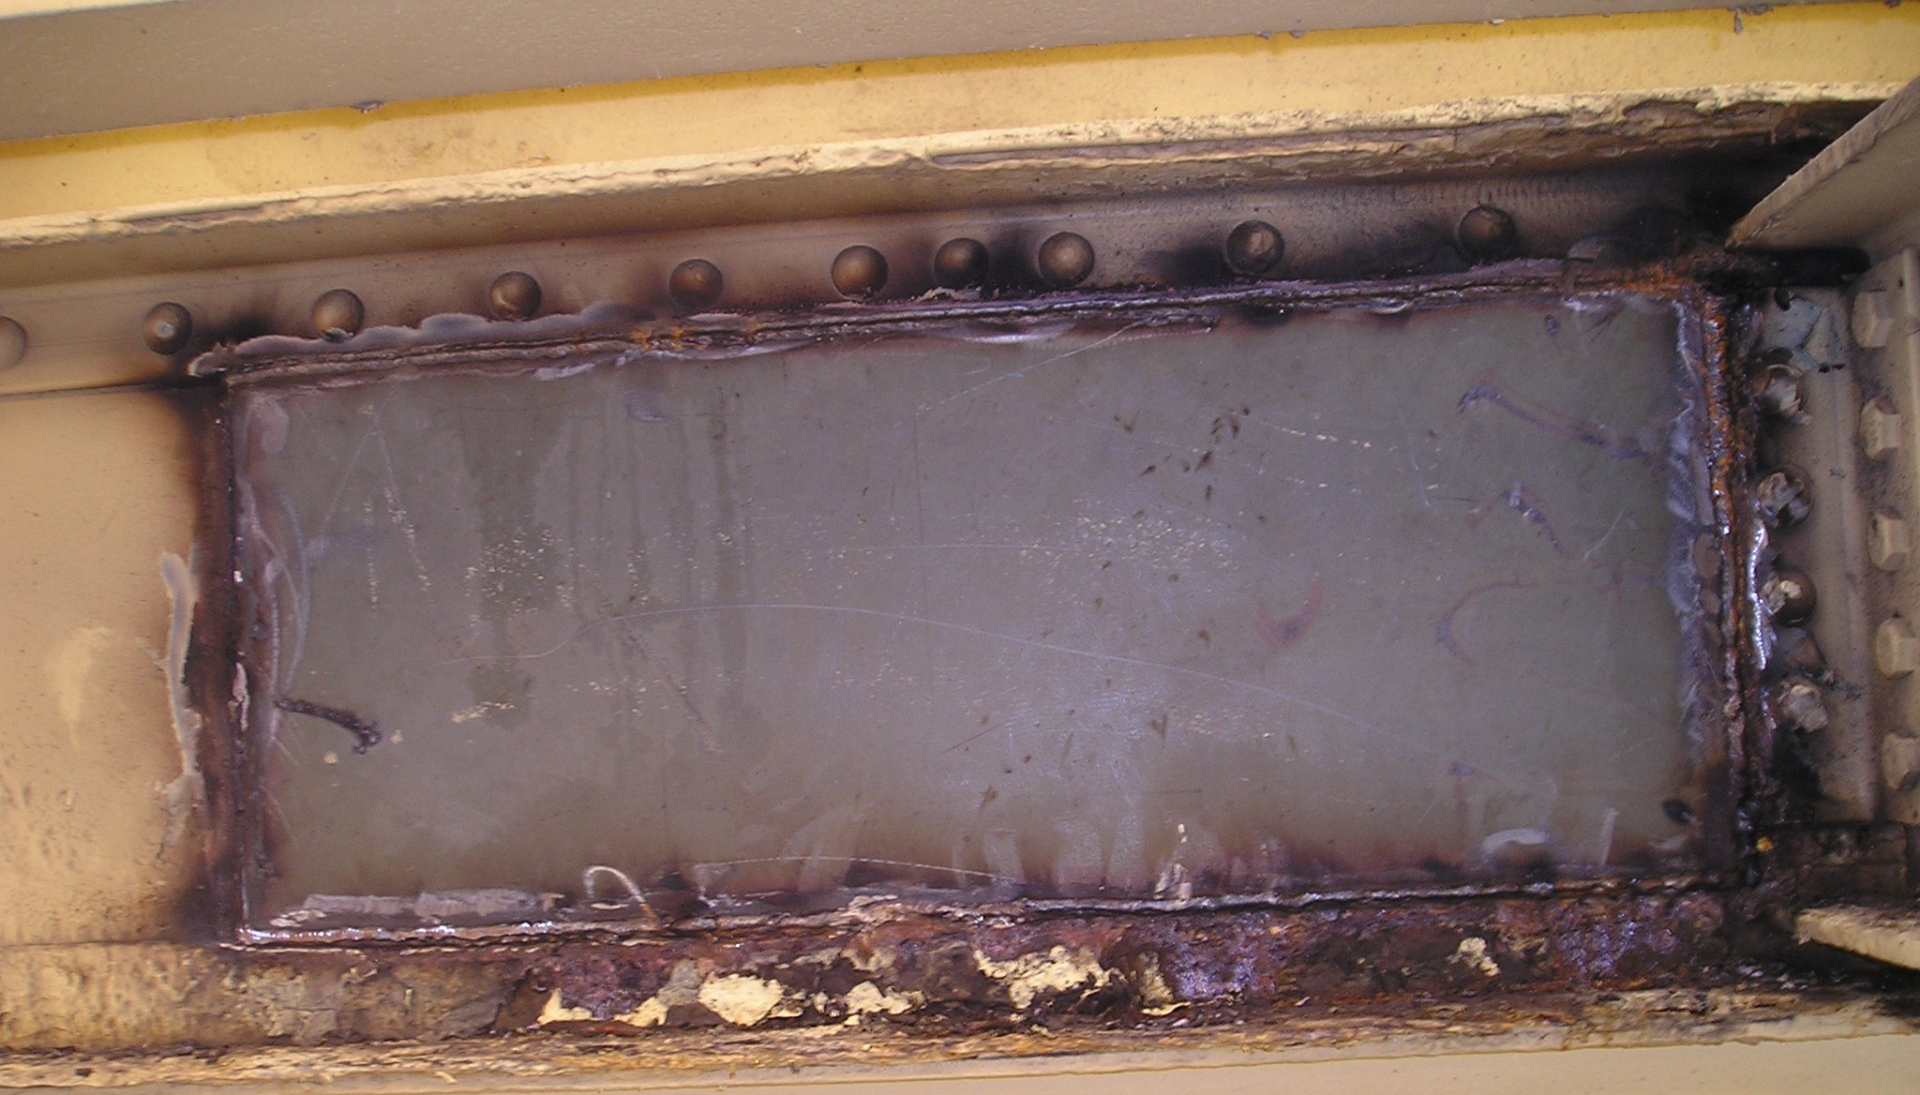
Additional floor beam repair as a result of the blasting

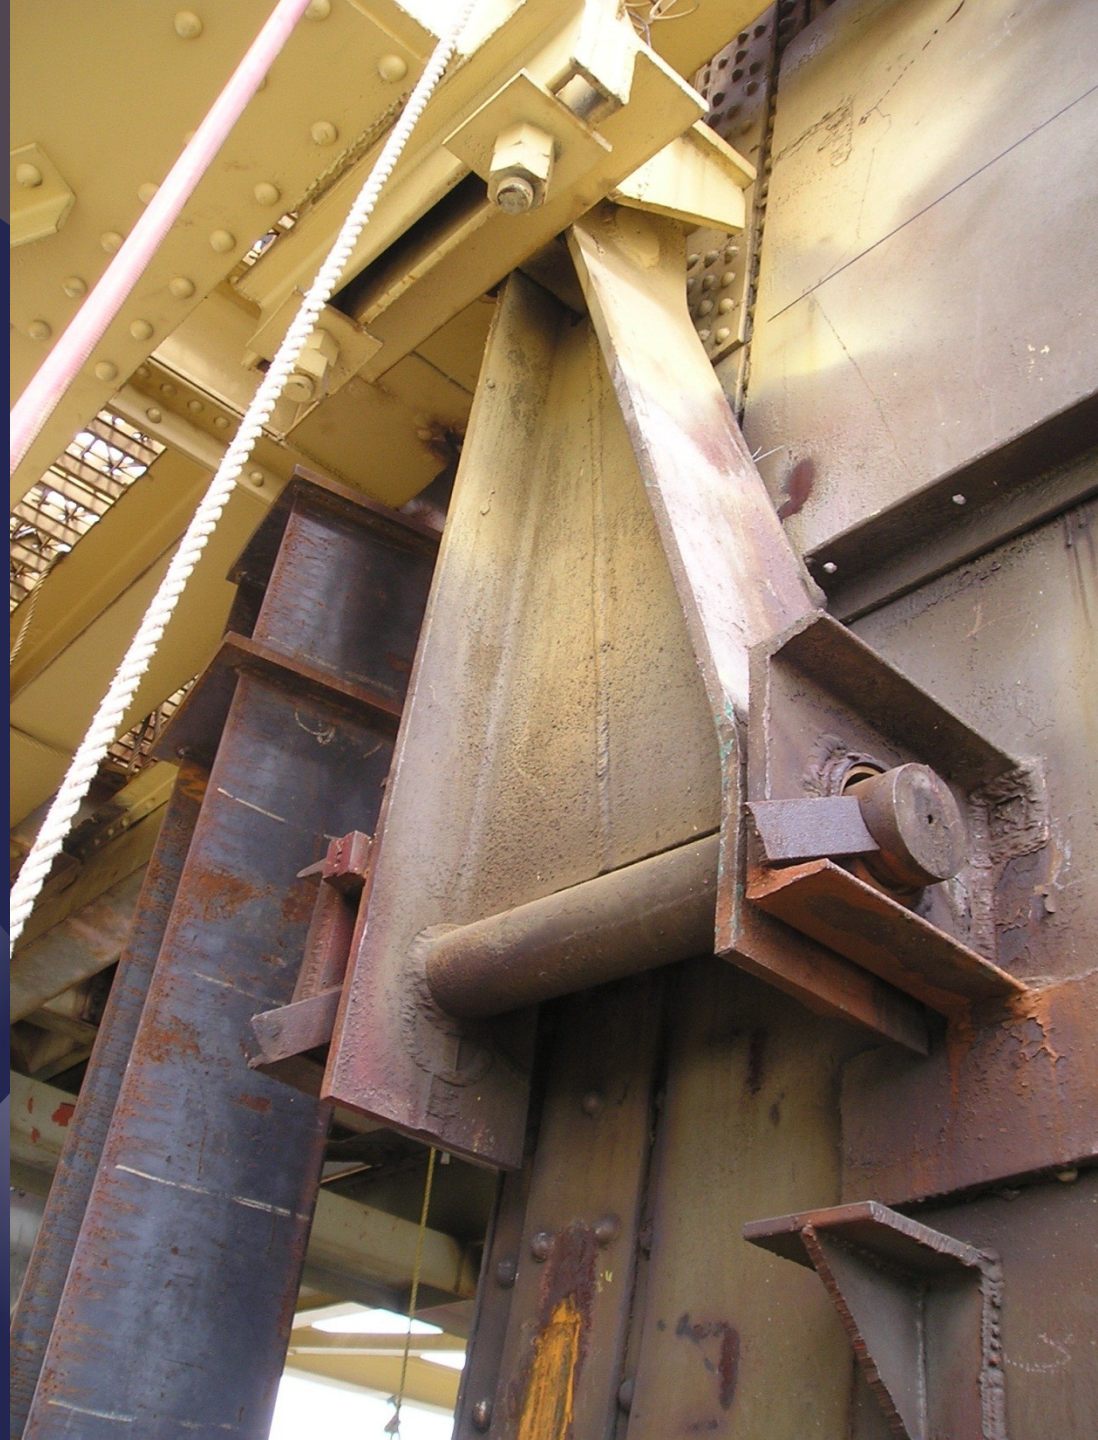
New rocker in place

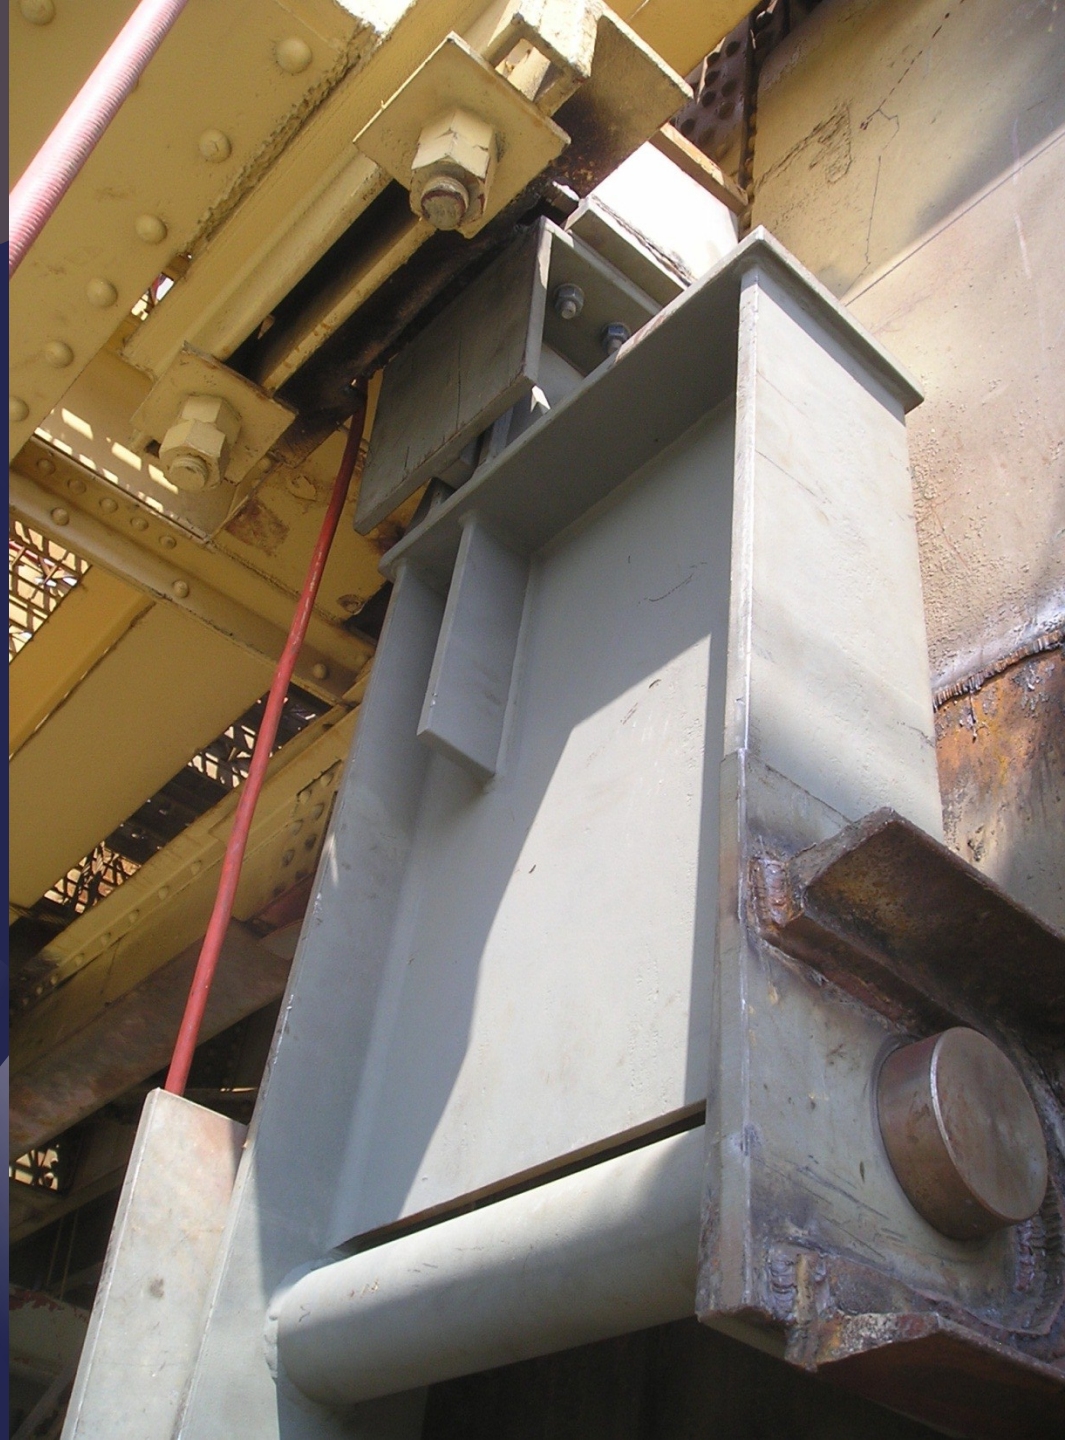
Connection to the tower

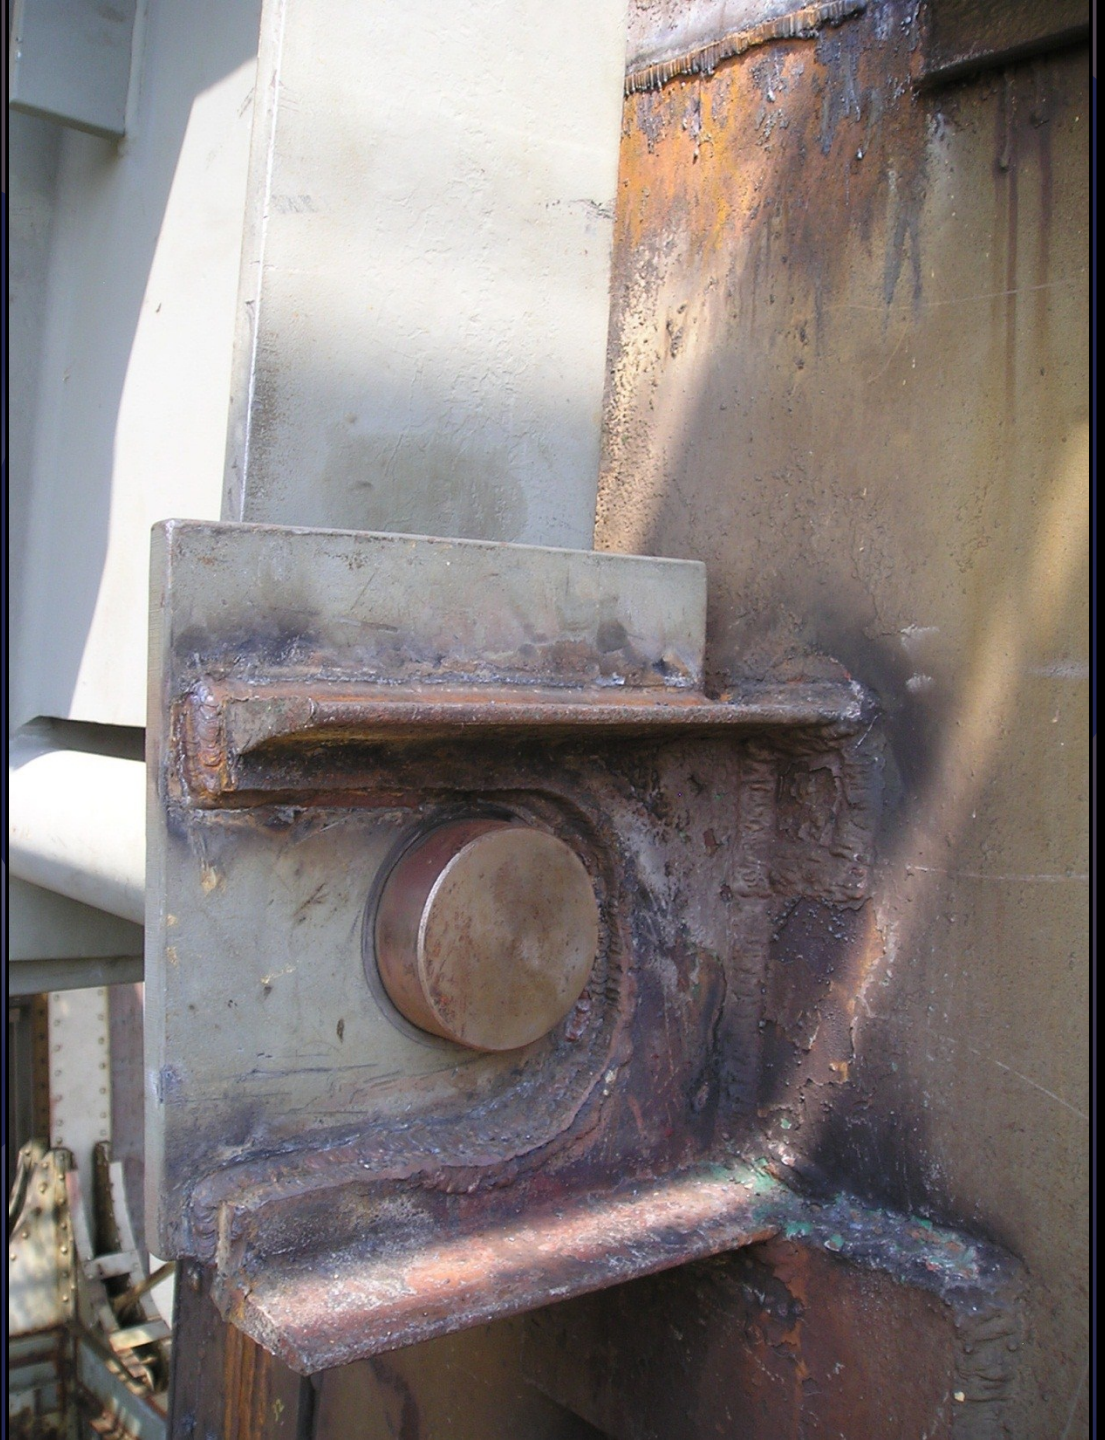
Connection to the
lower chord

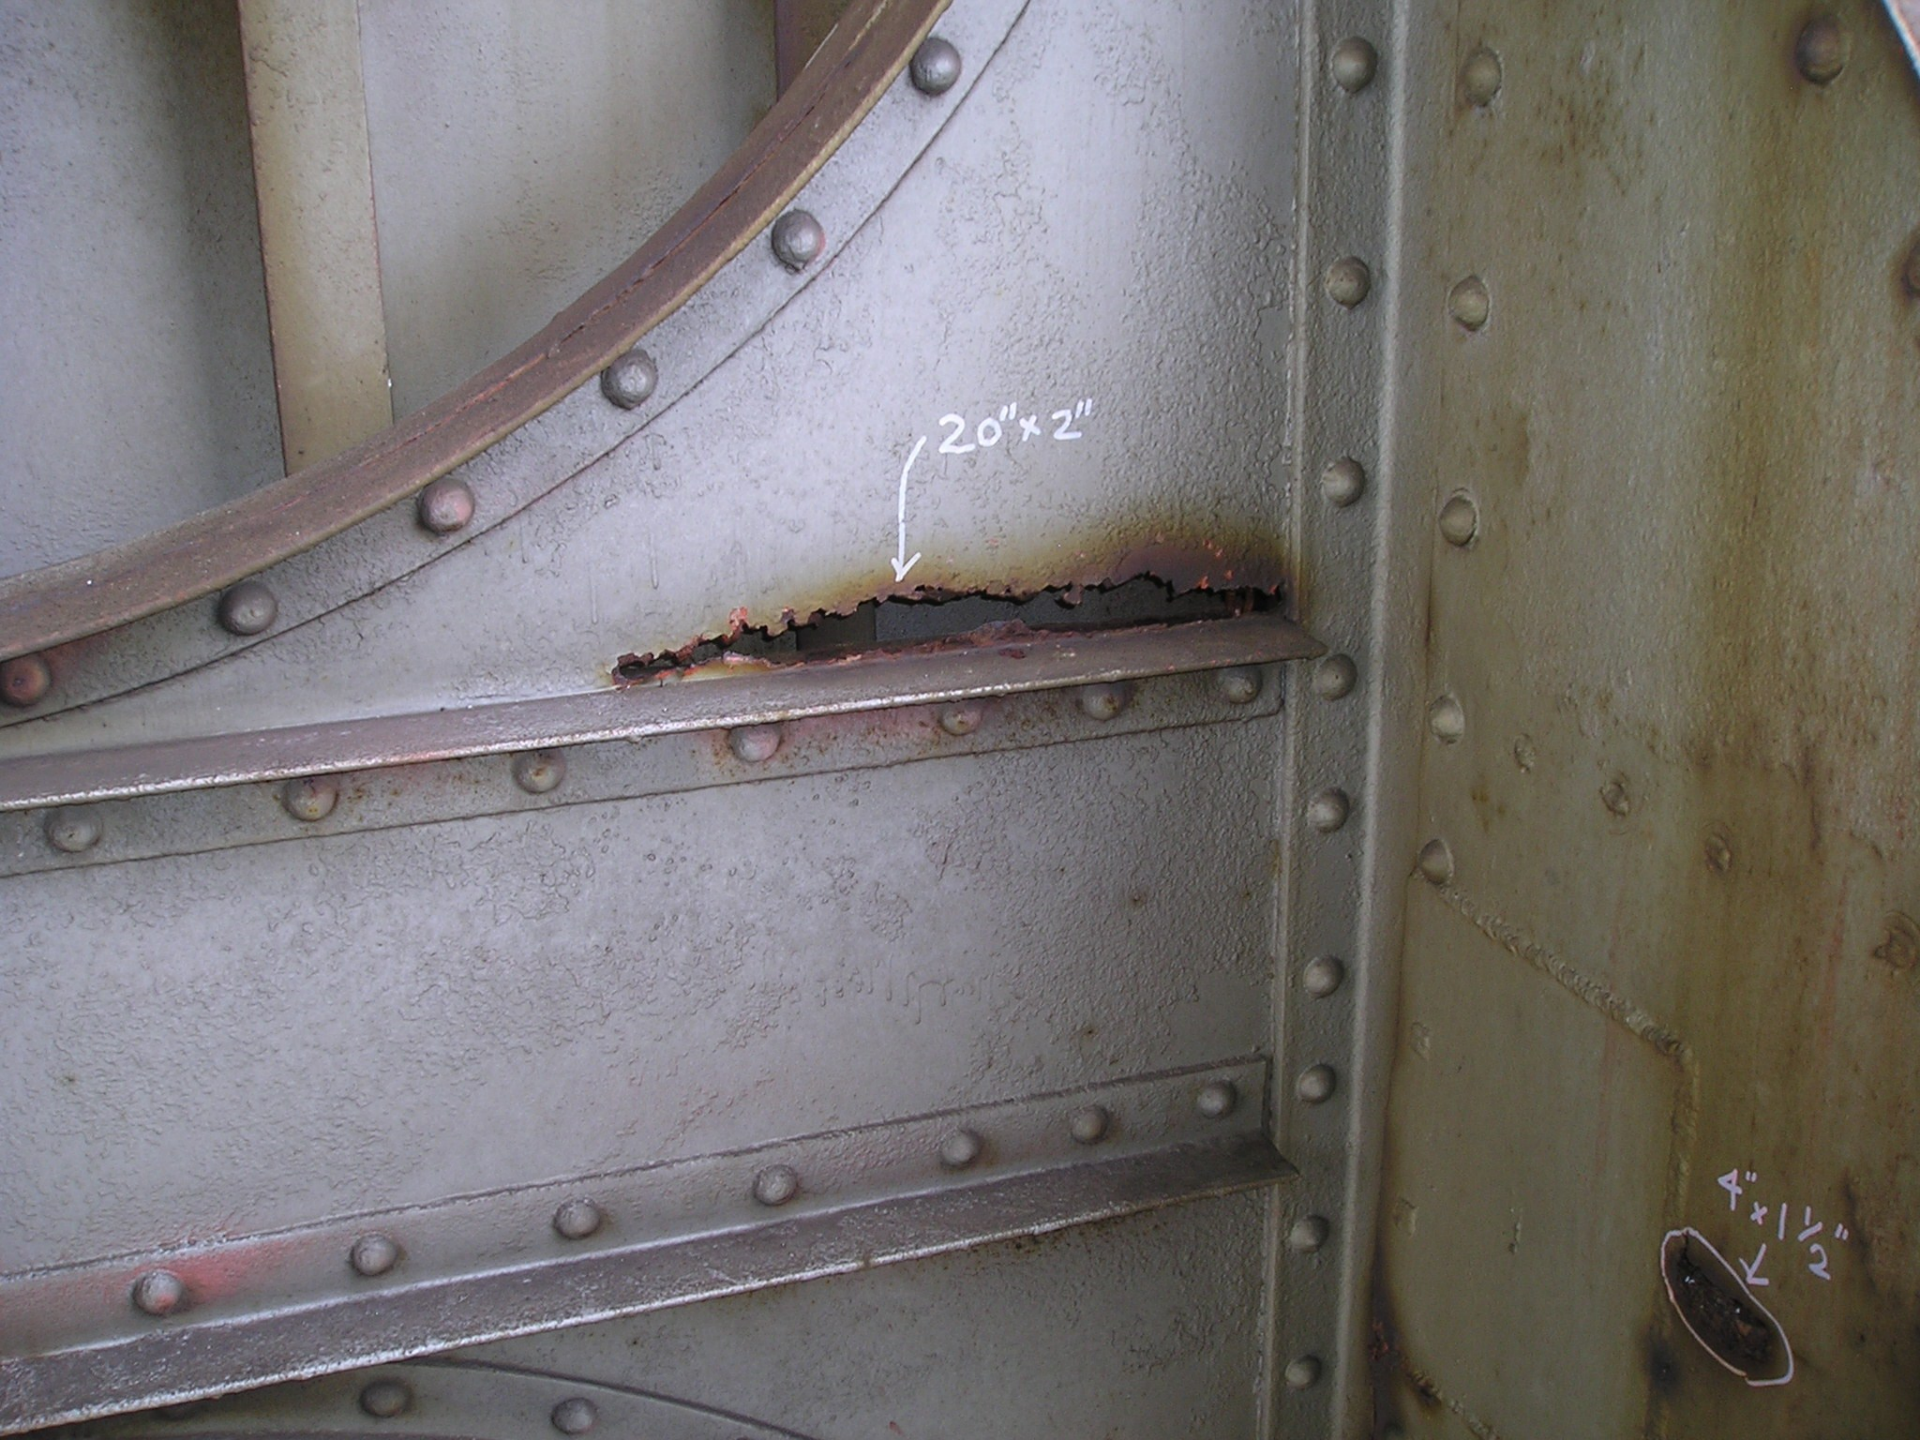
6x1 1/2
hole

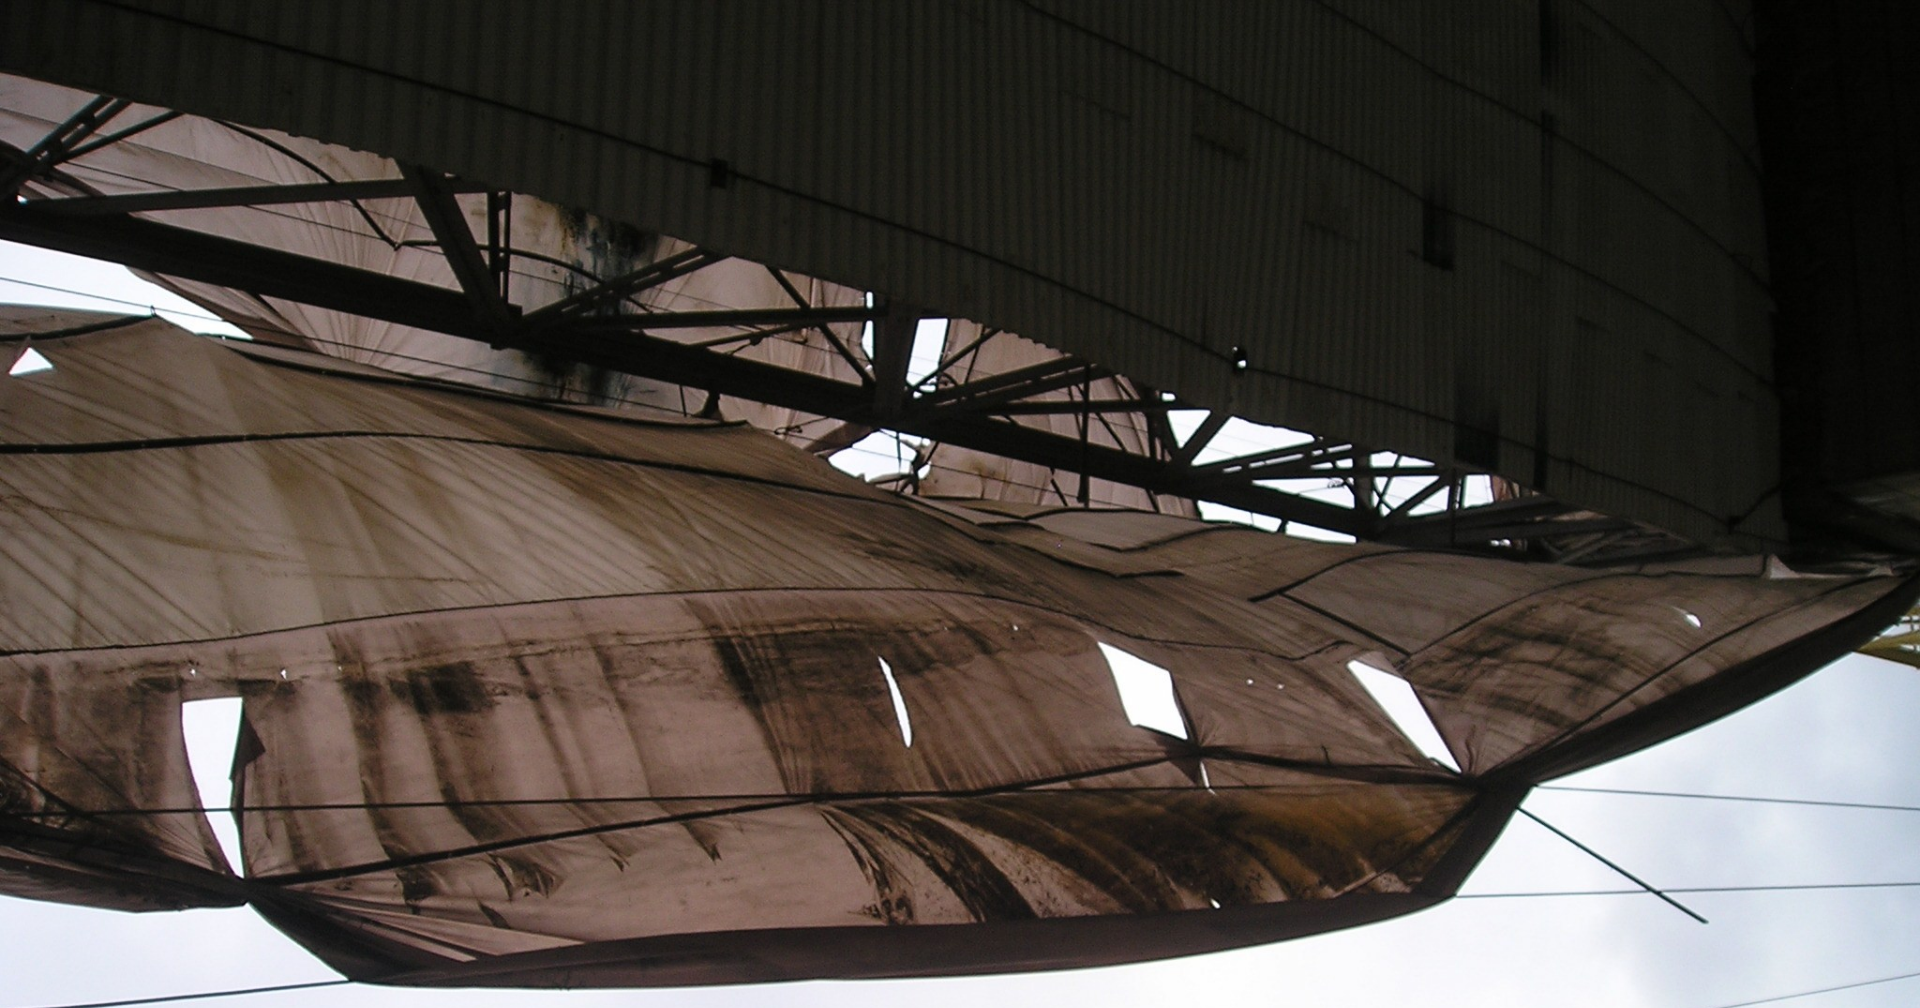
Tarps in the electric lines
