Cross beam replacement

Rocker Replacement Ohio tower

Painting

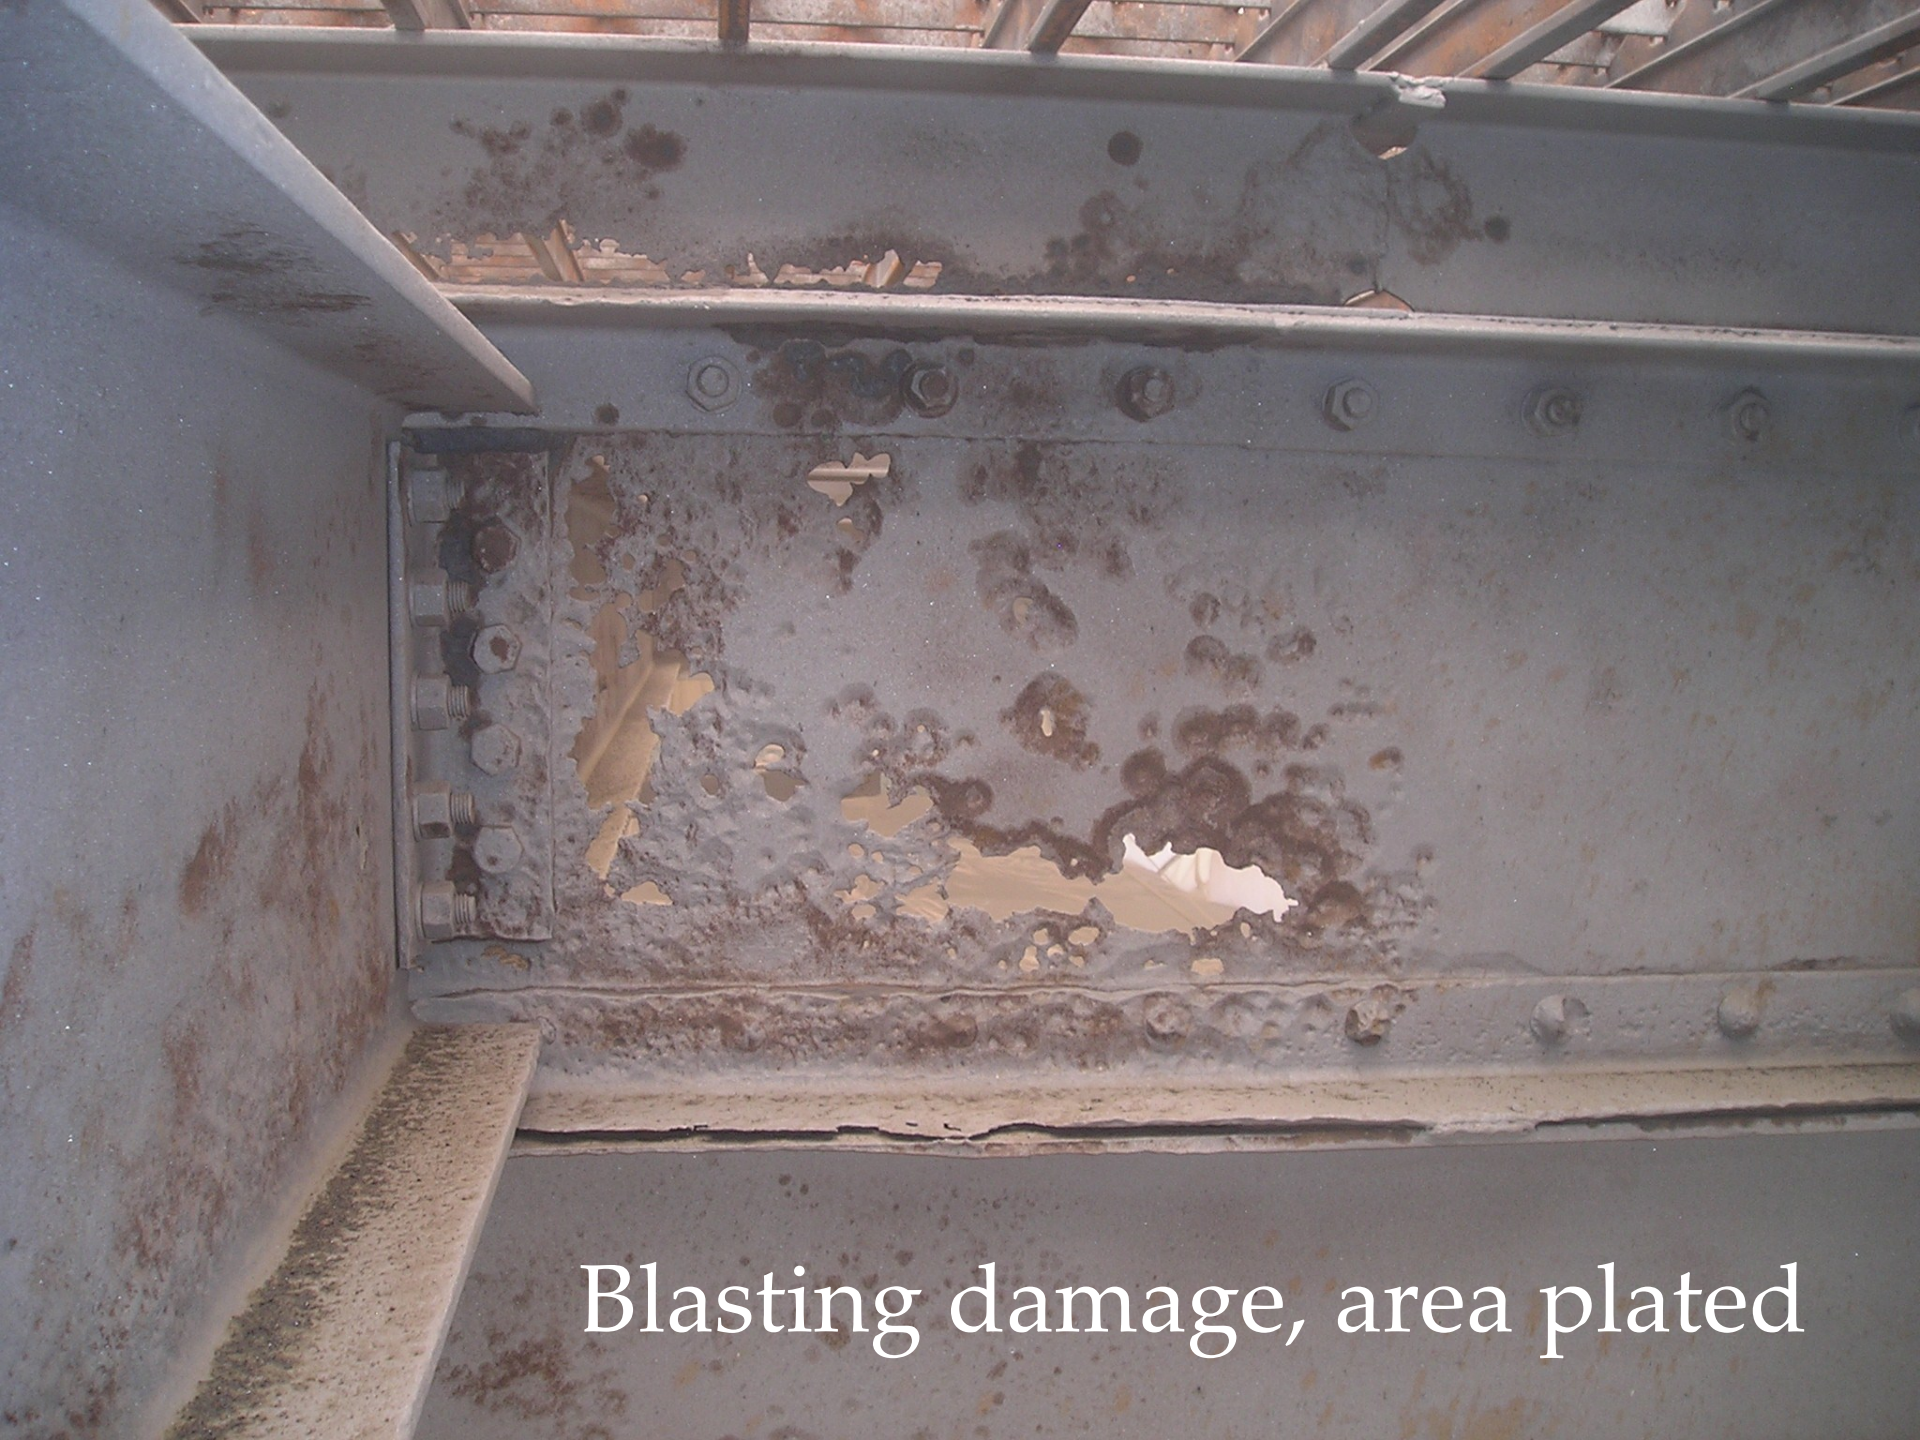
Blasting damage, area plated

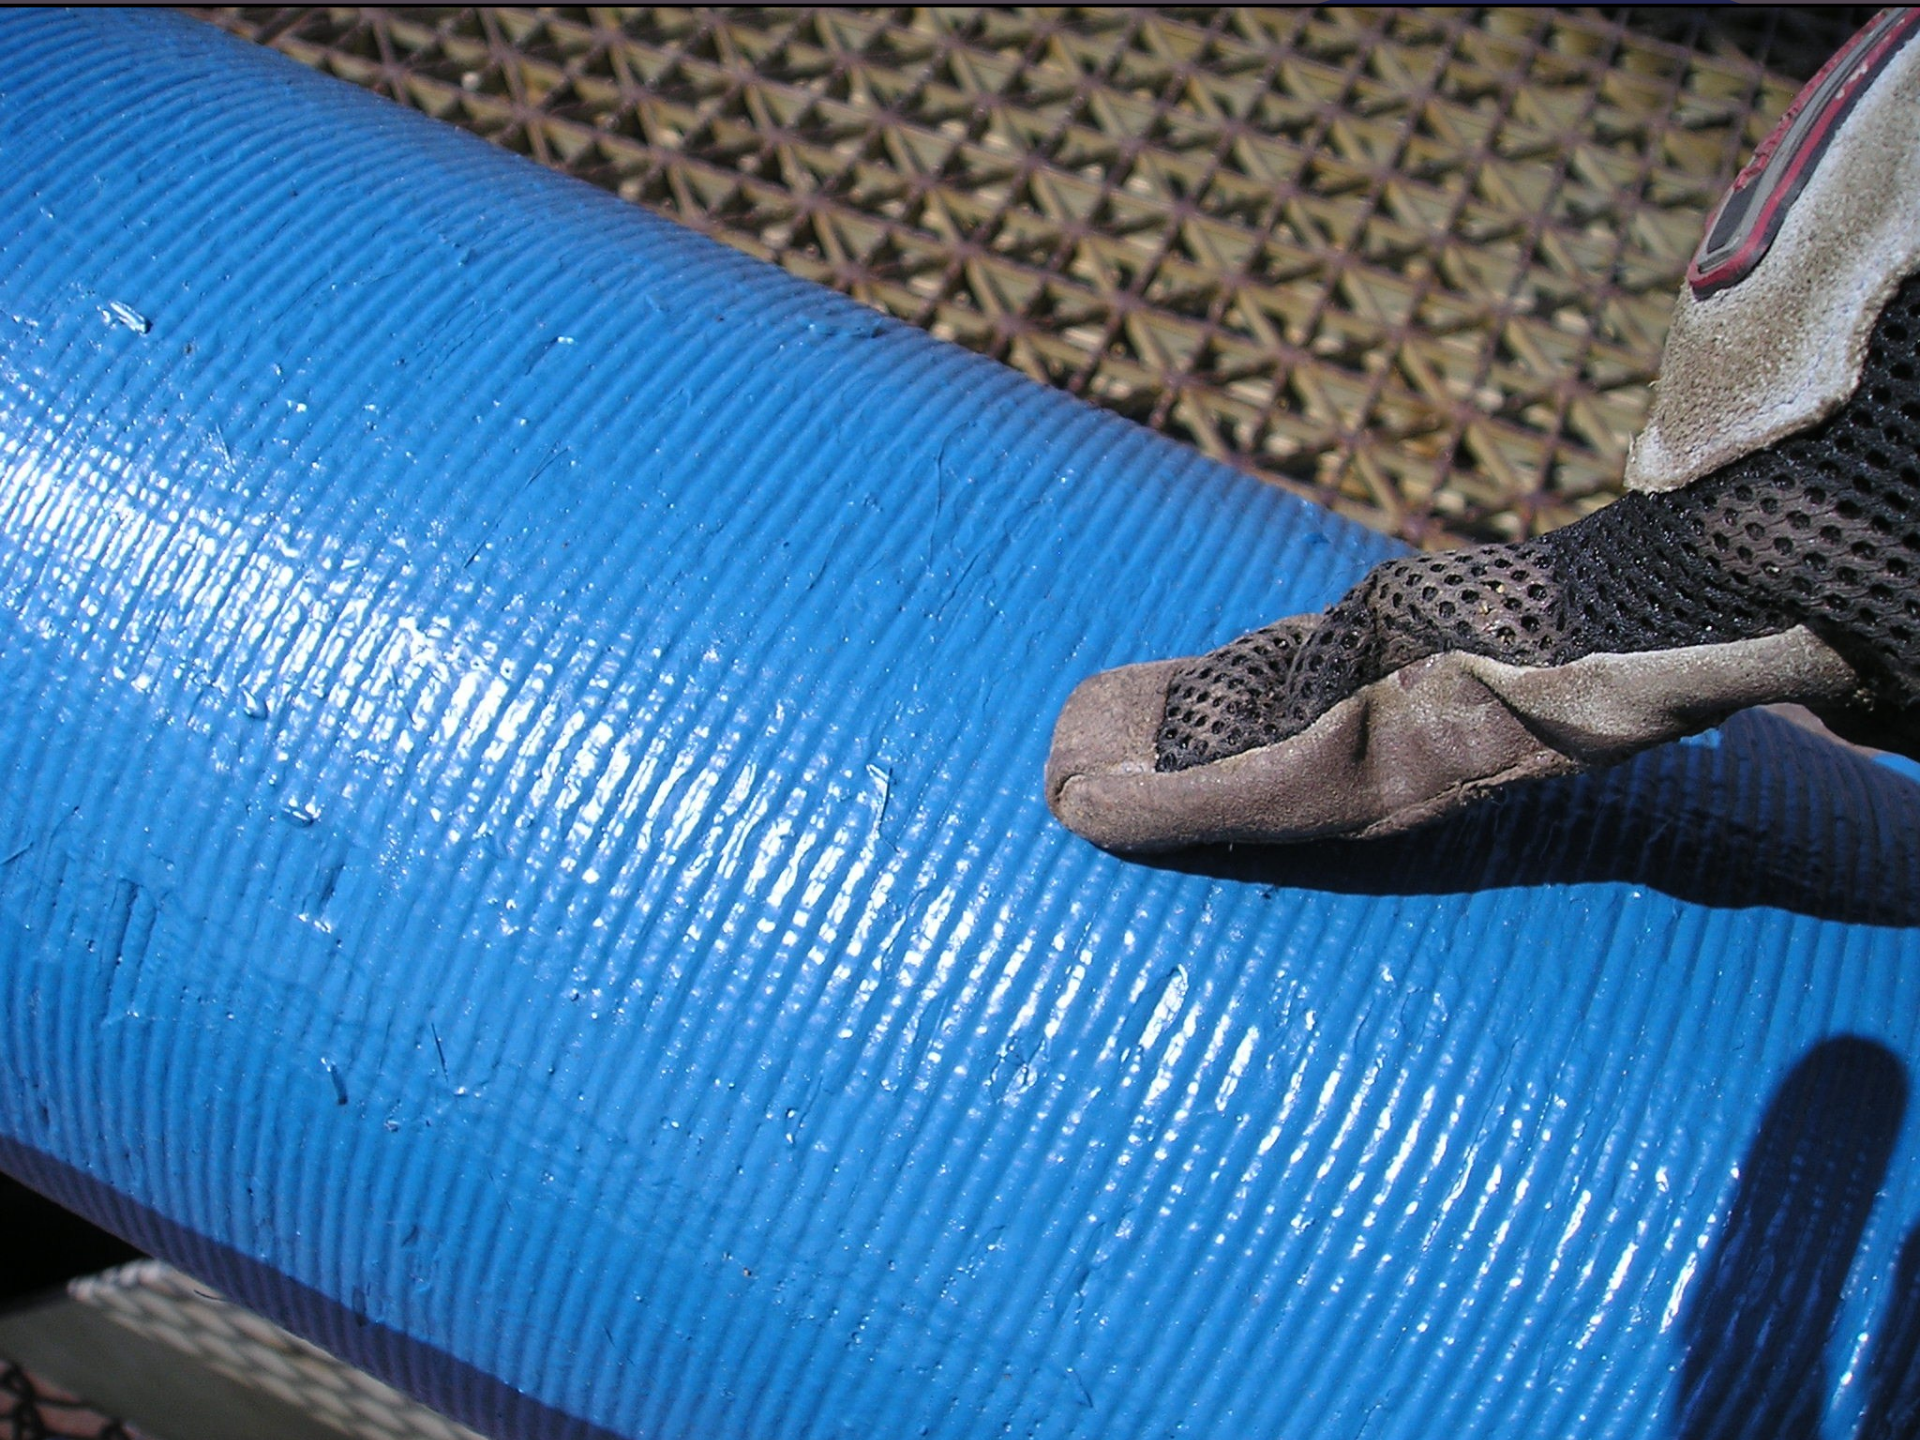
Still elastic on hot days

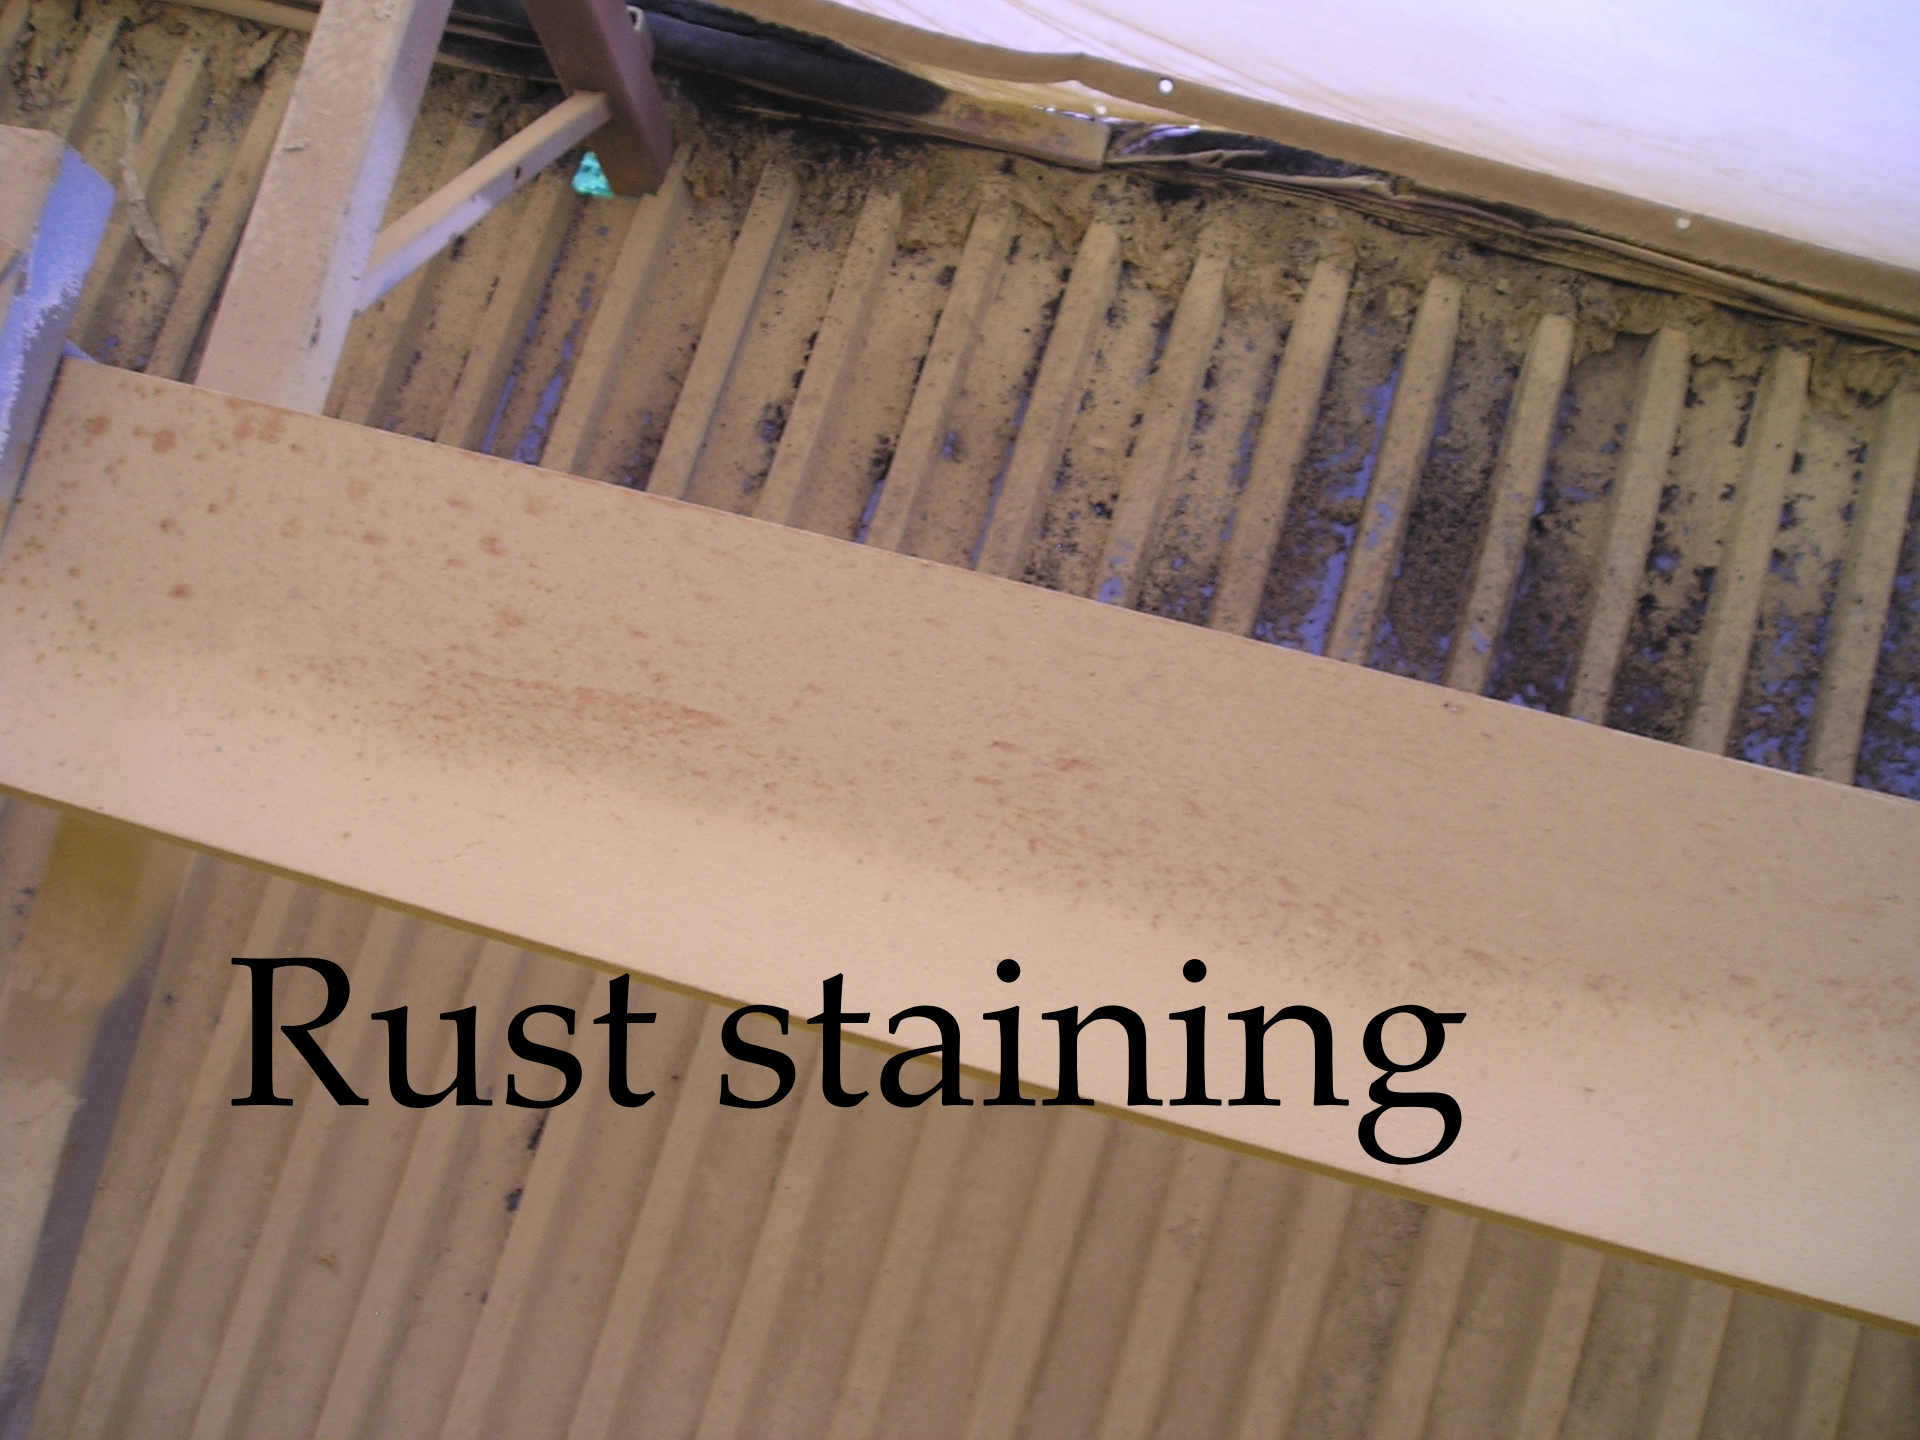
Rust staining

Painting contractor hired KTA to review paint

KTA advised the rust was on the surface not coming from the steel

The penetrate sealer would push water out of pack rusk joints which then would stain the surface. Contractor wiped stains with paint thinner and they would come off. However, we do have the staining across the bridge. The paint manufacture reviewed the issue and came to the same conclusion, and said it would not affect the warranty.

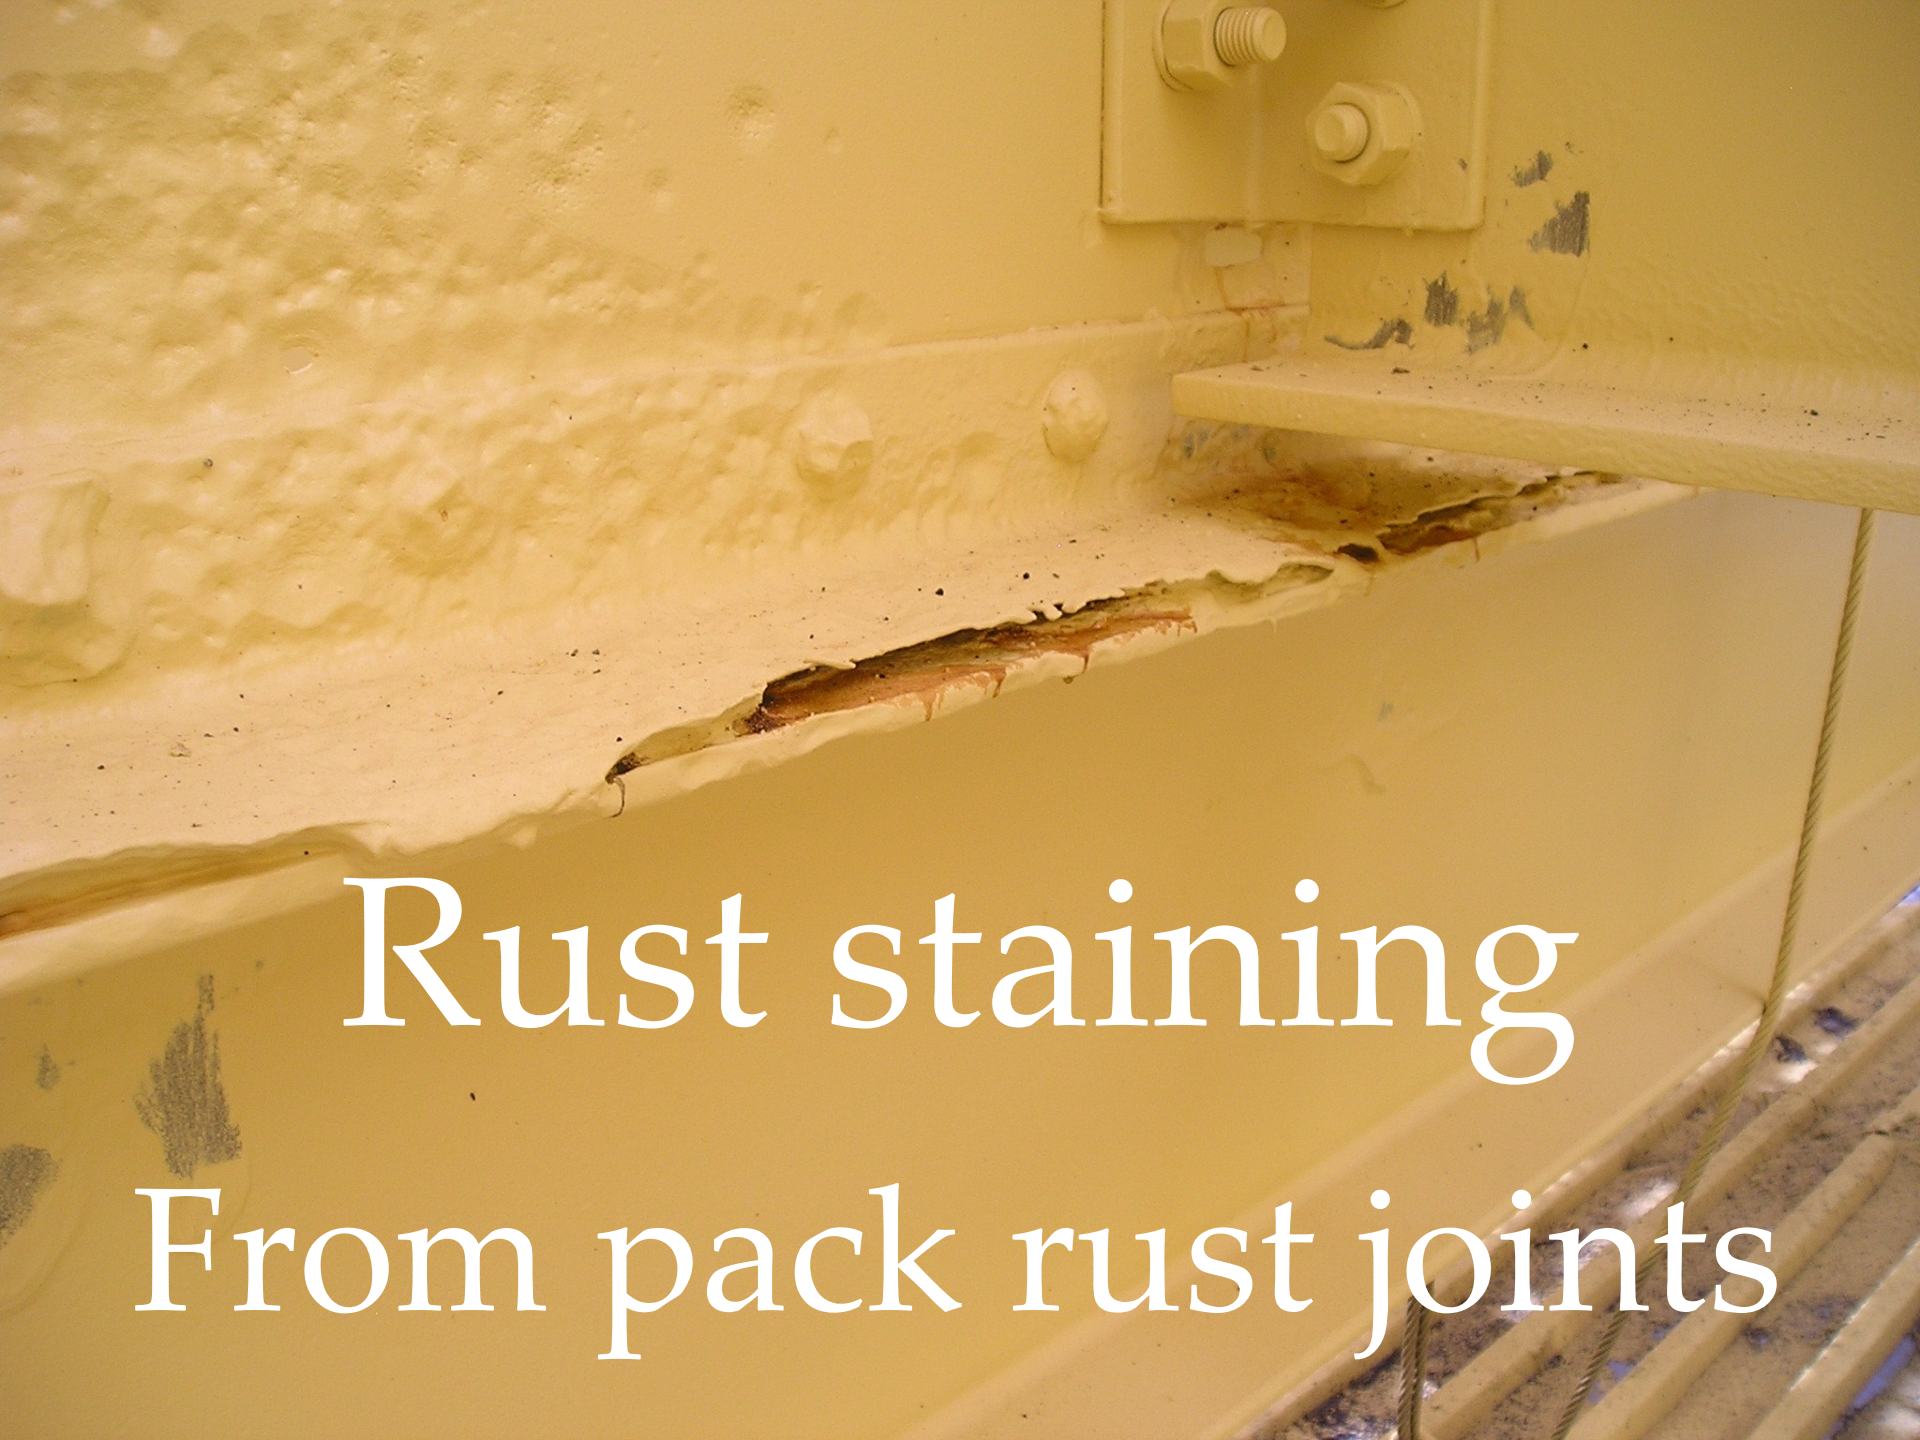
Rust staining

From pack rust joints

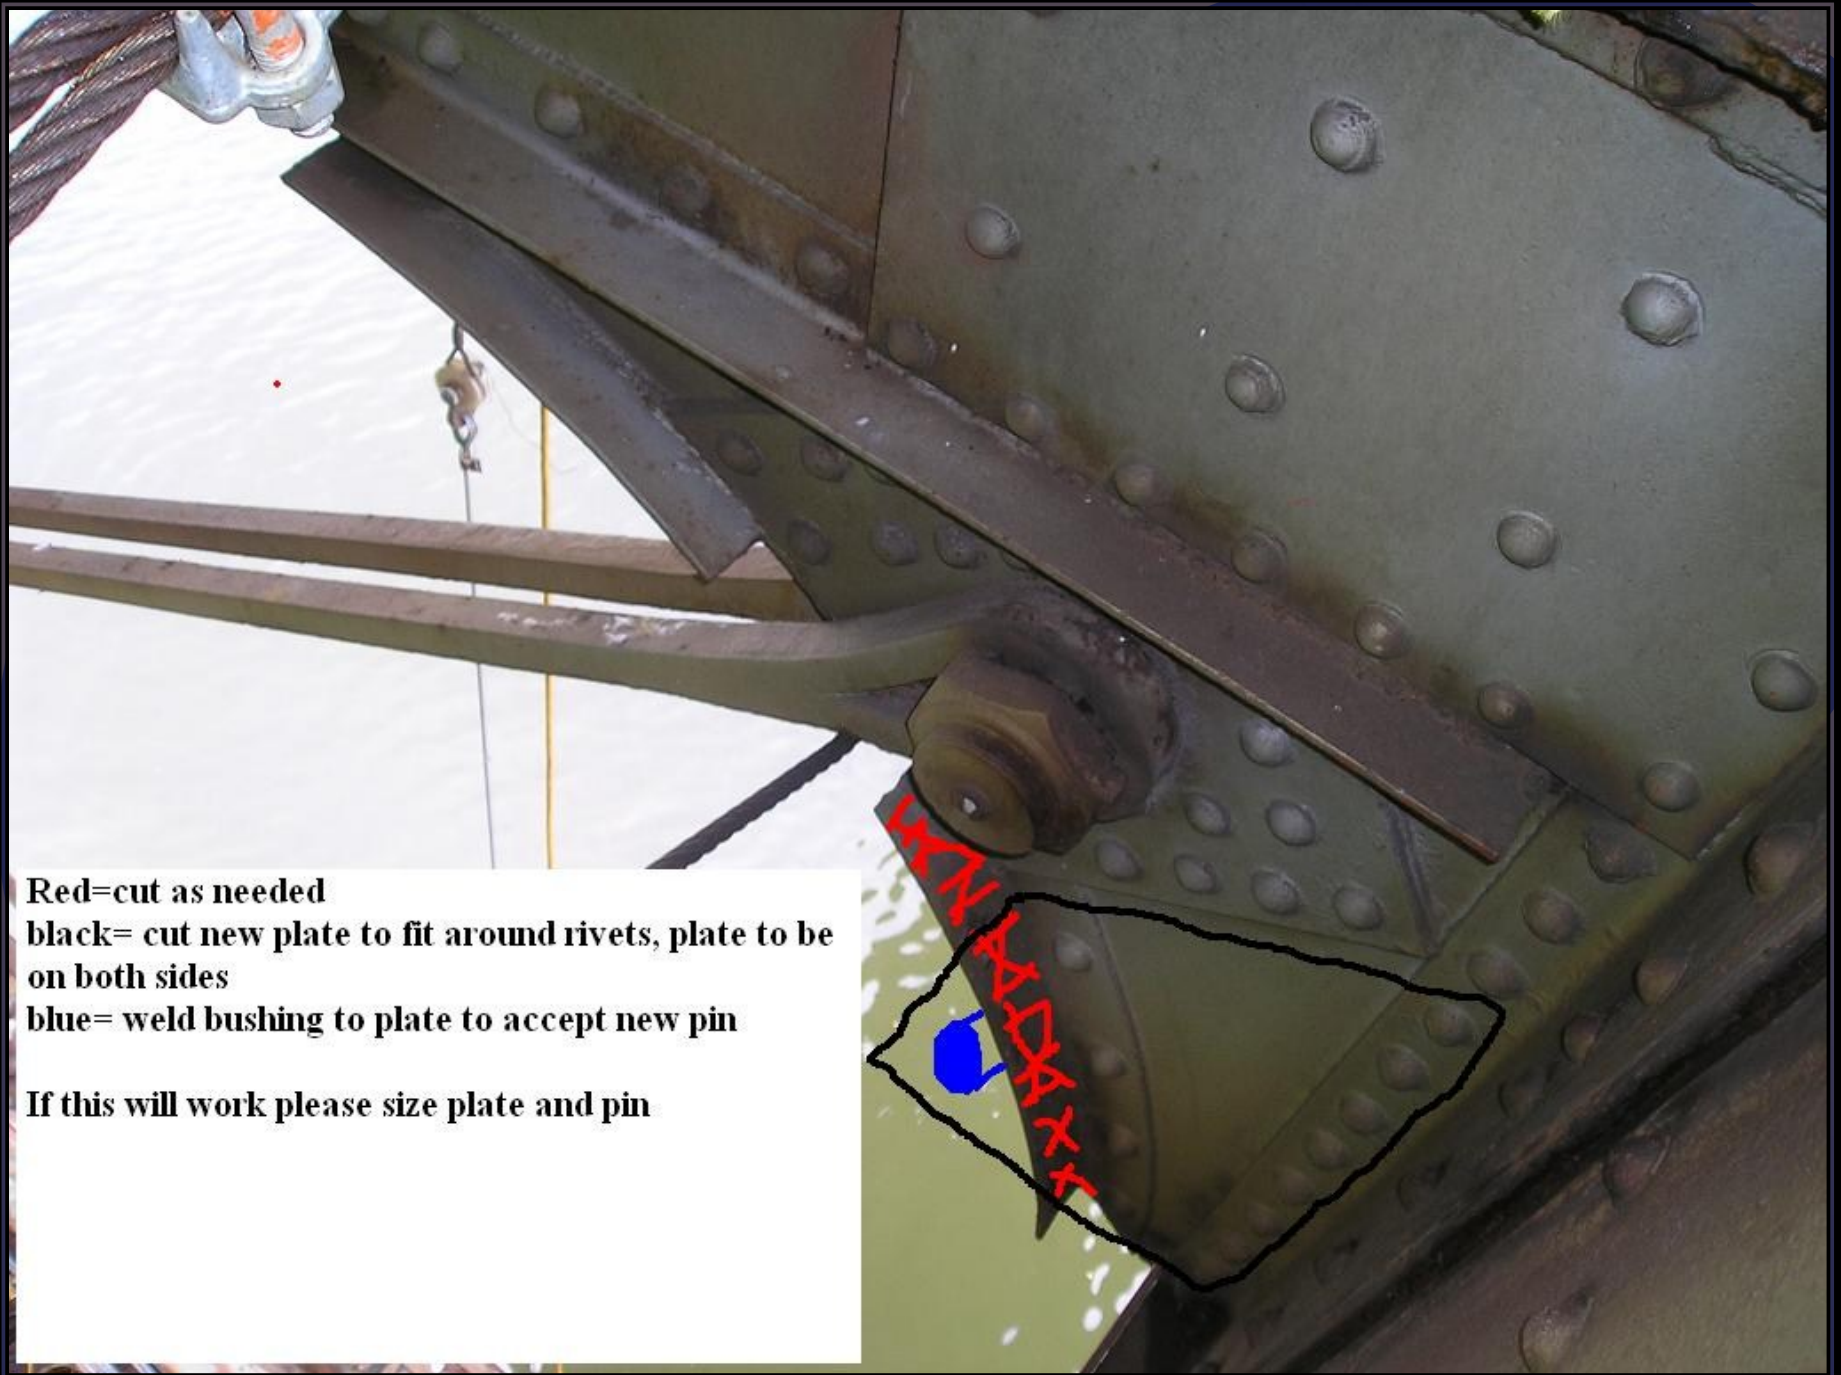
Red=cut as needed

black= cut new plate to fit around rivets, plate to be on both sides

blue= weld bushing to plate to accept new pin

If this will work please size plate and pin

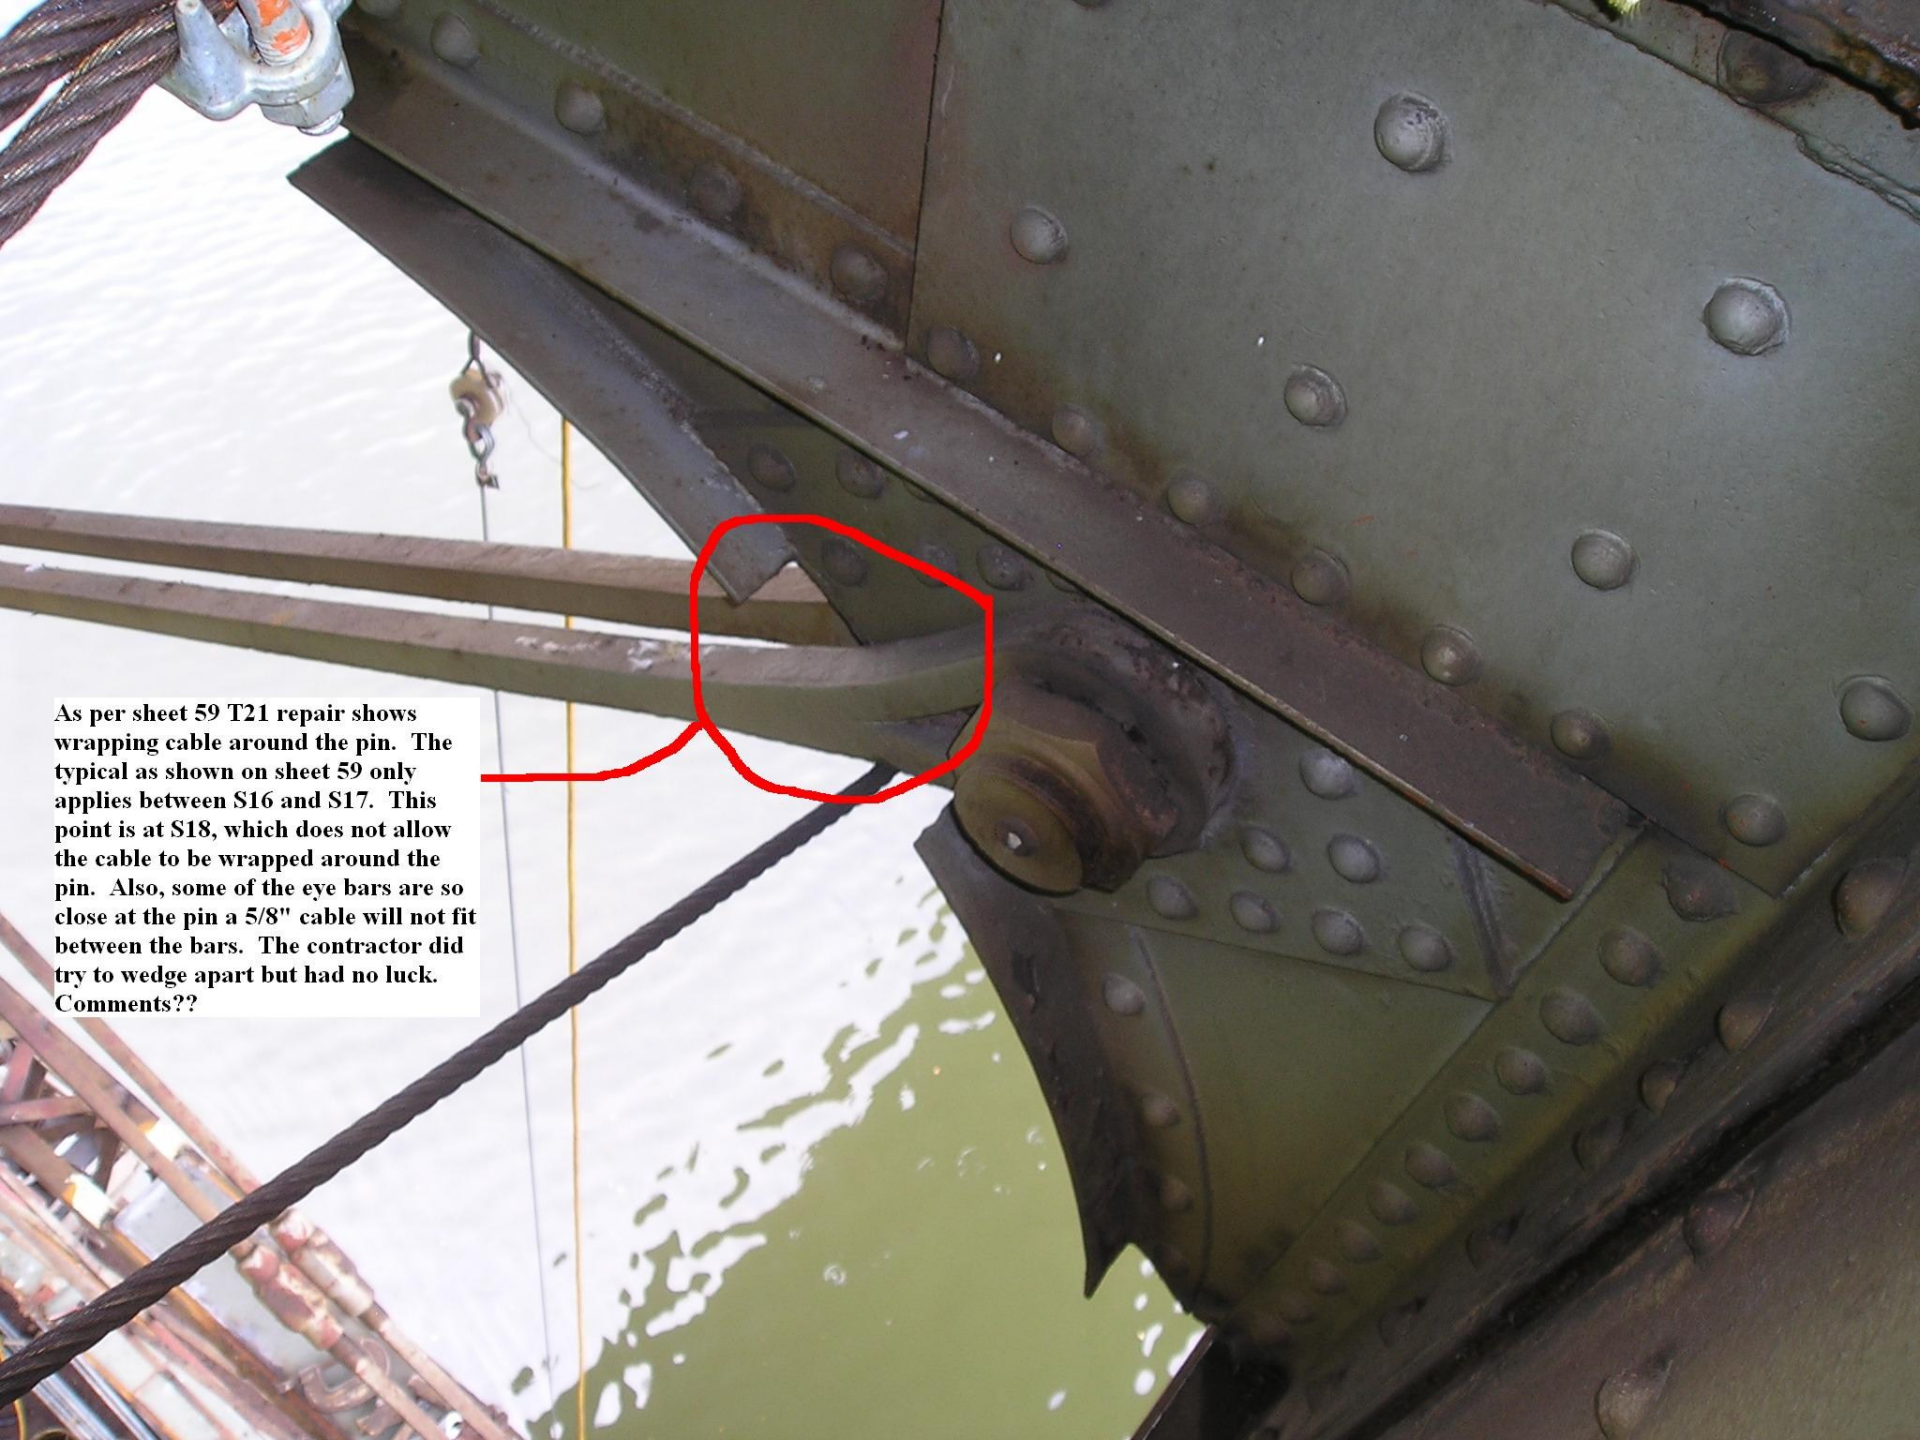
As per sheet 59 T21 repair shows wrapping cable around the pin. The typical as shown on sheet 59 only applies between S16 and S17. This point is at S18, which does not allow the cable to be wrapped around the pin. Also, some of the eye bars are so close at the pin a 5/8" cable will not fit between the bars. The contractor did try to wedge apart but had no luck. Comments??

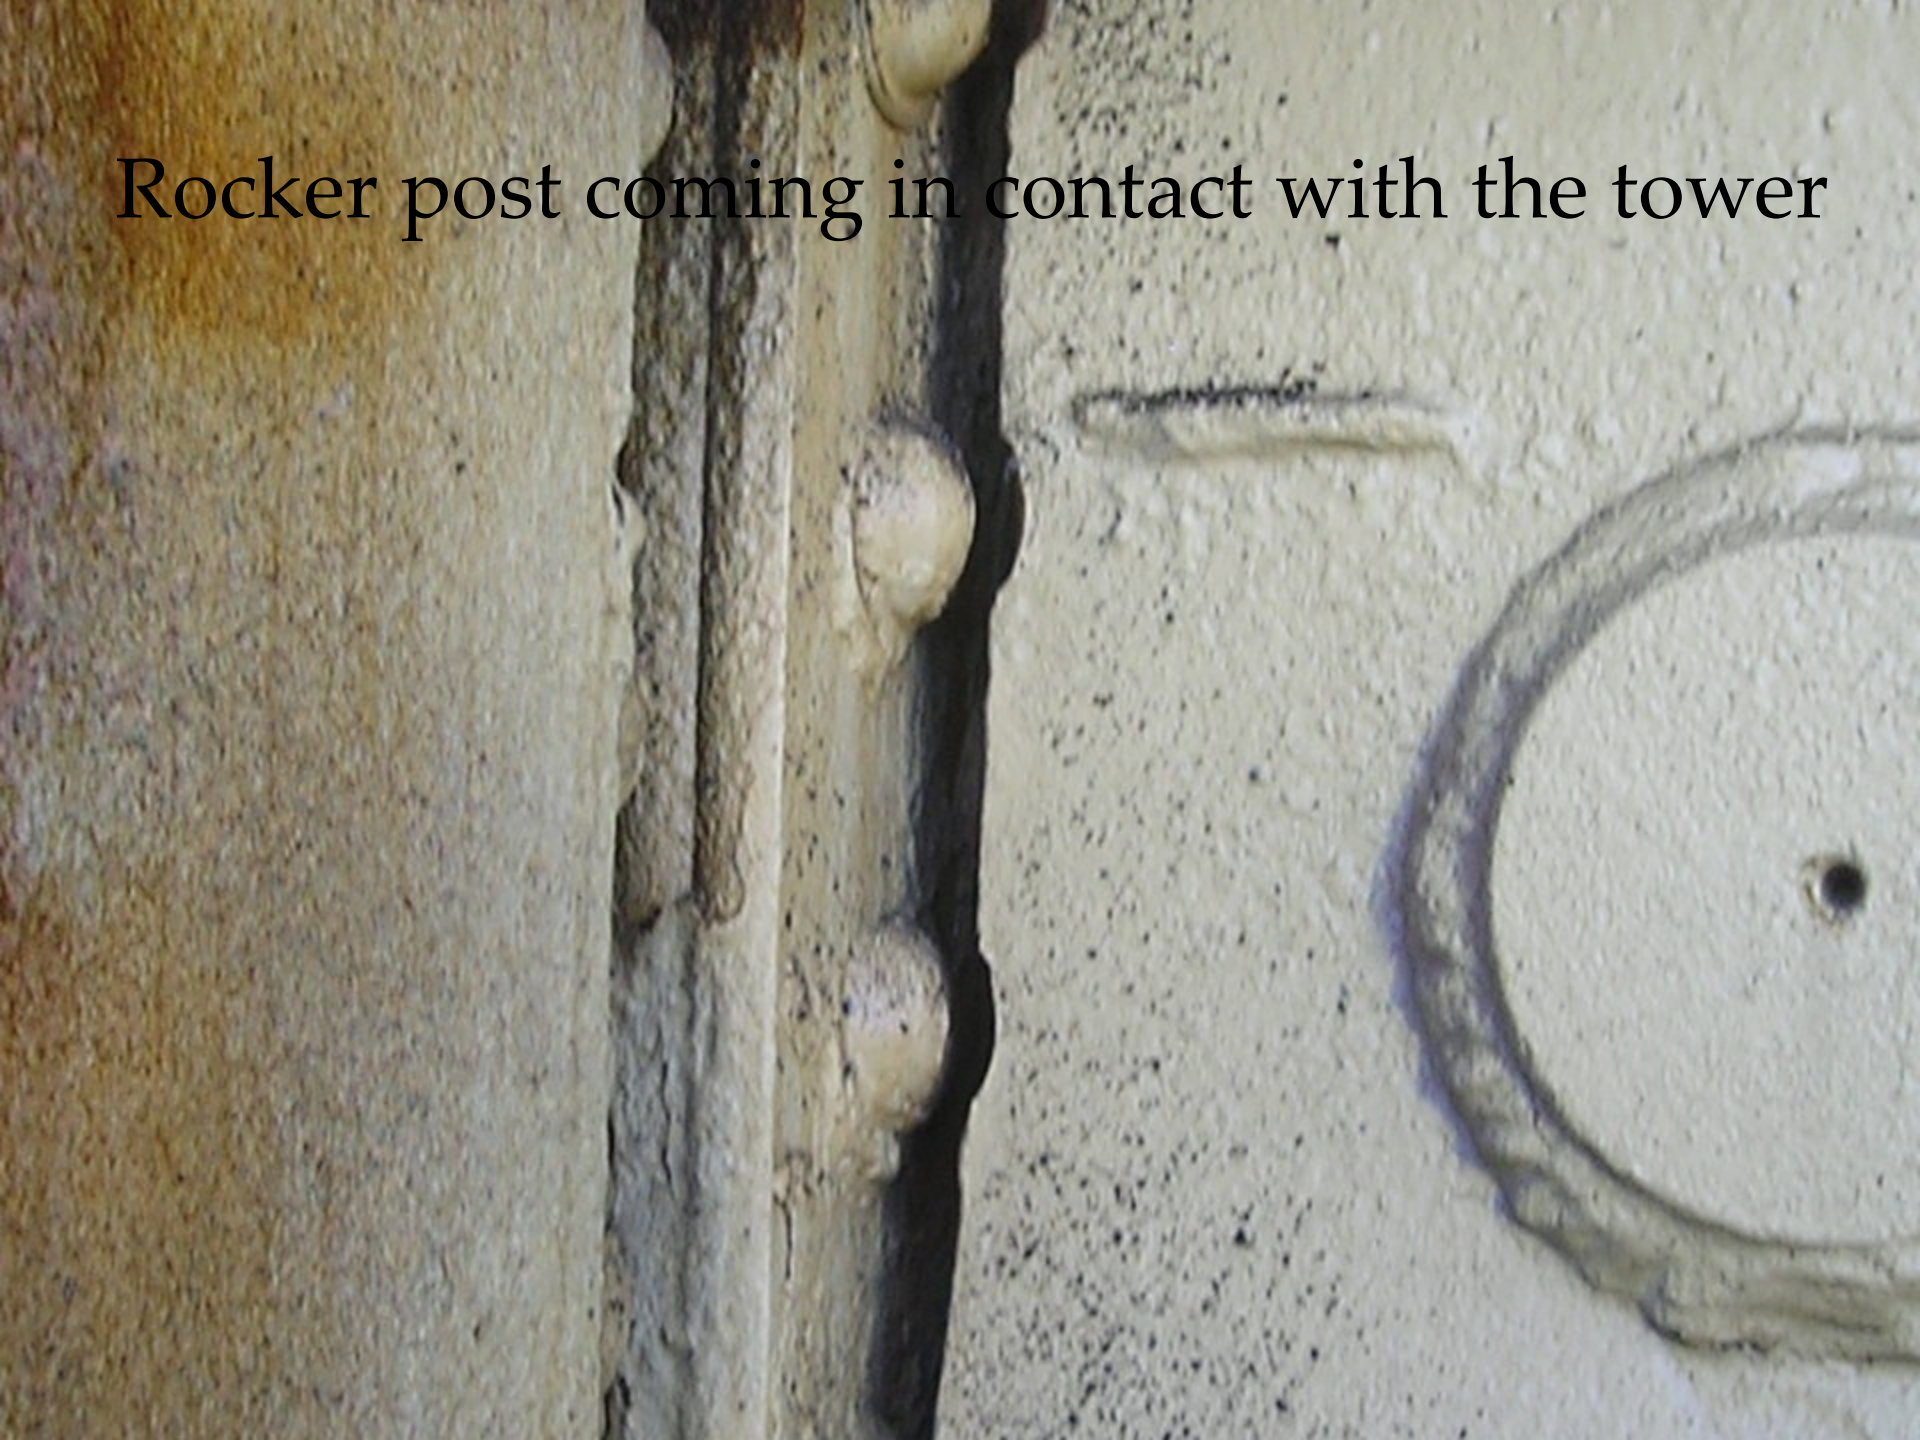
The Rocker post were discovered during the blasting operation that they were coming in contact with the towers. Also, a small crack in the low chord was discovered at the WV tower. The tooth dams were also discovered not to have enough room for expansion. Burgess & Niple inspected the areas of concerns and developed correction plans. 3 additional rockers were replaced and the tooth dams were trimmed as well as the low chords.

Rocker post coming in contact with the tower

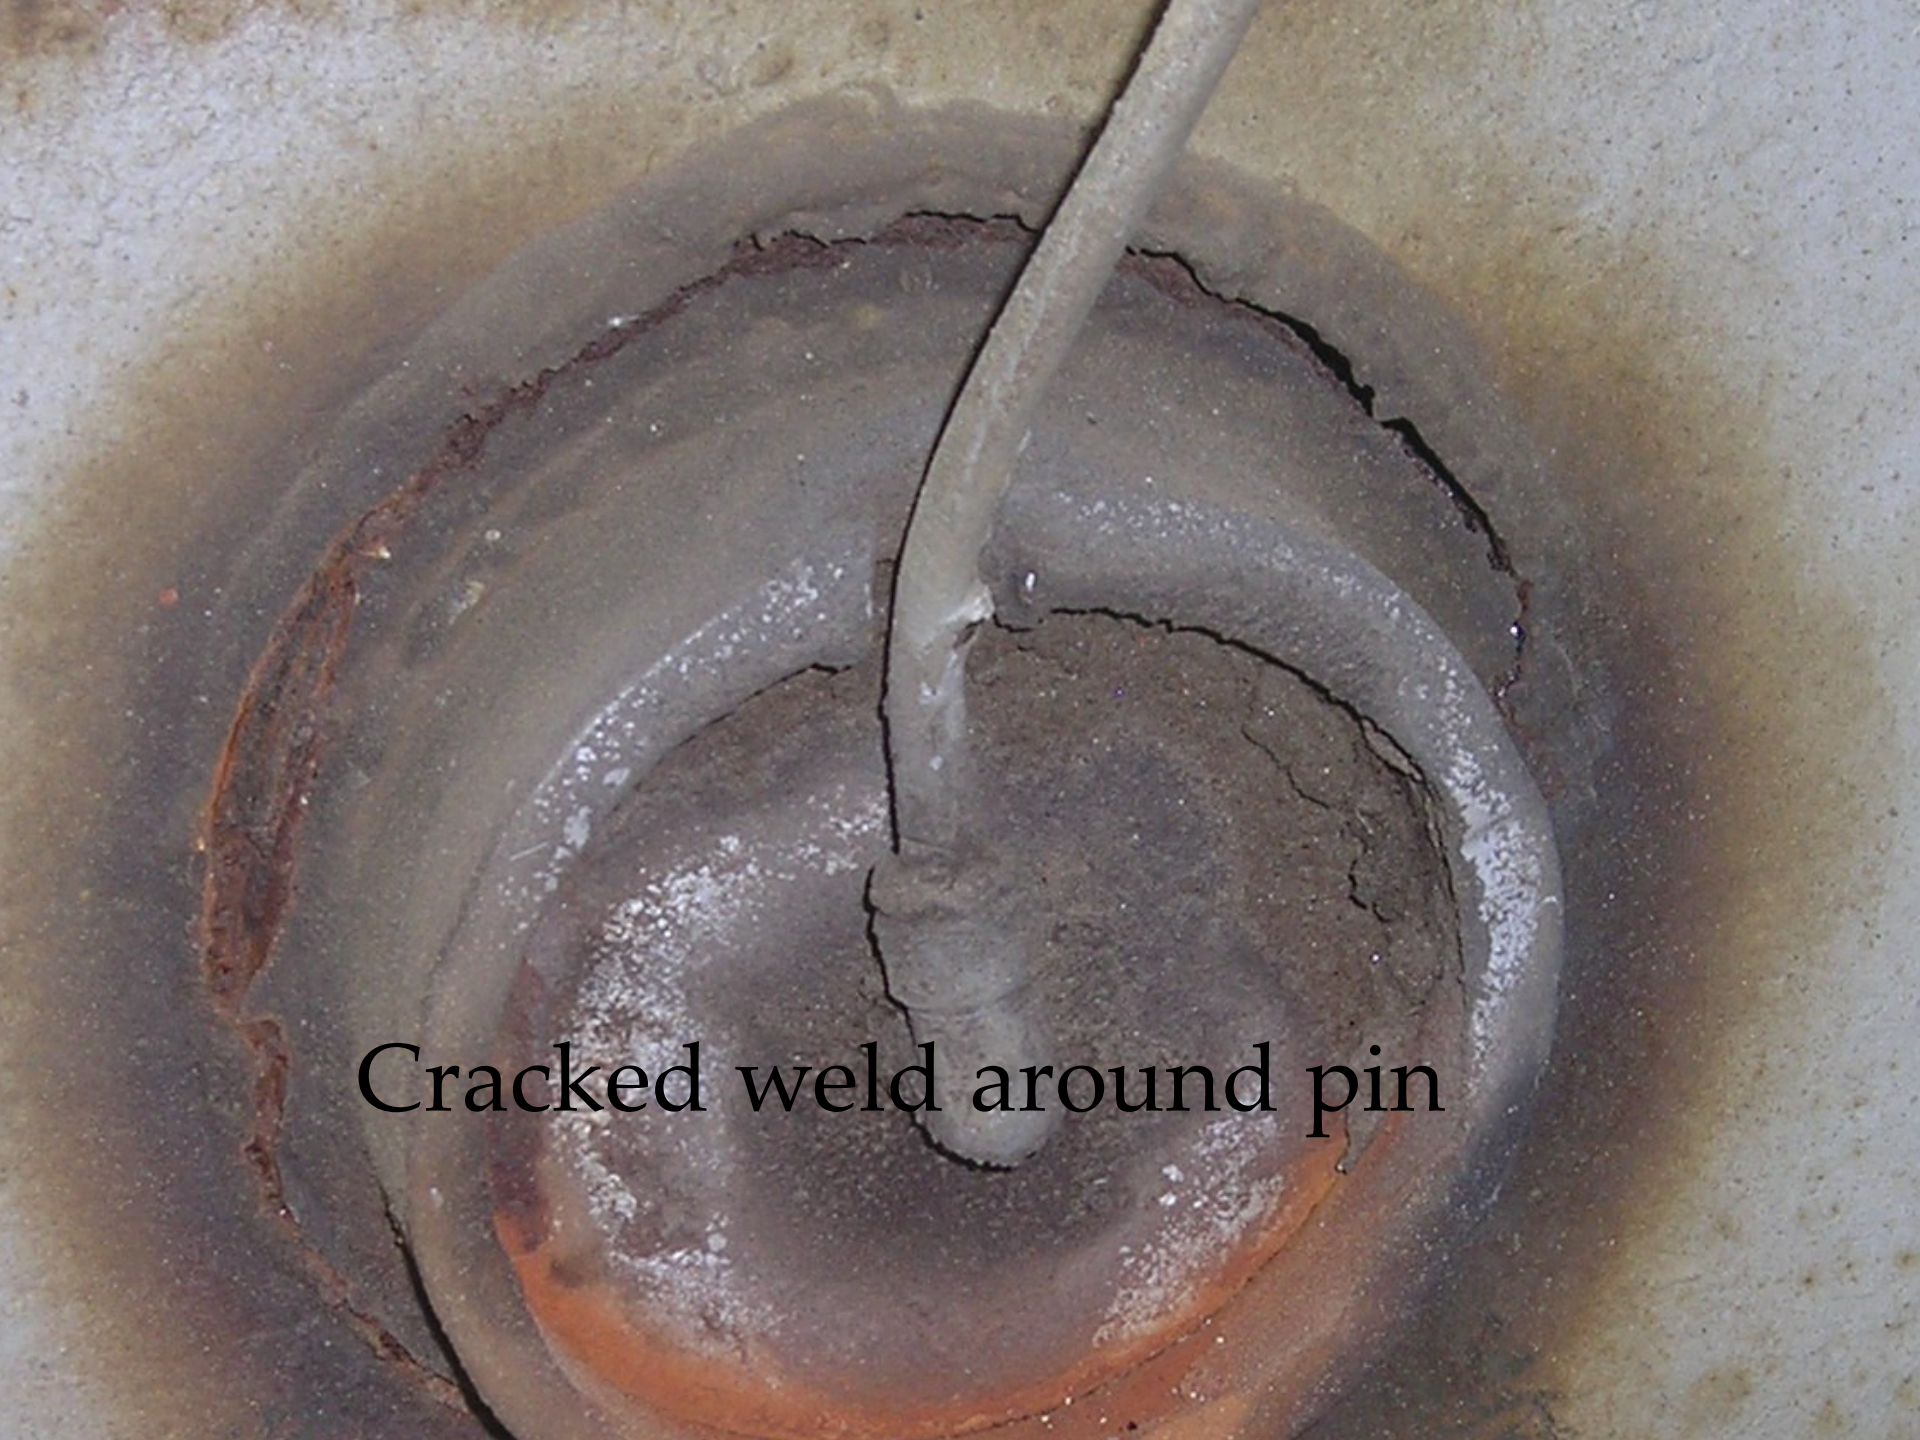
Cracked weld around pin
