Cross beam replacement

Rocker Replacement Ohio tower

Painting

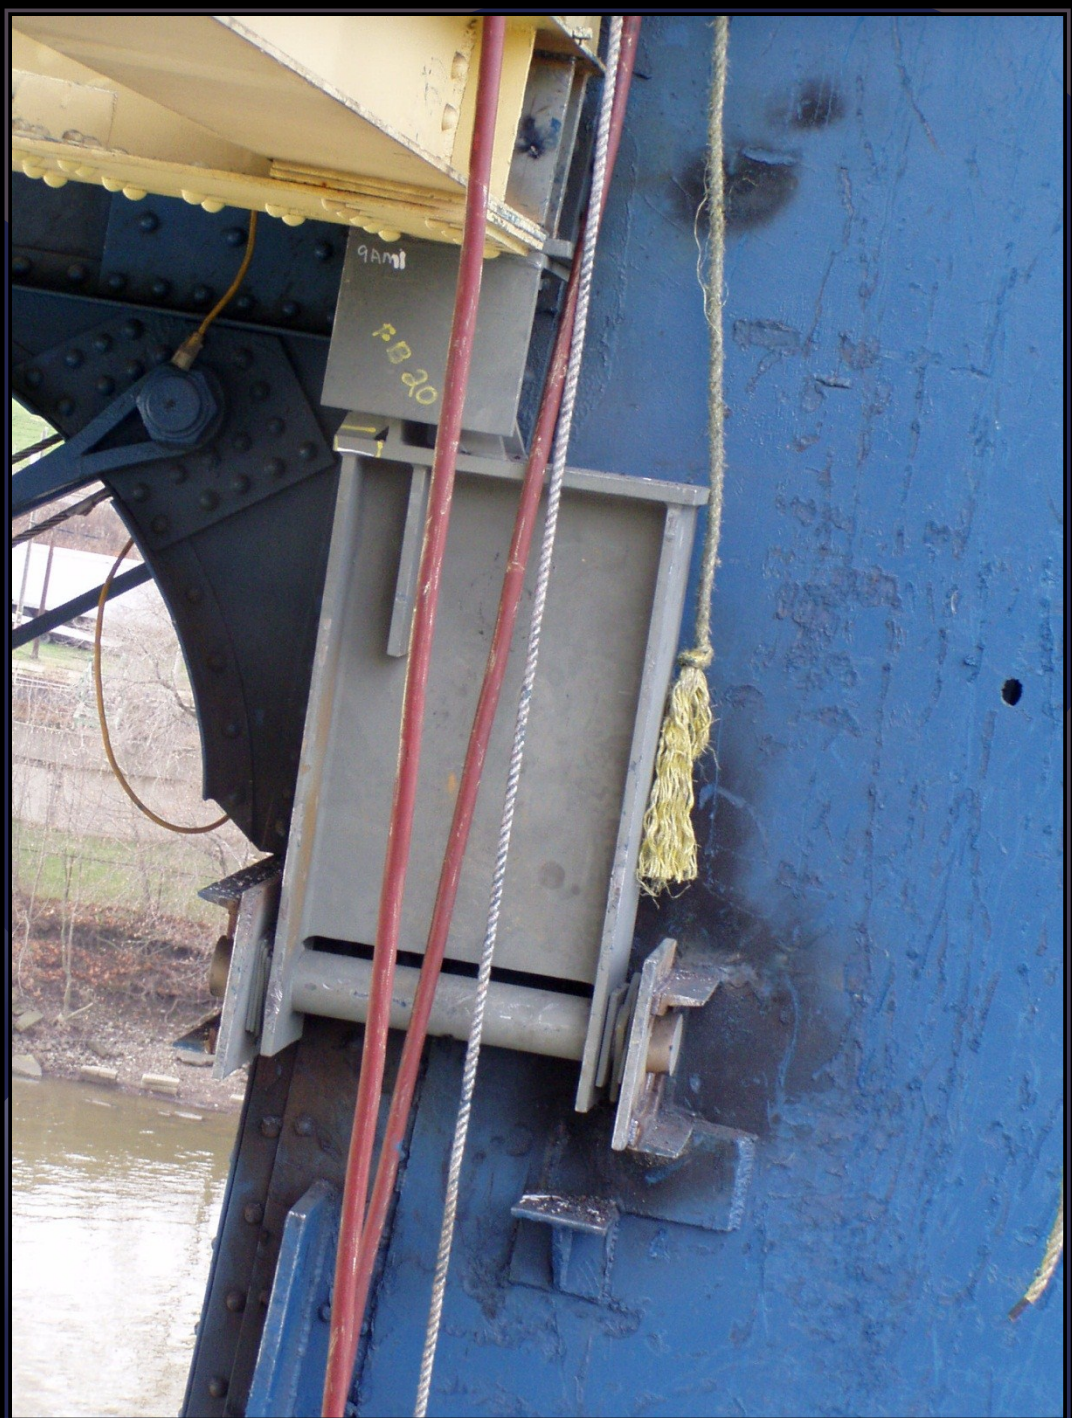
New rocker in place ,
Ohio tower
