# Detailed Alternatives Analysis for the AGSM Bridge Replacement Environmental Assessment

The following report details the analysis of alternatives for the PFC Abraham G. Sams Memorial (AGSM) Bridge Replacement Project. It describes the development of the range of alternatives considered and the selection of a Preferred Alternative for carrying through the Environmental Assessment, prepared in accordance with the National Environmental Policy Act (NEPA).

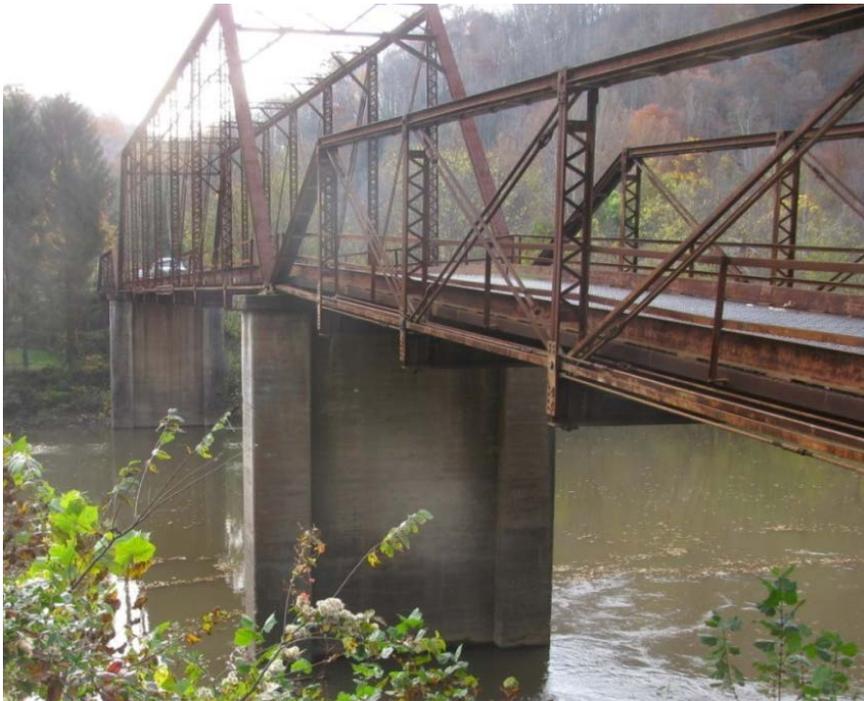
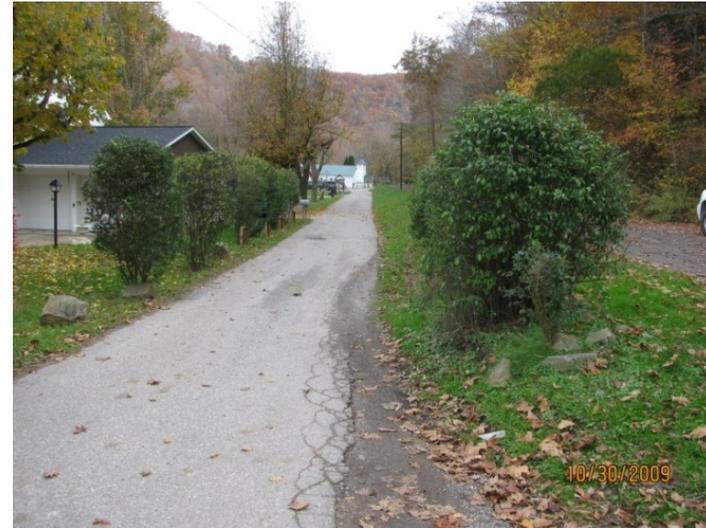
**Figure 1:** Project area elements. Left = View of the AGSM Bridge from the north. Top Right = Neighborhood to the southeast of the bridge, including County Route 4/5, homes, a church, and an inactive railbed (visible on the right). Bottom Right = One of the bridge's many pin locations, where one element's failure would cause the bridge to collapse.

The West Virginia Division of Highways (WVDOH), in cooperation with the Federal Highway Administration (FHWA), has considered a wide range of alternatives for replacing the PFC Abraham G. Sams Memorial Bridge (AGSM Bridge), also known as the Camp Creek Truss Bridge. This bridge carries Clay County Route 4/5 (CR 4/5) over the Elk River. Views within the Project Area are shown in Figure 1.

Based on the findings of a bridge inspection performed by WVDOH in 2000, the existing bridge was found to have a sufficiency rating of 40.1 out of 100<sup>1</sup>. The 2012 inspection found "fracture critical" locations where, if a break occurs, the bridge fails. The bridge piers exhibit cracking and spalling, and various pieces of the truss display substantial loss, with rusting and holes. The bridge and an example of its rusted pin locations are shown in Figure 1.

In addition to these challenges, removing the middle span with a large crane poses a particular risk of bridge debris collapse into the river because of structural instability. The swinging and twisting motion would stress the fracture critical pin locations (see example in Figure 1). Therefore, to avoid the risk of uncontrolled collapse and impacts from

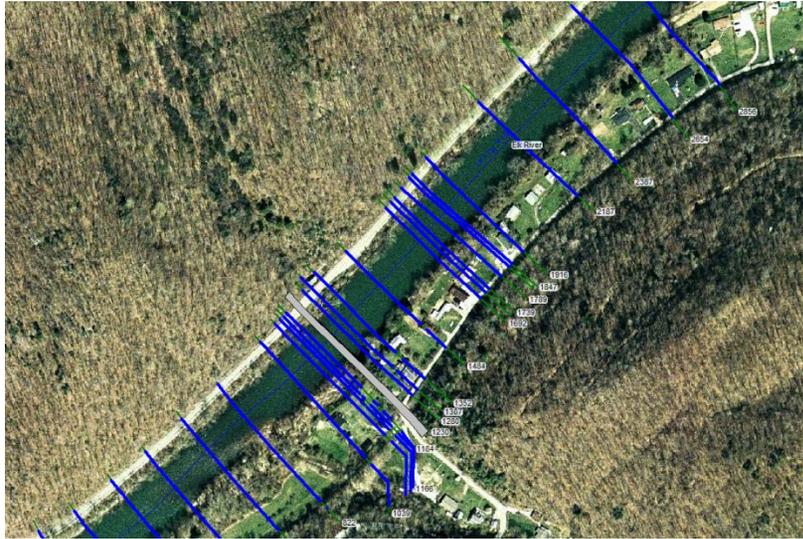
**Figure 2:** Depiction of flooding in Project Area. **Left** - Plan view above Project Area, with existing bridge shown in gray and blue lines indicating the breadth of 100-year floodwaters. **Right** - Profile cross-section view, looking downstream, at River Station 1739, approximately 600 feet upstream of the existing bridge. Blue indicates 100-year floodwaters, which inundate the banks, including CR 4, CR 4/5 (the bridge itself), and CR 4/6.

In addition to the impact to the mussels, this alternative is unacceptable because of safety and floodplain impacts. Currently, the existing bridge and a small adjacent community are located within the 100-year floodplain of the Elk River, constrained within a narrow valley. Unpredictable and uncontrolled collapse of the bridge poses safety concerns to people using the river or bridge for recreation or travel. Hydraulic and hydrologic studies show that leaving the existing bridge piers in combination with a new bridge would increase the 100-year flood elevation. As shown in Figure 2, the existing 100-year floodplain already inundates the banks, and any increase is unacceptable.
