WEST VIRGINIA DEPARTMENT OF TRANSPORTATION DIVISION OF HIGHWAYS MATERIALS CONTROL, SOILS AND TESTING DIVISION

MATERIALS PROCEDURE

GUIDE FOR EVALUATION OF ASPHALT PAVEMENTS WITH SUBSTANDARD PROPERTIES

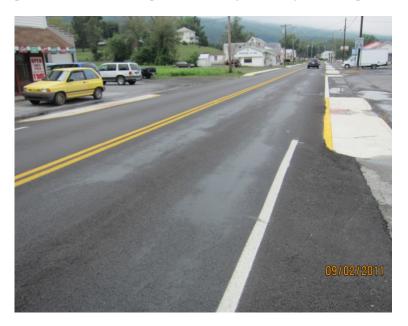
10.1 *Flushing and Bleeding* occur when the liquid asphalt cement comes to the top of the mix surface generally under traffic loading and are usually in the form of long streaks or strips along the wheel paths within the mat. *Fat Spots* are more isolated areas where liquid asphalt comes to the surface of the mix, but are not necessarily concentrated in the wheel paths. They can occur anywhere across the mat and generally occur during the laydown and compaction process, and in many cases result in very thick patches of free liquid asphalt on the surface of the mat. These characteristics may result from a high AC or in-place density, low VTM or VMA, or an excessively fine gradation. These types of distresses are serious in nature and not easily addressed with remedial treatments. Pavements in this condition often eventually rut, shove, and can present numerous safety concerns.

Excessive Bleeding and Flushing along wheel paths in new asphalt pavement.

- 10.1.1 The above defects are all indications of excess binder in the mix and should be considered for removal and replacement if the areas are large enough, occur in a pattern and affect a significant portion of the mix. Specifically, any flushing that extends more than about 30 feet in length and occurs in multiple locations as opposed to an isolated area is a cause for concern. Fat spots that are relatively small (less than approximately 12 inches in diameter) and occur only occasionally are not generally a concern. However, large fat spots (greater than 12 inches in diameter) and/or fat spots prevalent throughout the mat are a concern. The best action is to remove and replace the affected area.

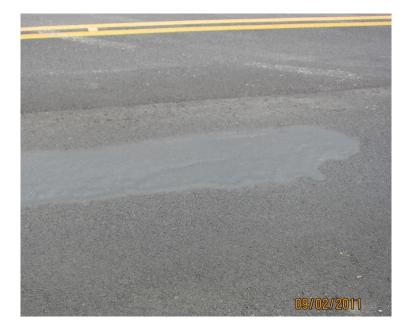
Excessive Fat Spot in new asphalt pavement.

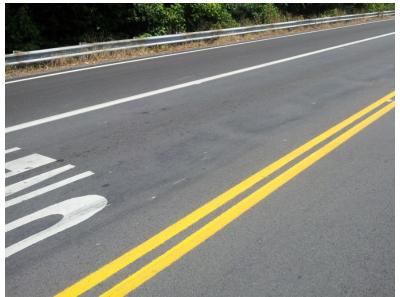
- 10.2 Locations of *rutting or shoving* often occur corresponding to areas exhibiting flushing and bleeding. Again, these types of distresses are serious and present numerous safety concerns. Excessively deep pavement ruts can be a significant hazard to drivers. Along with a likely decreased skid resistance to begin with, water can pond in ruts and create a potential for vehicular hydroplaning and excessive spray, which can obscure a driver's vision. Ponded water may also freeze in cold temperatures and result in the formation of ice.

Excessive rutting and shoving in new asphalt pavement. Note the displacement of the road lettering. Also note the presence of corresponding flushing of liquid asphalt.

- 10.2.1 Therefore, rutting that occurs within the first three months of service life and exceeds ¹/₄ inch may be an indication of further rutting and should be monitored further. Additionally, rutting that occurs within the first three months of service life and exceeds ¹/₂ inch is considered a safety hazard and remediation is required. The best action is to remove and replace the affected area.

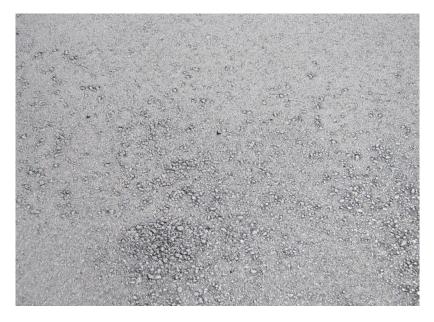
10.3 A *segregated* mat can result from a number of factors ranging from the aggregate stockpiles at the asphalt mixing plant to the paving equipment at the project site. If segregation is widespread over several hundred feet of continuous pavement, removal and replacement of the affected area is probably the best option. When the segregated areas are discontinuous or "spotty," removing and replacing various areas introduces a number of new construction joints. This scenario may often be less desirable than the original, segregated mat. In these cases, a fine-textured seal course is an option to consider for the affected locations.

Segregation in new asphalt pavement, Superpave 9.5 mm mix.

Additional guidance on the evaluation of and severity of segregation can be found in Standard Specifications Section 410, Part 410.7.3 and use of MP 401.07.24.

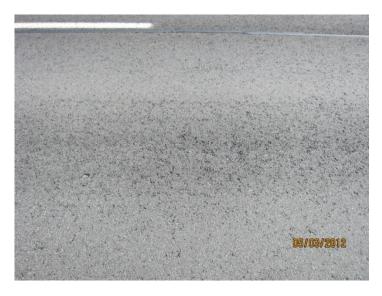
10.4 *Raveling* generally begins with the loss of surface fines or smaller aggregates, and then progresses to include larger aggregates sizes. It often occurs within a segregated mat after exposure to traffic and climate. For this reason, raveling is considered serious because some amount of coated aggregate has already been lost at the pavement surface, presenting more opportunity for moisture infiltration or premature oxidation.

Photo shows excessive raveling of pavement within an area of segregation during first year of service – 12.5 mm Superpave mix.

As with segregation, if the raveling is widespread and generally continuous, removal and replacement of the affected area is probably the best option. Excessive raveling and segregation can result in premature cracking of the asphalt pavement. However, when the raveled areas are discontinuous, removing and replacing various unconnected areas introduces a number of new construction joints. This scenario may often be less desirable than the original pavement. In these cases, a fine-textured seal course or micro surfacing may be an option to consider for the affected locations.

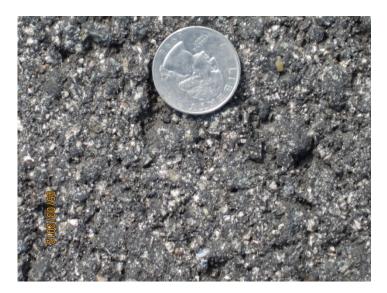
Photo showing close view of raveling from photo above.

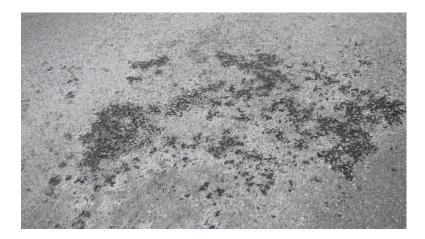
Photo shows advanced raveling and segregation of a Superpave 12.5 mm mix.

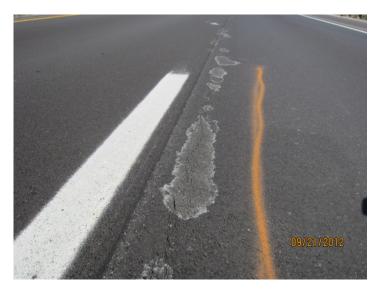
10.5 *Tearing or pulling* is another defect that can be found in newly placed mat. The mat can be torn or pulled by a paver that is traveling too fast, a paver with a screed that is worn or not heated properly, compacted by a roller that is traveling too fast or rolling a tender mix. The areas affected will have reduced density and are more susceptible to raveling and to the adverse effects of moisture. Depending on the severity of the tears, it may become a safety concern. The best option is to remove and replace the affected area.

Tear in new asphalt pavement. Note water stains along cracks. Area has been marked for repair.

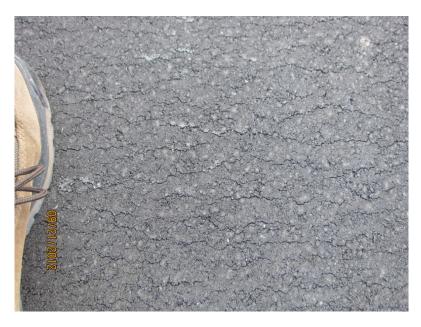
10.6 *Checking* is defined as short transverse cracks, usually 1 to 3 inches in length and generally a little less than 1 inch to as much as 3 inches apart, that develop in the surface of the mat during the compaction process. Although the cracks generally extend from about 3/8 inch to ½ inch in depth, they are considered detrimental to long-term pavement performance. It is necessary to determine if the cause for checking is primarily mix deficiencies resulting in a tender mix, or excessive deflection in a pavement structure under the compaction equipment. Mixes that exhibit checking are a direct indication of likely insufficient density; therefore, the pavement life under traffic will likely be greatly reduced.

Typical observations of checking in new asphalt pavement – Superpave 9.5 mm mix.

- 10.6.1 If it can be determined that checking is caused by the presence of a yielding foundation (such as by means of proof rolling to detect deflection or otherwise) under the new asphalt layer, the best solution is to remove and properly repair the existing pavement structure by also removal and replacement of the yielding subbase and/or subgrade material. This work may be outside of the scope of the original contract and will need to be evaluated prior to the repair process for contractual considerations.

- 10.6.2 If checking is determined to be the result of mix characteristics only, it may also be possible to seal the course affected by use of a fine textured asphalt mix or microsurfacing course or other seal course to the satisfaction of the Engineer. Otherwise, it may be necessary to remove and replace the areas affected.

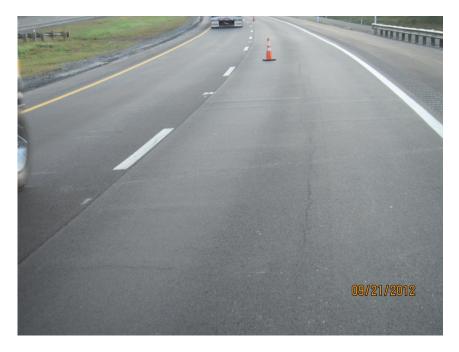
- 10.7 *Bumps* in the surface may be the cause of slight shoving and transverse tearing of the pavement, and will at a minimum cause an increase in roughness. If they are bad enough that tearing is present, they can lead to other issues described above. If not torn, the pavement's structural capacity is only affected if the bumps are severe enough to cause vehicles to bounce significantly as they traverse the uneven pavement. This would increase impact loading and thus increase the overall

Photo showing excessive transverse bumps and associated transverse tearing as well. This photo also shows longitudinal cracking in the center of the mat.

loading to which the pavement is subjected. In such severe cases, the likely best action is removal and replacement of the affected area.
