# Market Street Bridge

**T**HE MARKET STREET BRIDGE, which crosses the Ohio River to link West Virginia and Ohio, had been in need of rehabilitation for some time. But that need became more pressing in 2009, when one of the two other bridges that spanned the river to link Brooke County, West Virginia, with Jefferson County, Ohio, was lost. After swift action by local and state leaders, a team of engineers from Burgess & Niple, Inc. (B&N), an engineering firm based in Columbus, Ohio, used such innovative techniques

as superimposing repair notes on plan photographs to meet an accelerated design schedule and transform the failing bridge, which is more than 100 years old, into an icon of the communities it connects.

A banker in Steubenville, Ohio, by the name of Tahirman J. Sinclair constructed the Market Street Bridge in 1905 to serve as a gateway for Steubenville residents who were interested in obtaining jobs at the tin mill that was being developed across the river. The 1,794-ft-long cable suspension bridge, stiffened by a Warren through-truss, carried workers

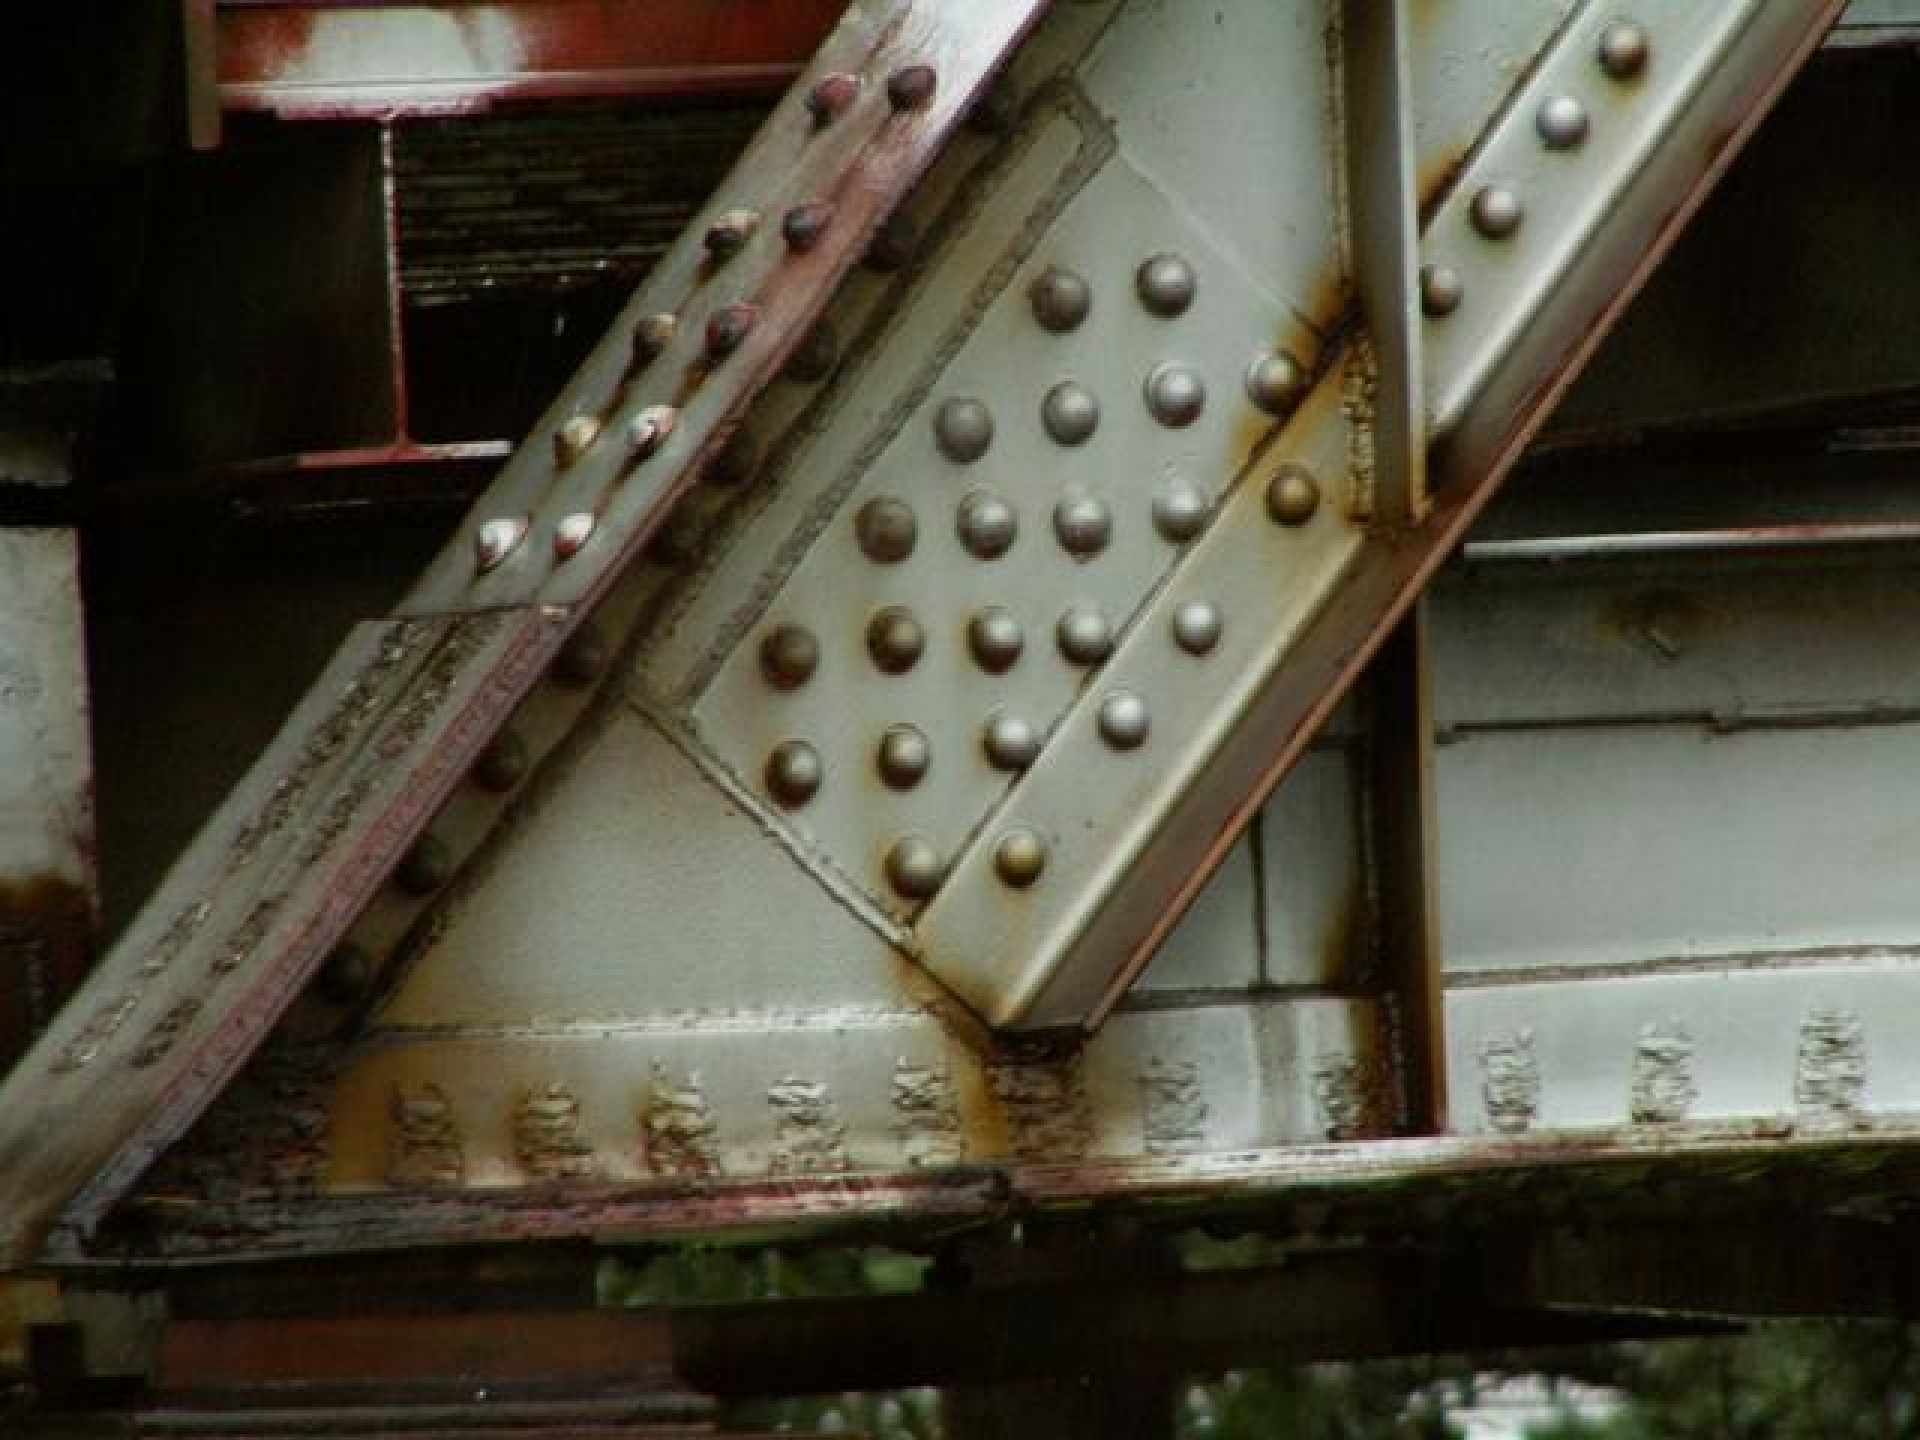
Floor beam support not that bad

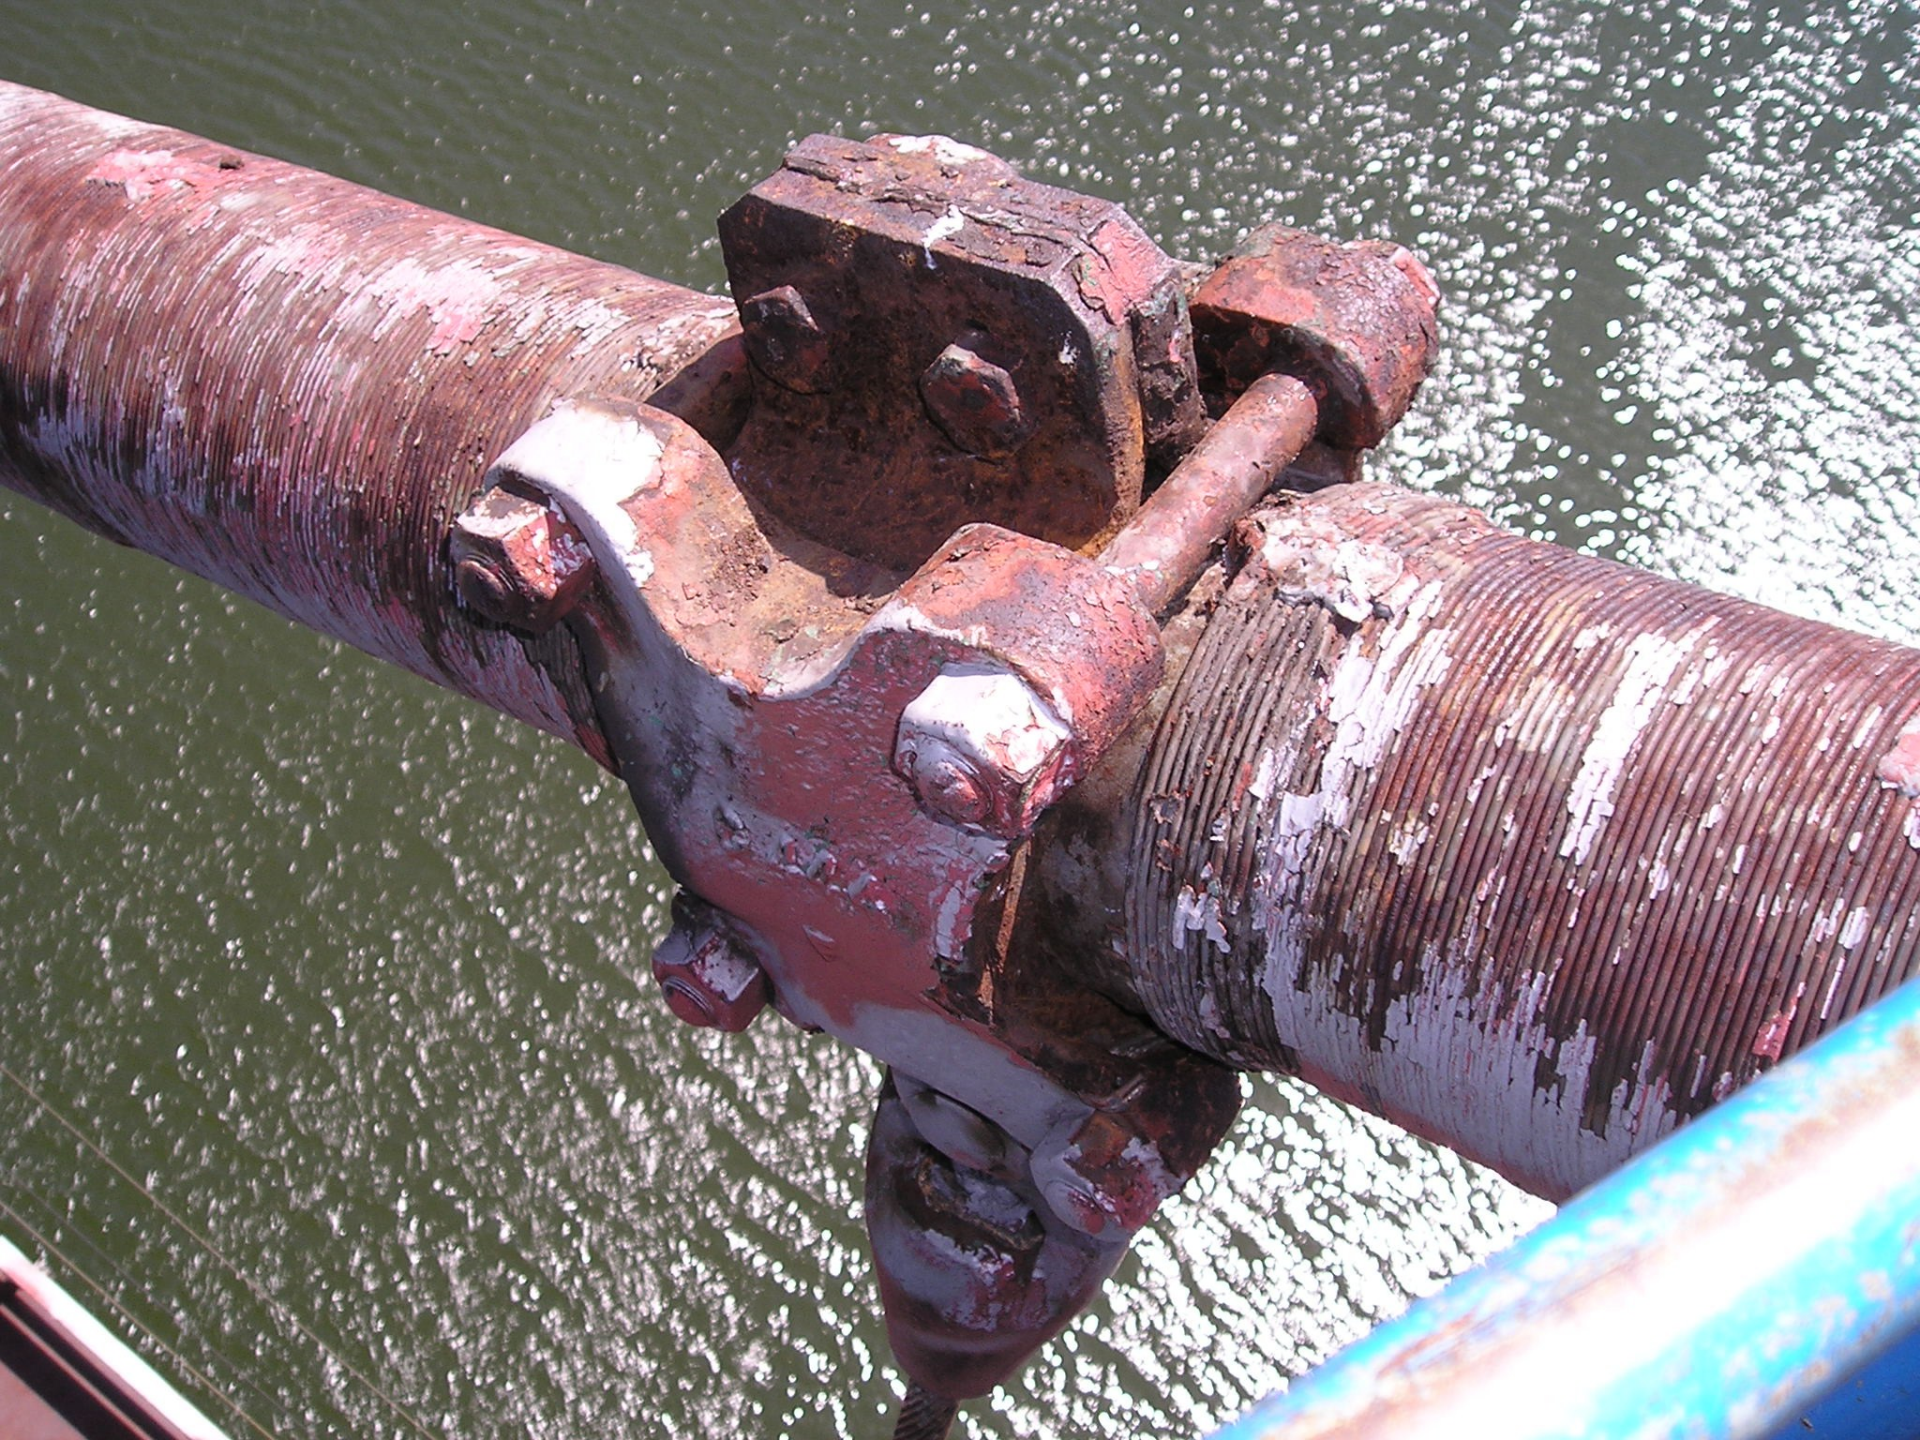
A photograph showing a close-up of a metal structure, possibly a ship's hull or a large industrial vessel. The structure is composed of various metal plates and beams, some of which are painted red. A prominent feature is a large, irregular hole in a white-painted metal plate. The surrounding metal is dark and shows signs of wear, including numerous rivets and bolts. The text "Just a few holes" is overlaid in white, serif font across the center of the image. The background is dark, suggesting an interior or a shaded area, with some light coming from the bottom left corner, possibly from an opening or window.

Just a few holes

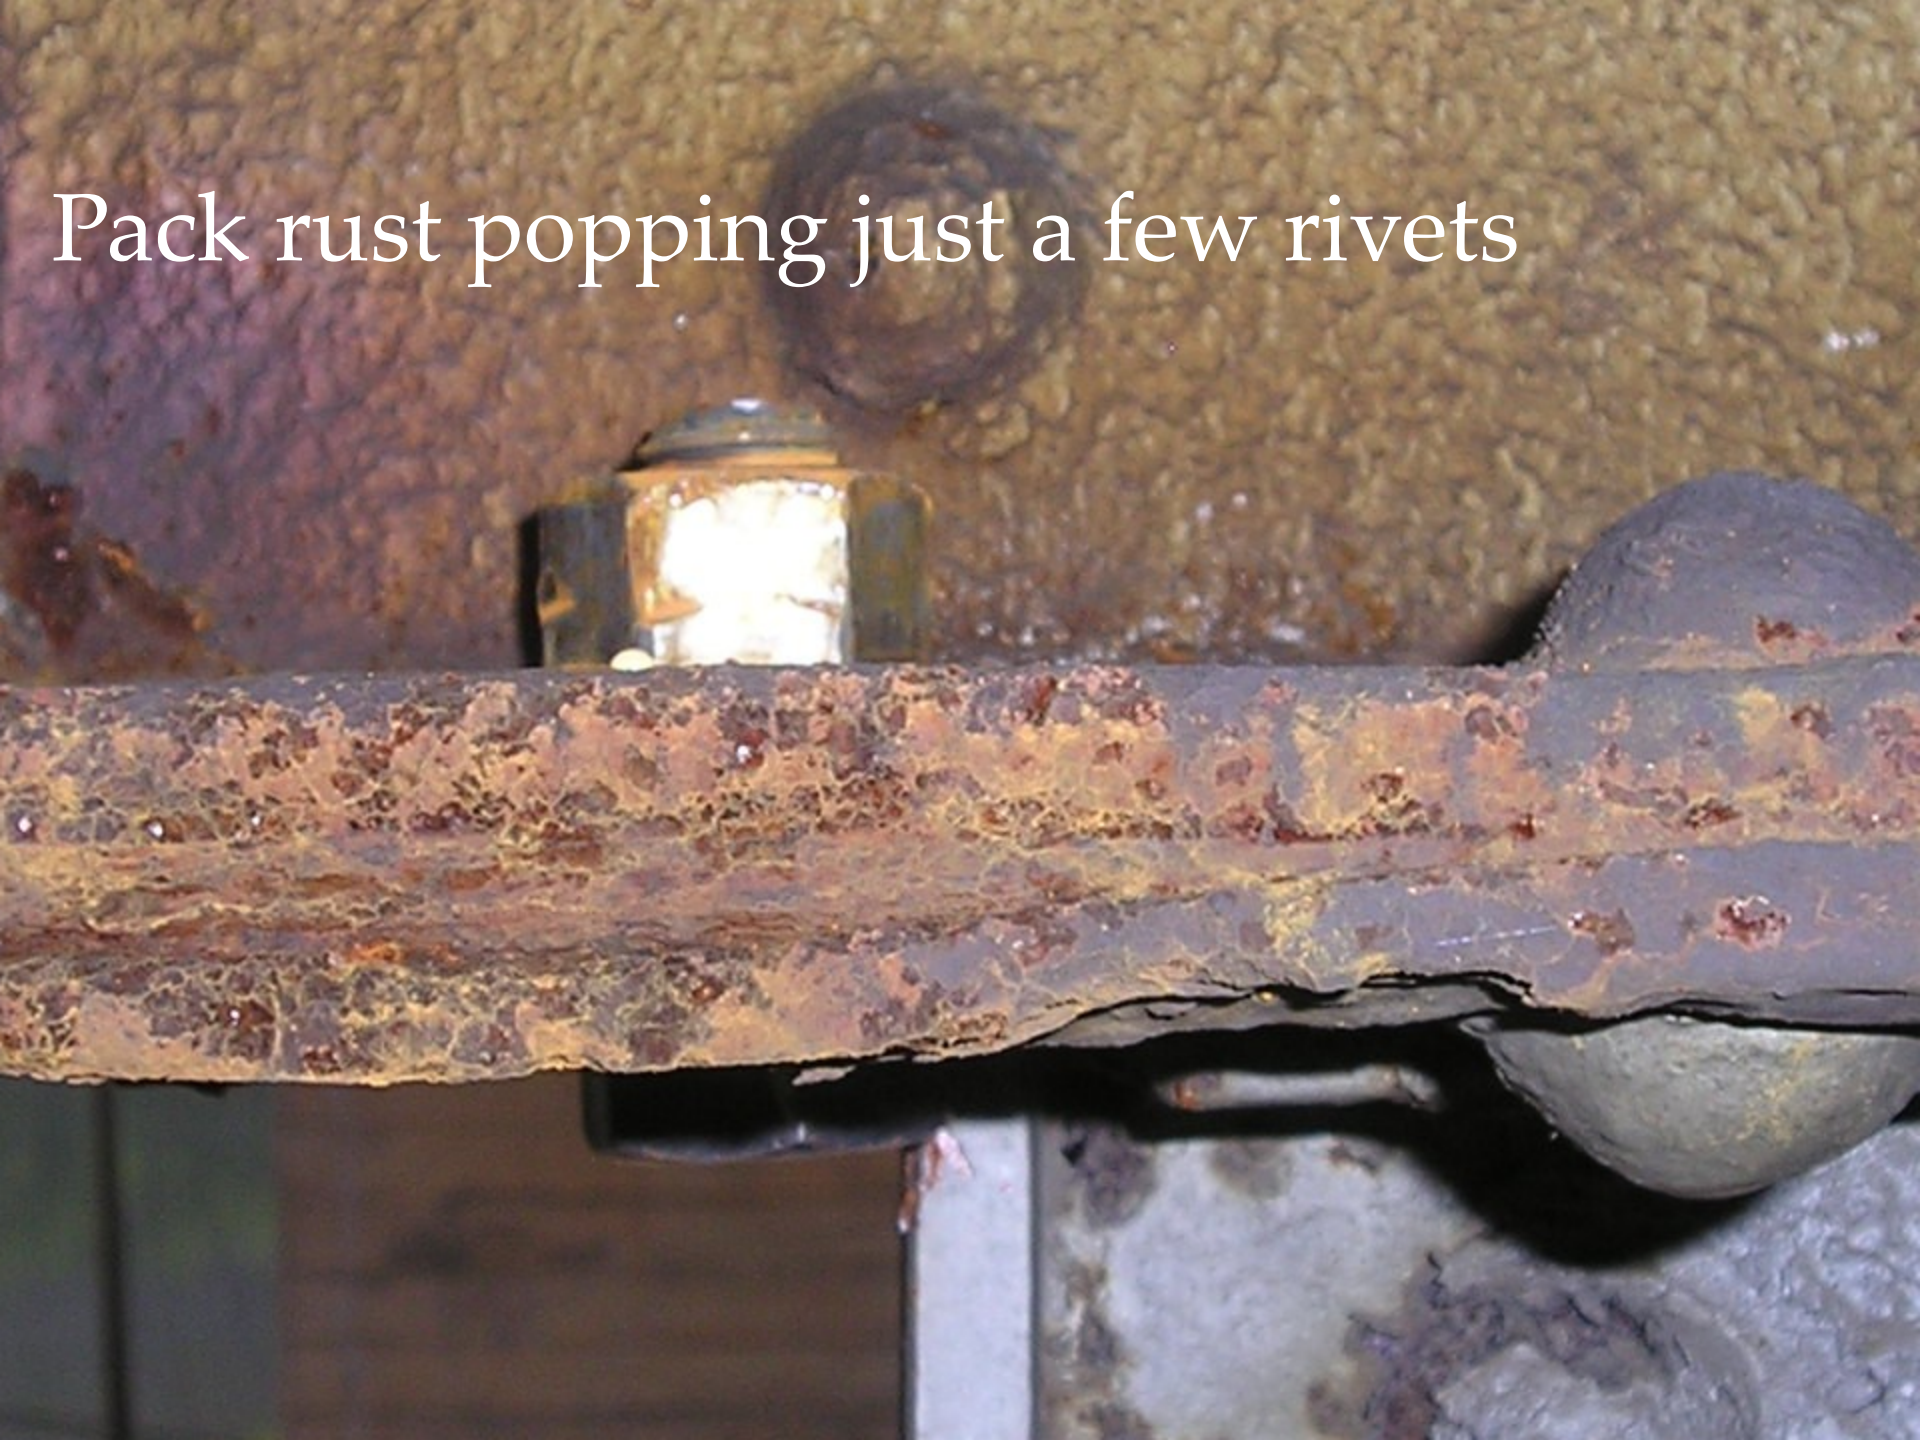
Pack rust popping just a few rivets

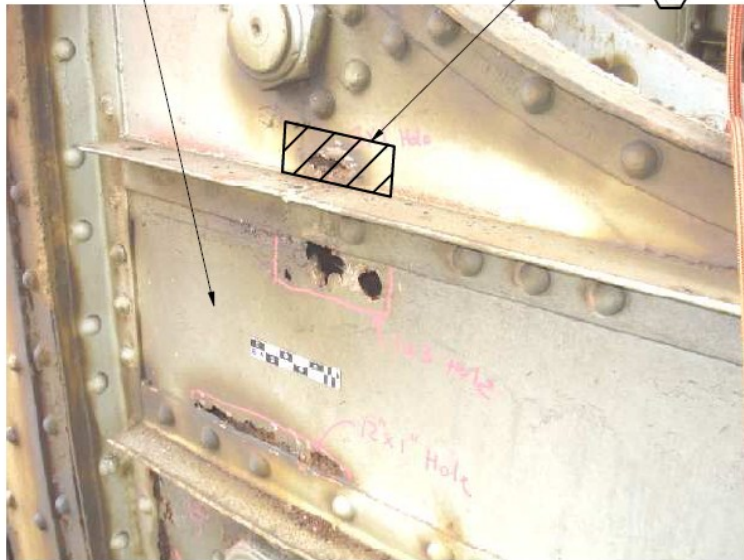
INSTALL PLATES  
PER REPAIR TYPE

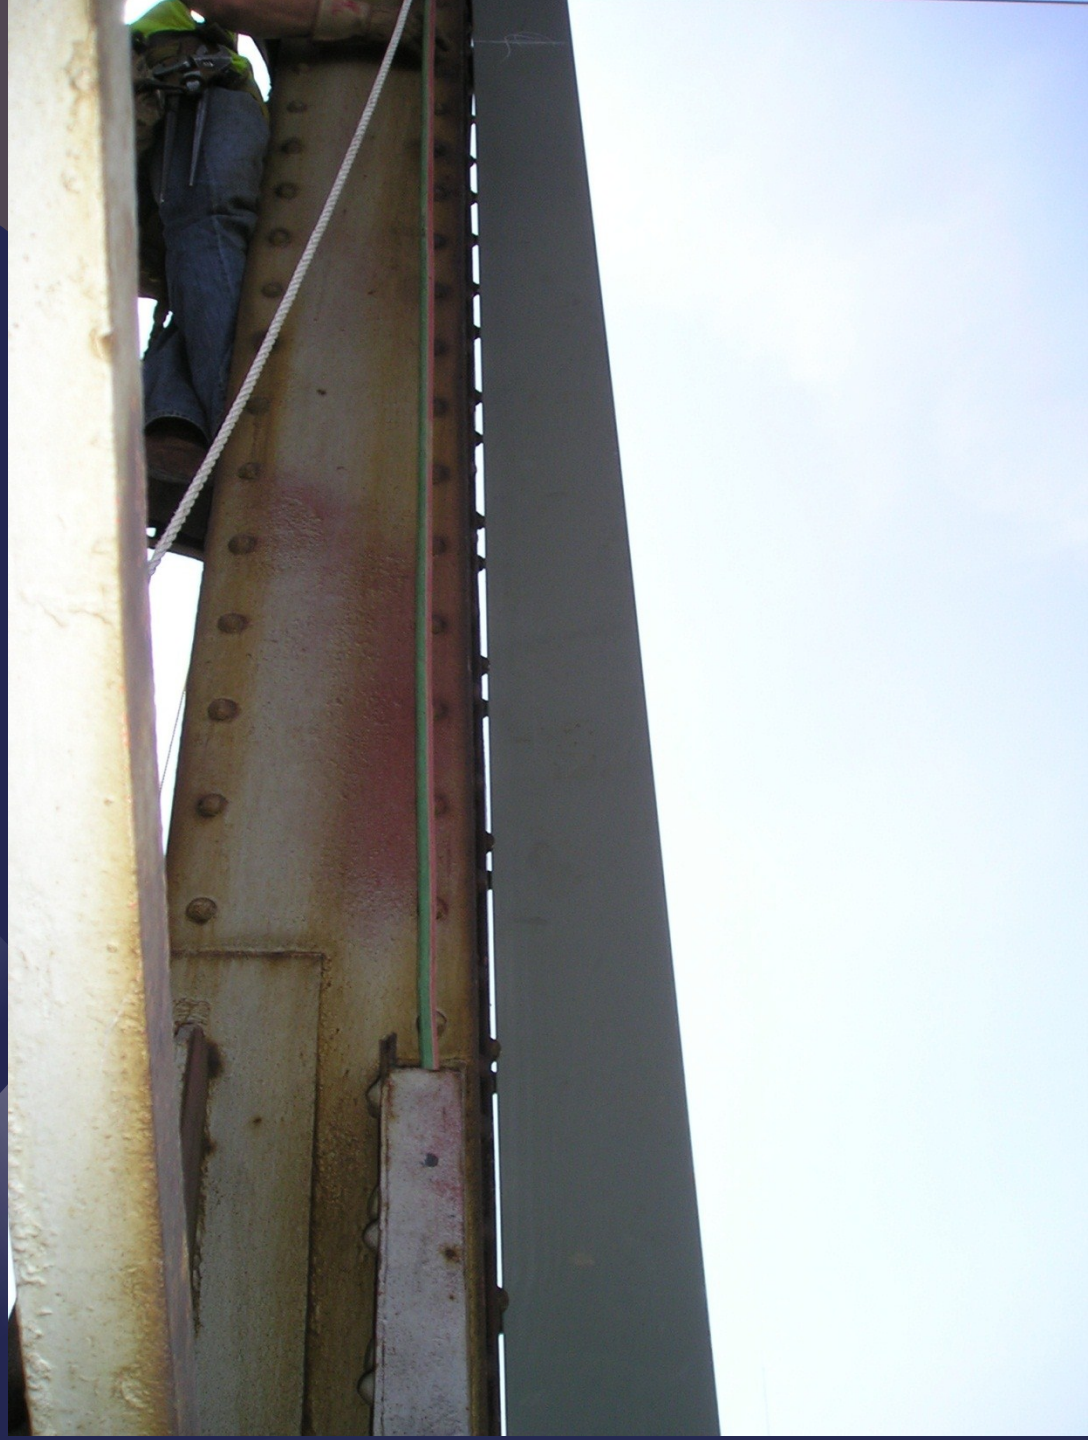
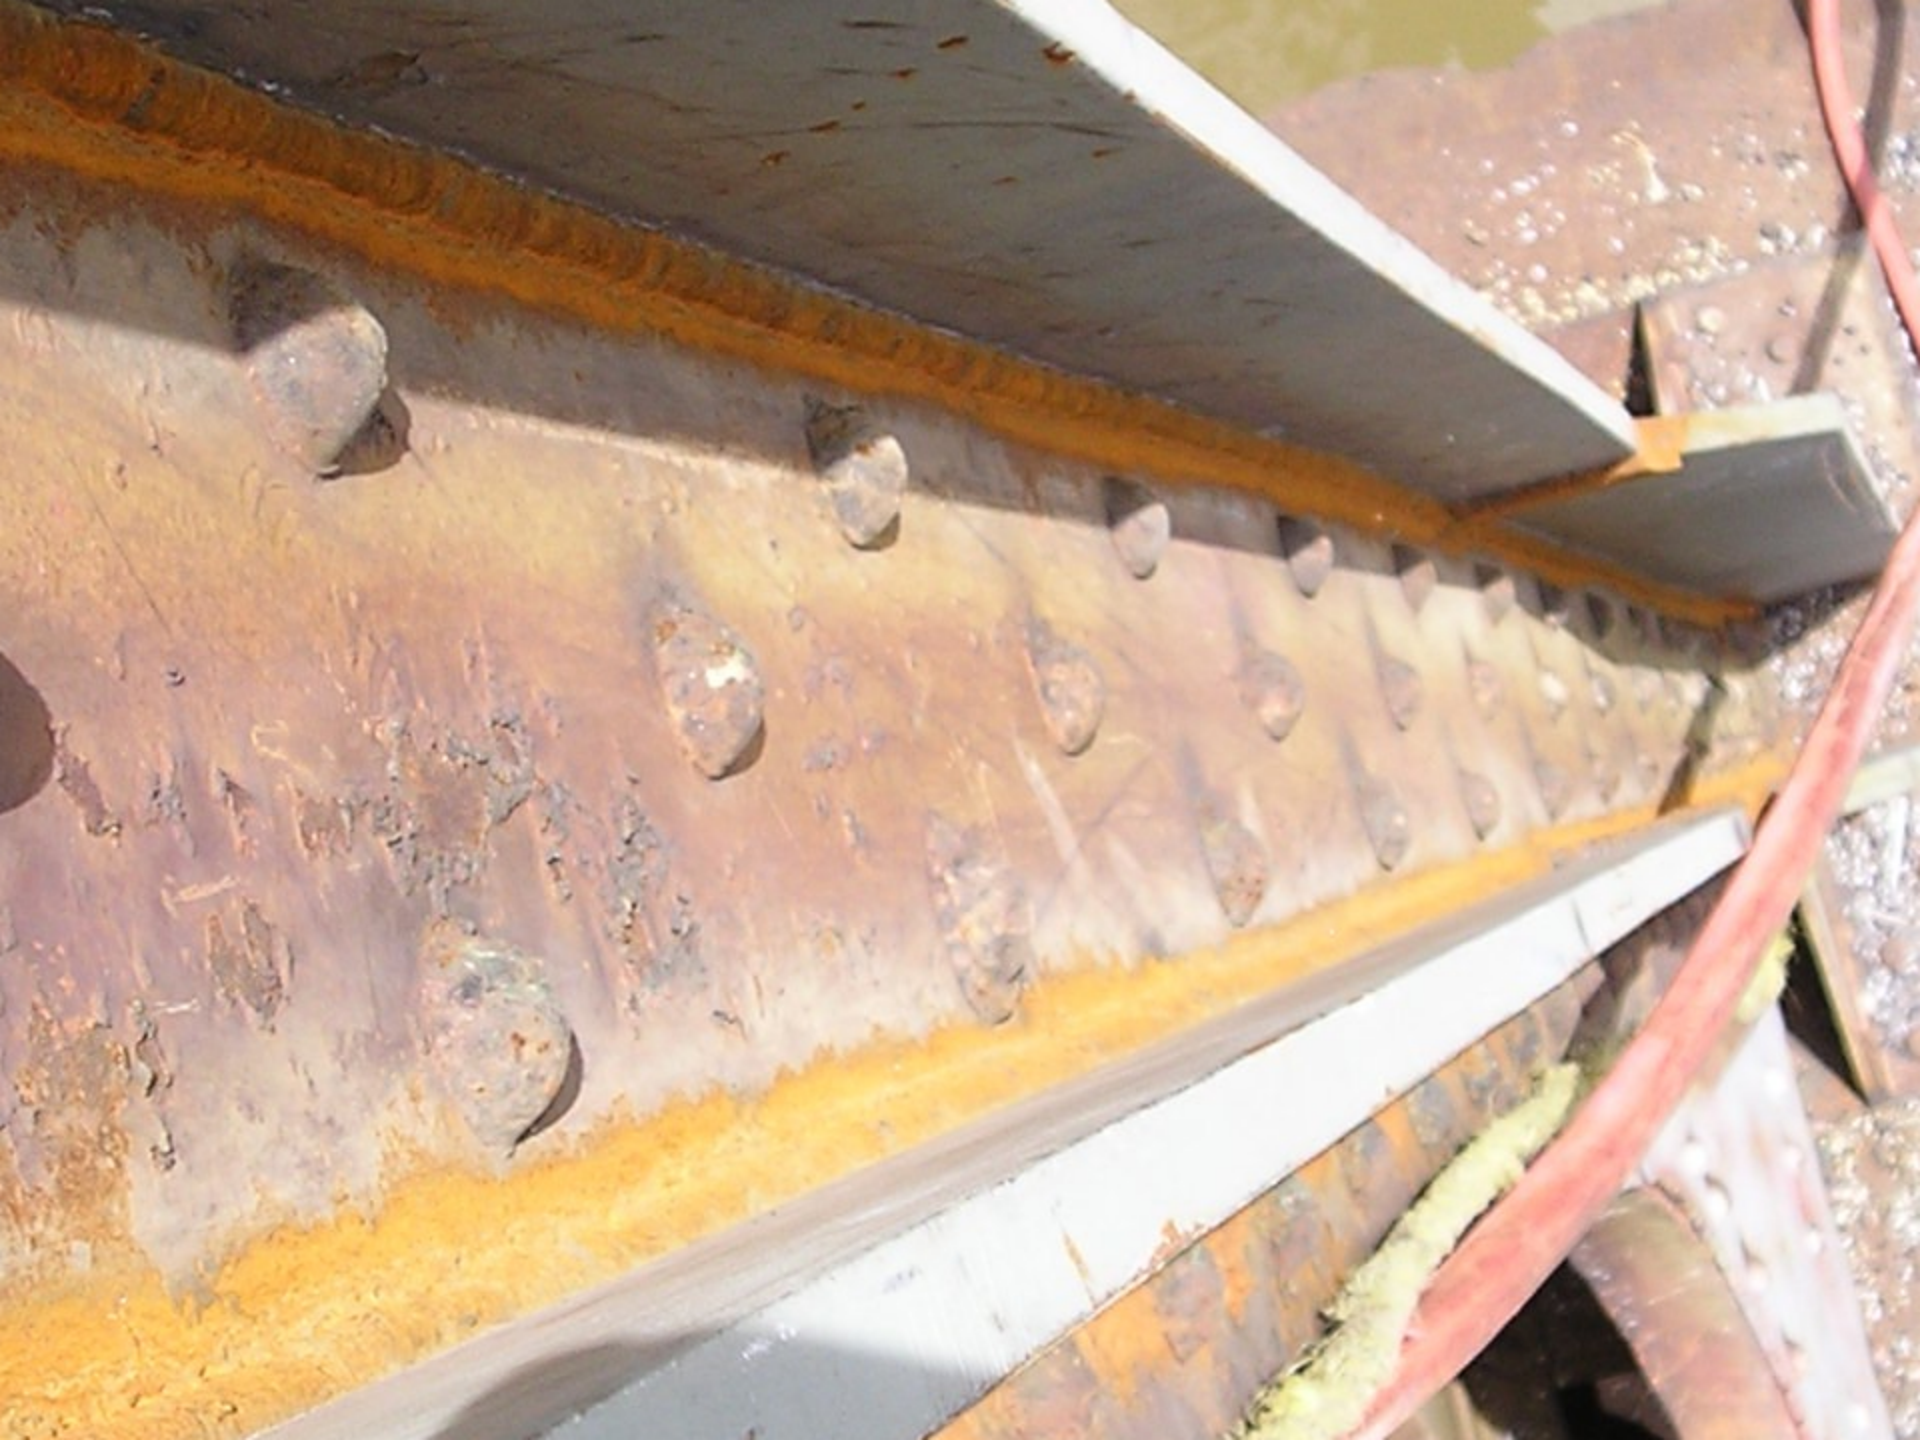
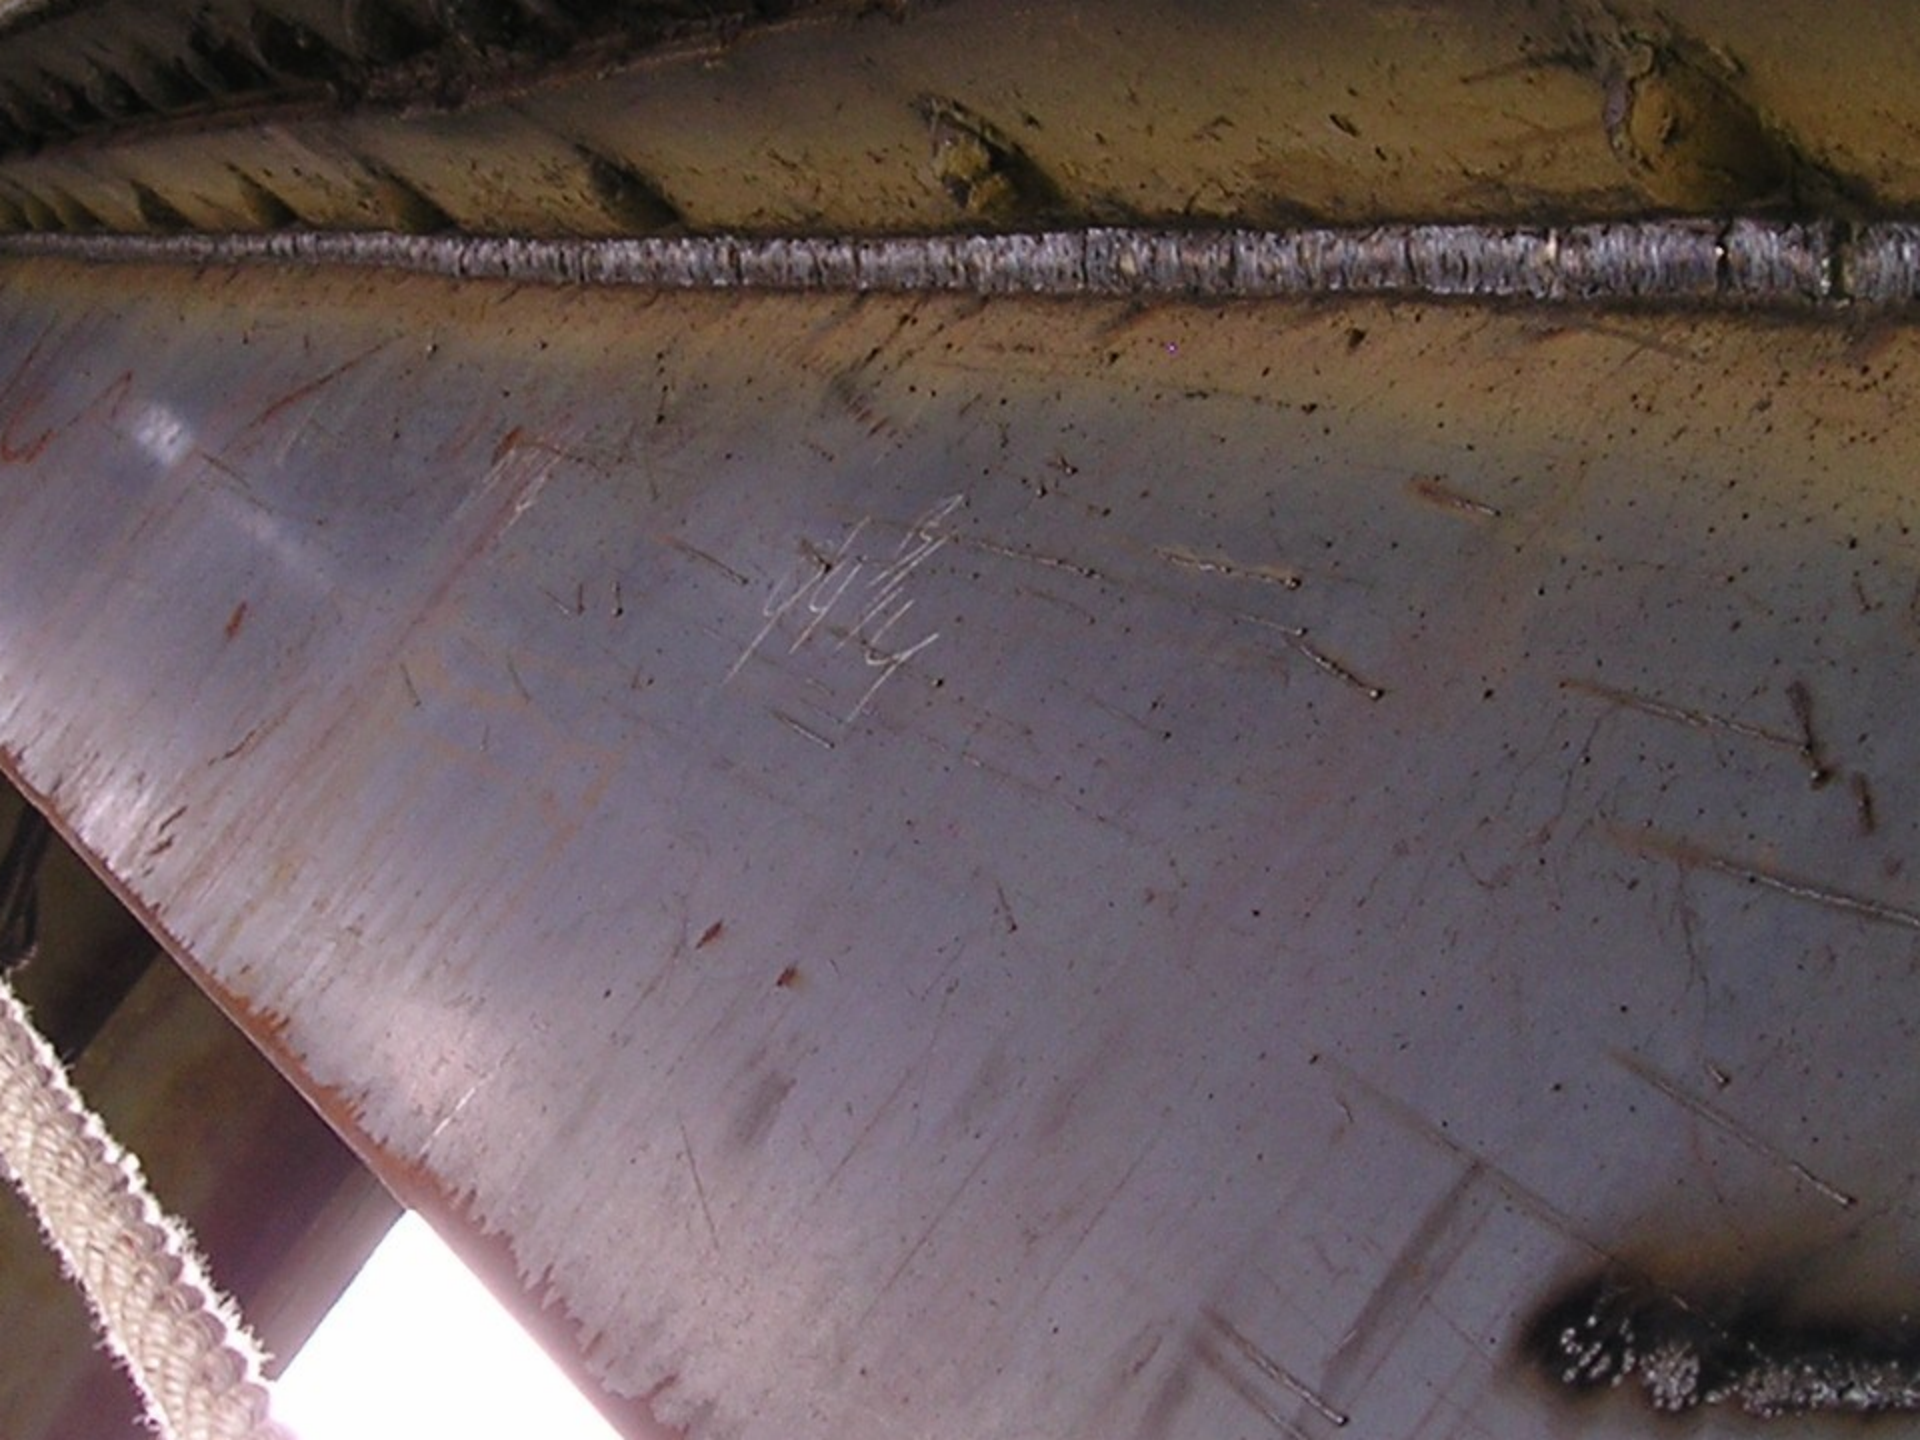
Tower repairs: over 30,000 lbs of structural steel added to the 2 towers

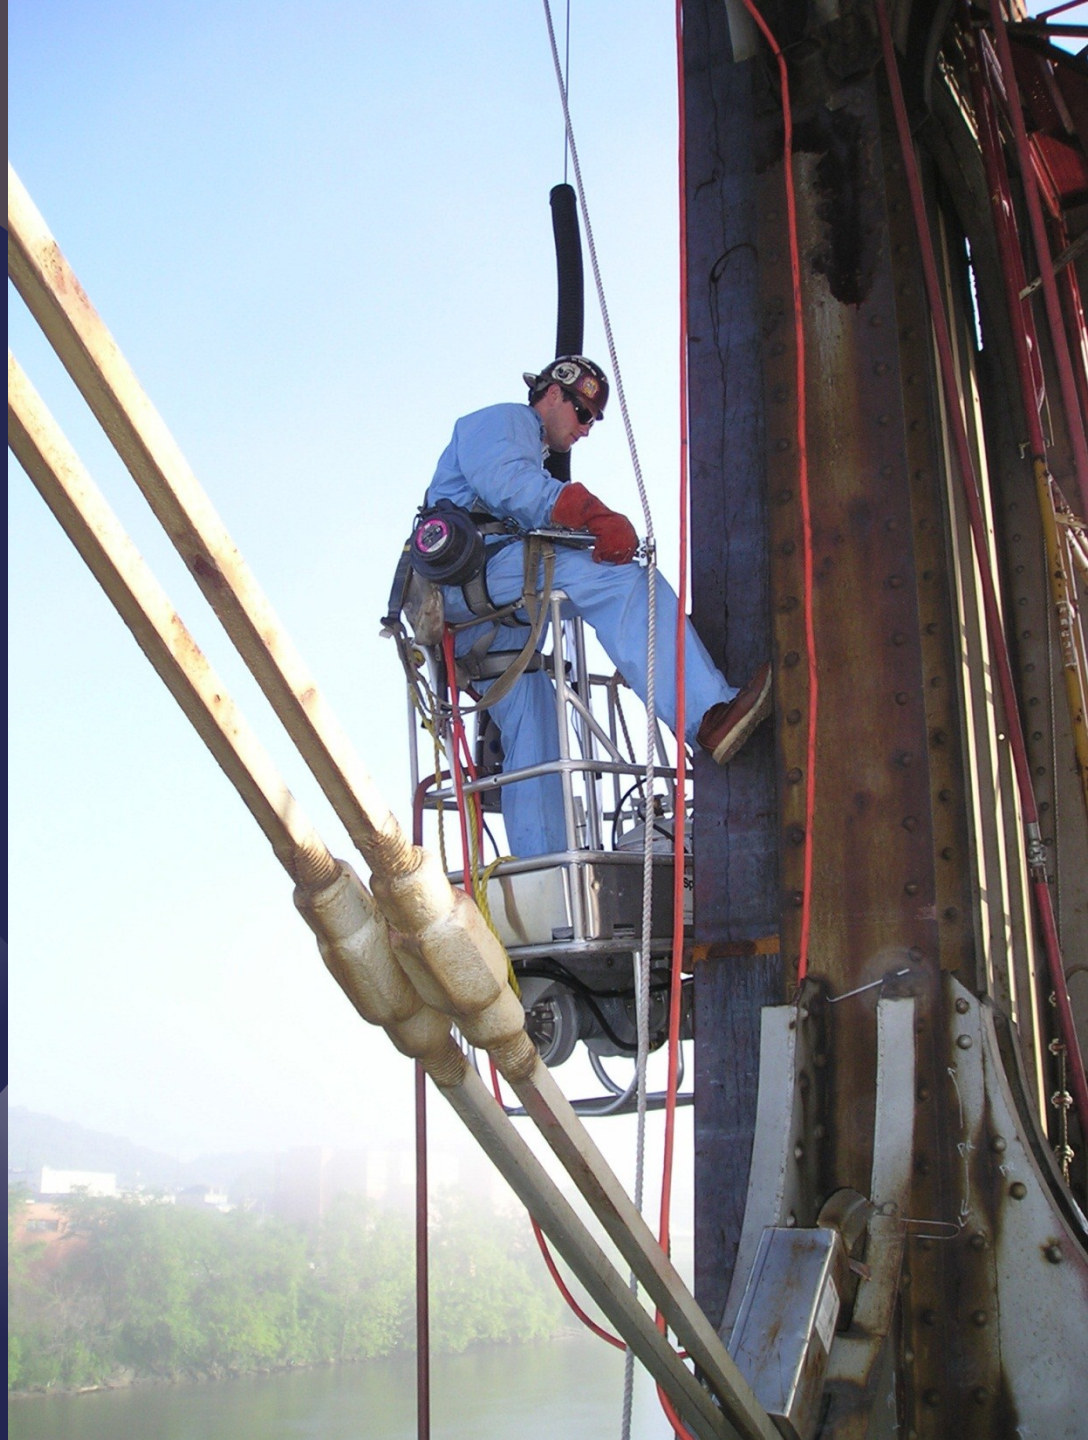
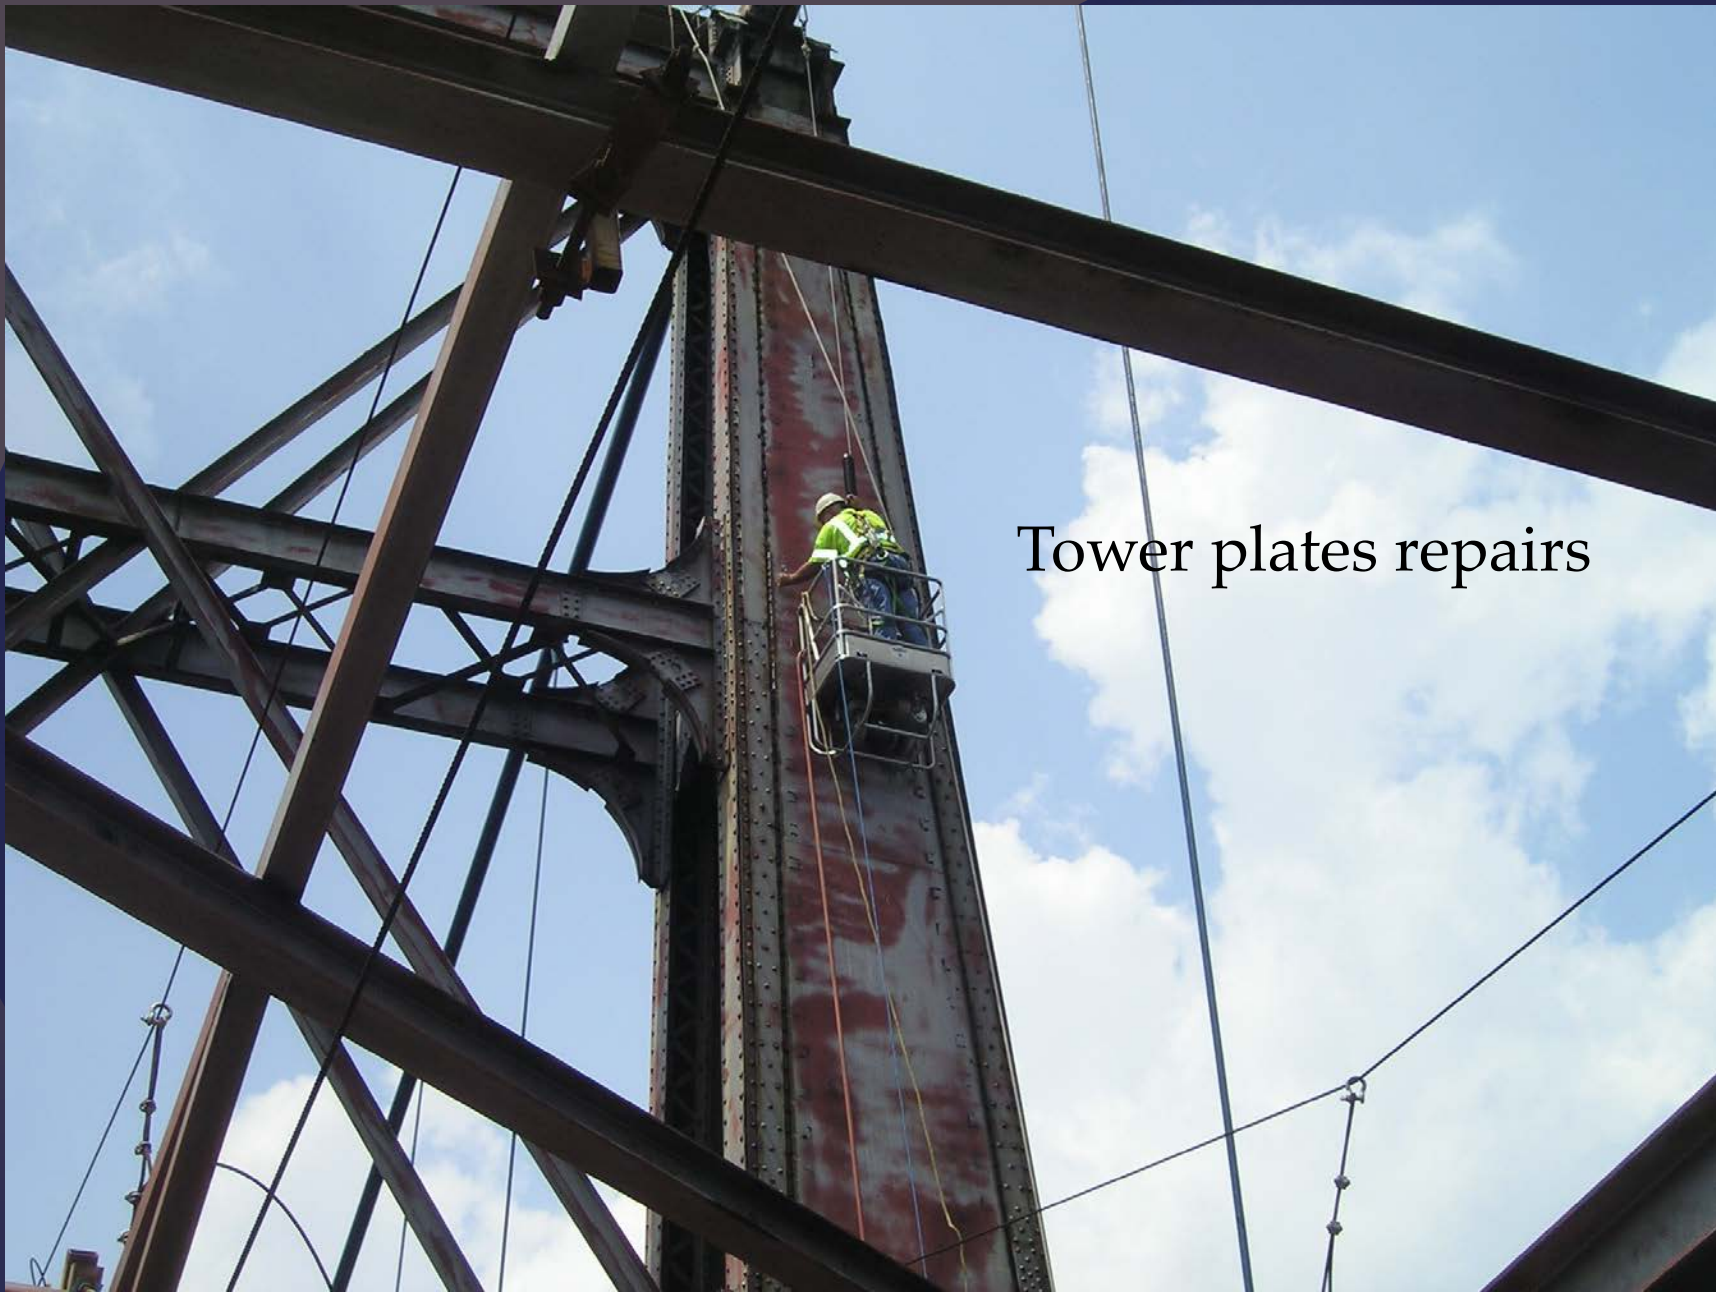
All work performed from spider baskets

Tower plates repairs
