# Market Street Bridge

**T**HE MARKET STREET BRIDGE, which crosses the Ohio River to link West Virginia and Ohio, had been in need of rehabilitation for some time. But that need became more pressing in 2009, when one of the two other bridges that spanned the river to link Brooke County, West Virginia, with Jefferson County, Ohio, was lost. After swift action by local and state leaders, a team of engineers from Burgess & Niple, Inc. (B&N), an engineering firm based in Columbus, Ohio, used such innovative techniques

as superimposing repair notes on plan photographs to meet an accelerated design schedule and transform the failing bridge, which is more than 100 years old, into an icon of the communities it connects.

A banker in Steubenville, Ohio, by the name of Tahirman J. Sinclair constructed the Market Street Bridge in 1905 to serve as a gateway for Steubenville residents who were interested in obtaining jobs at the tin mill that was being developed across the river. The 1,794-ft-long cable suspension bridge, stiffened by a Warren through-truss, carried workers

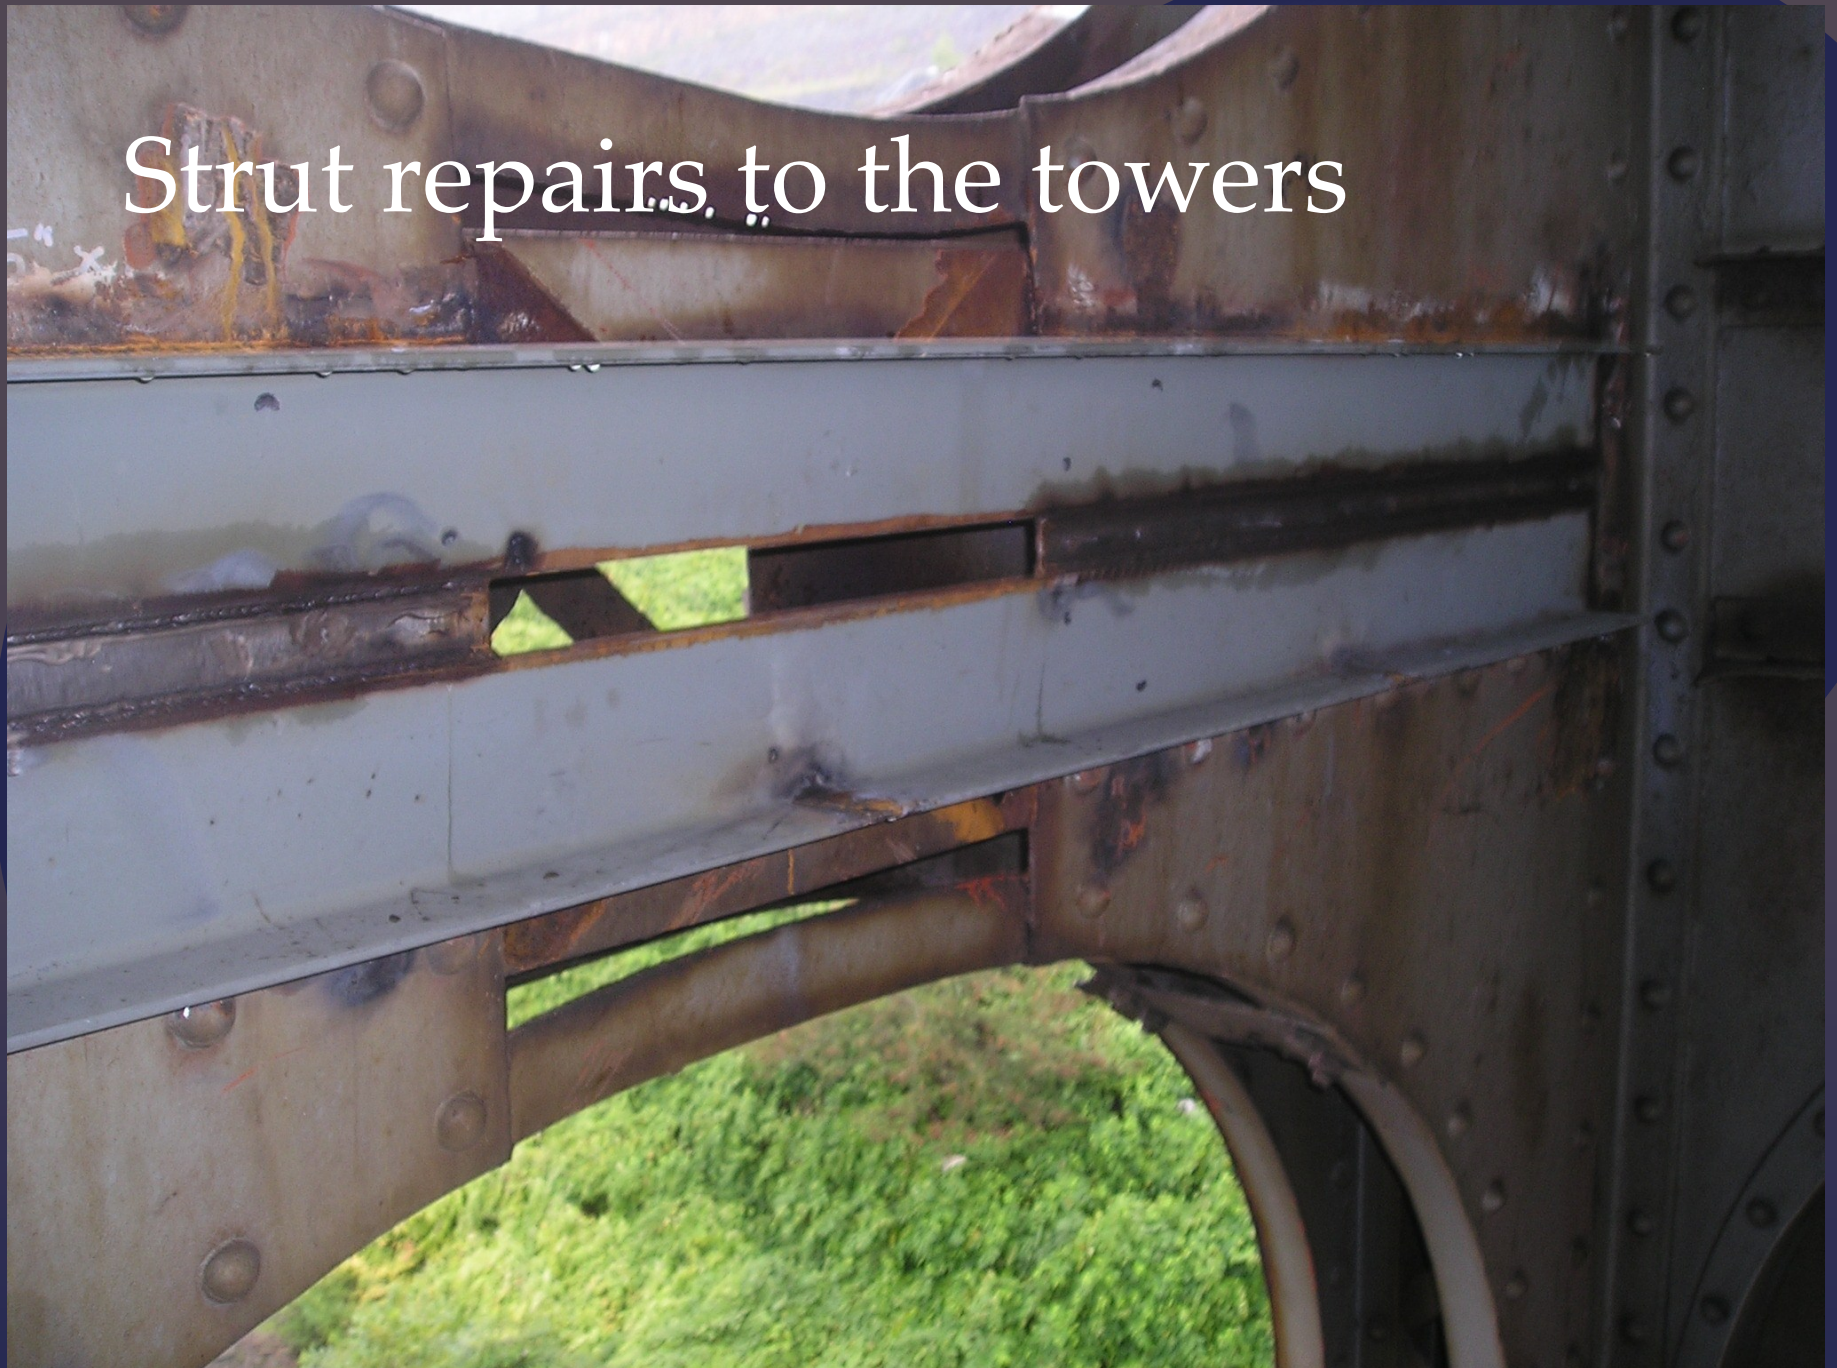
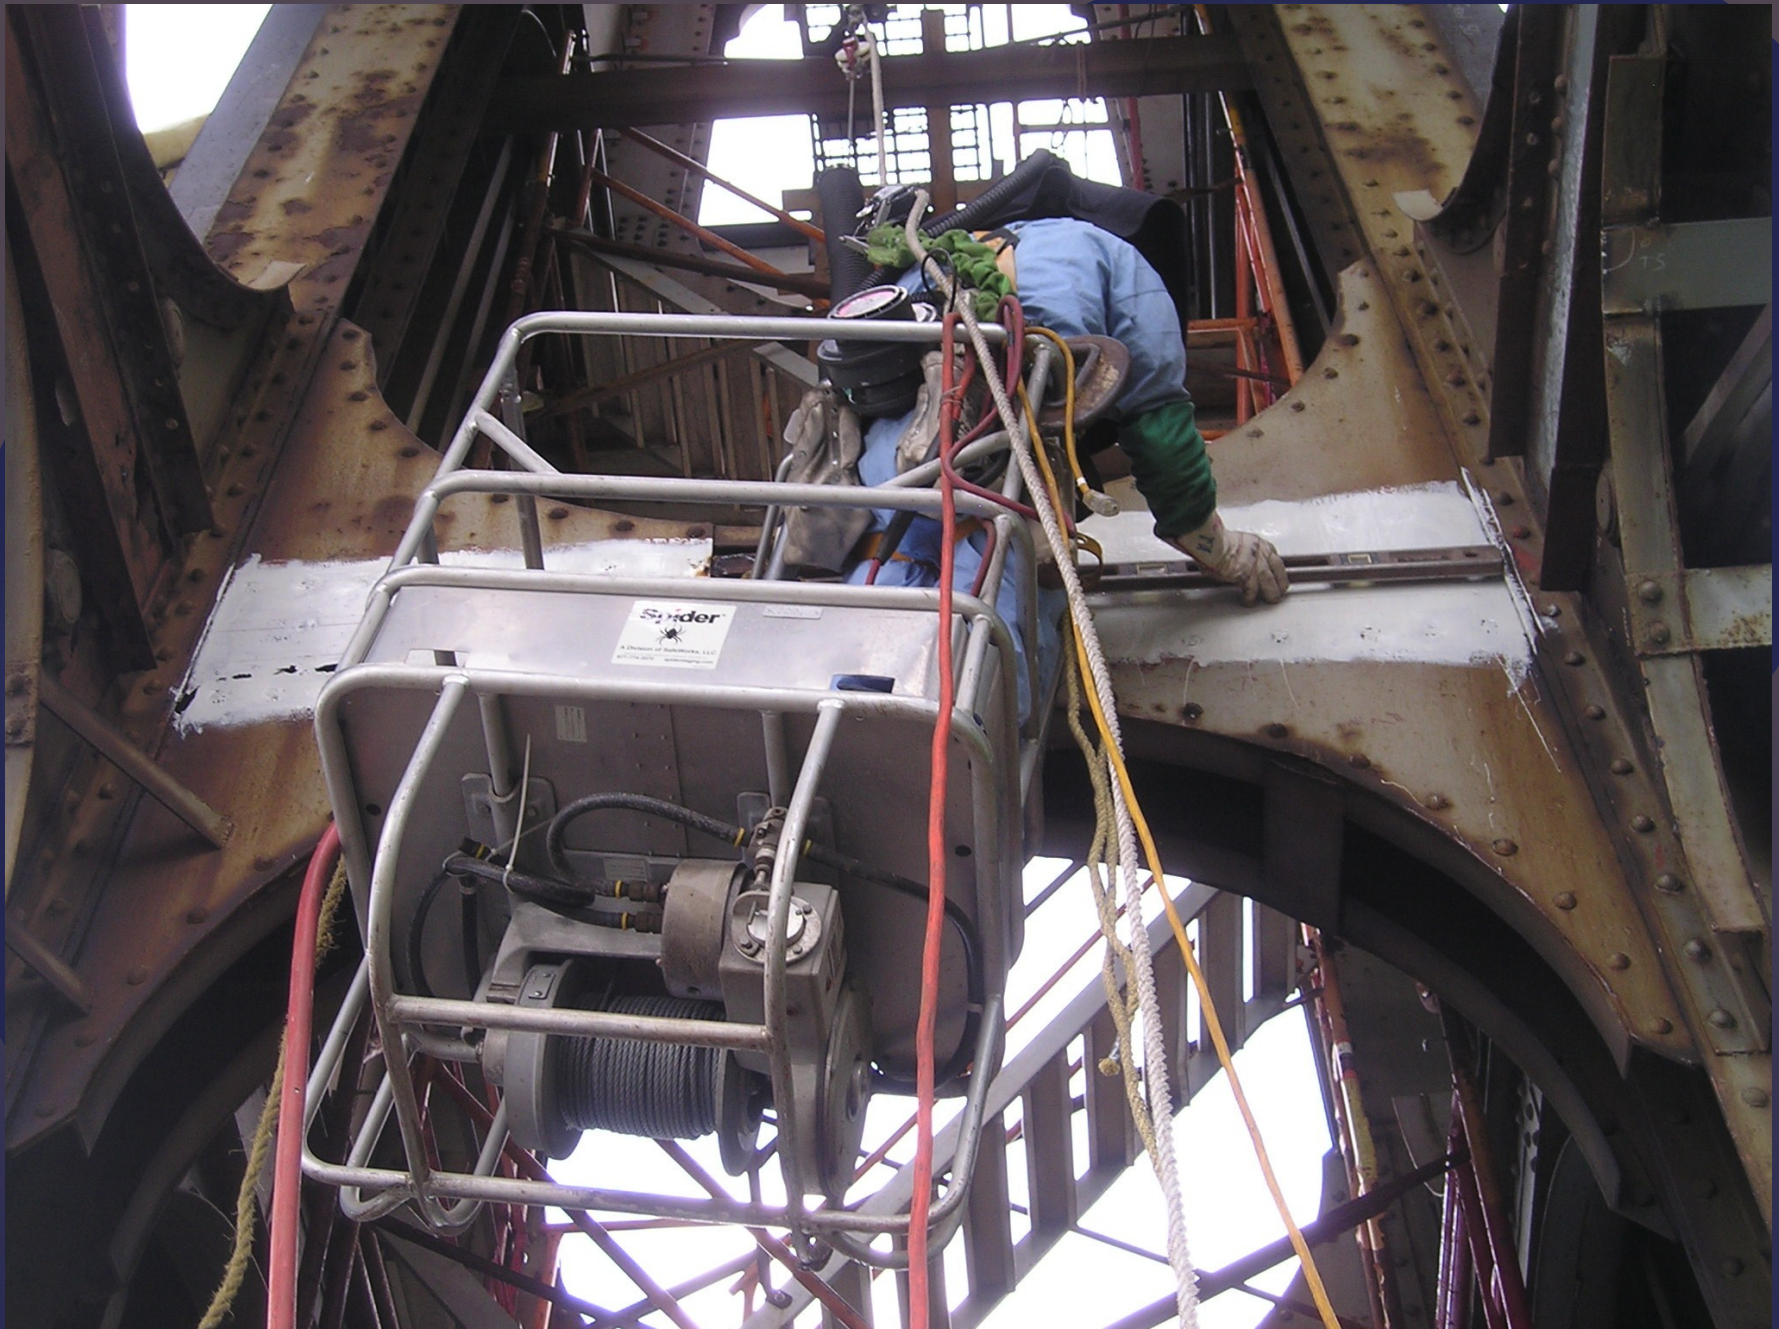
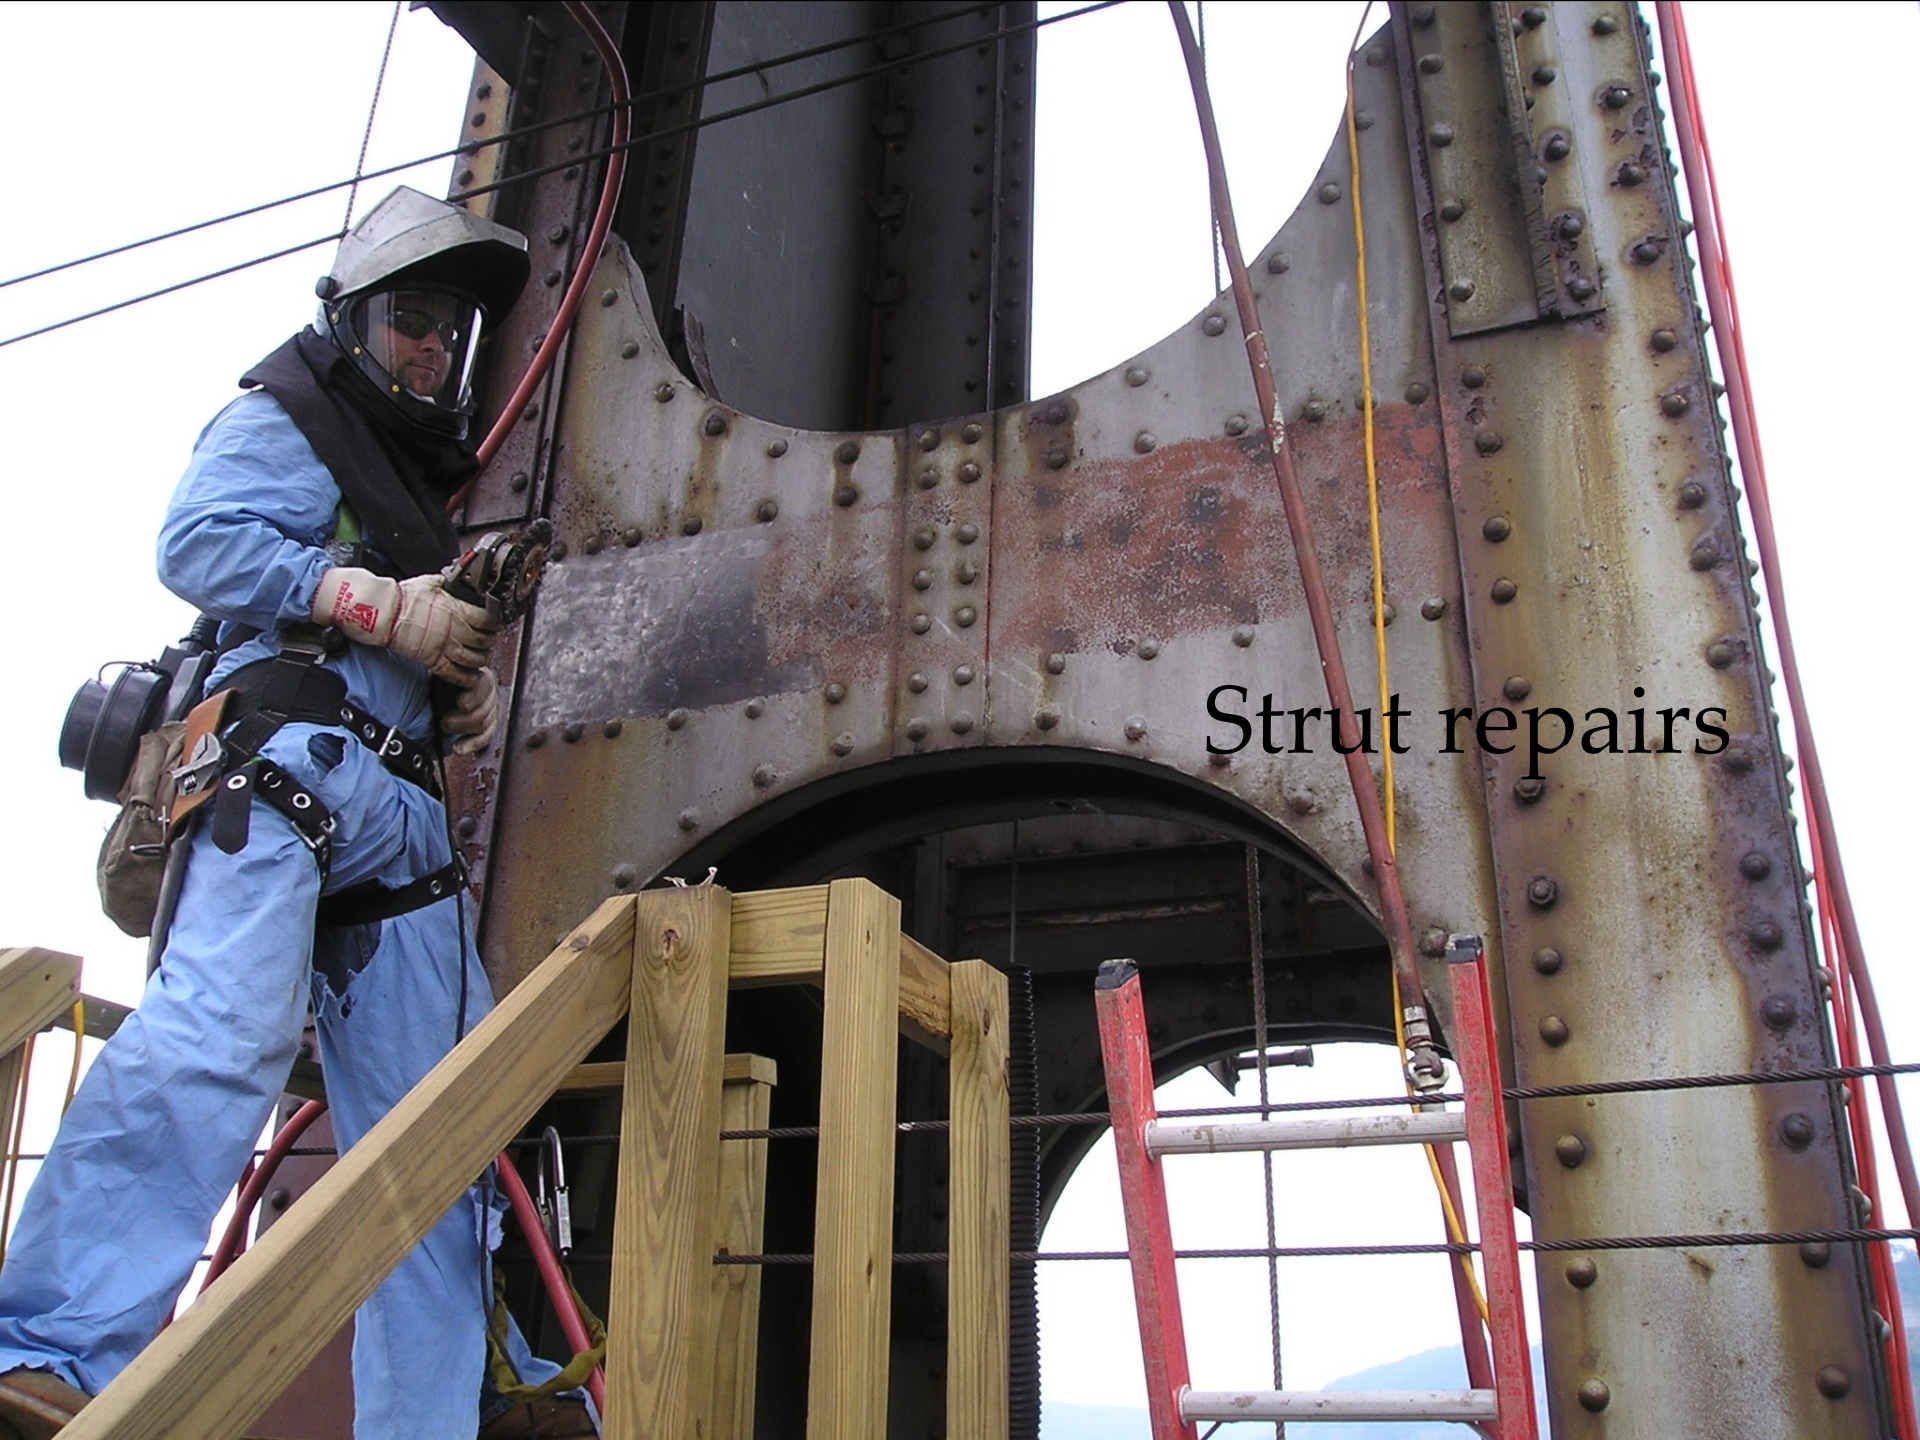
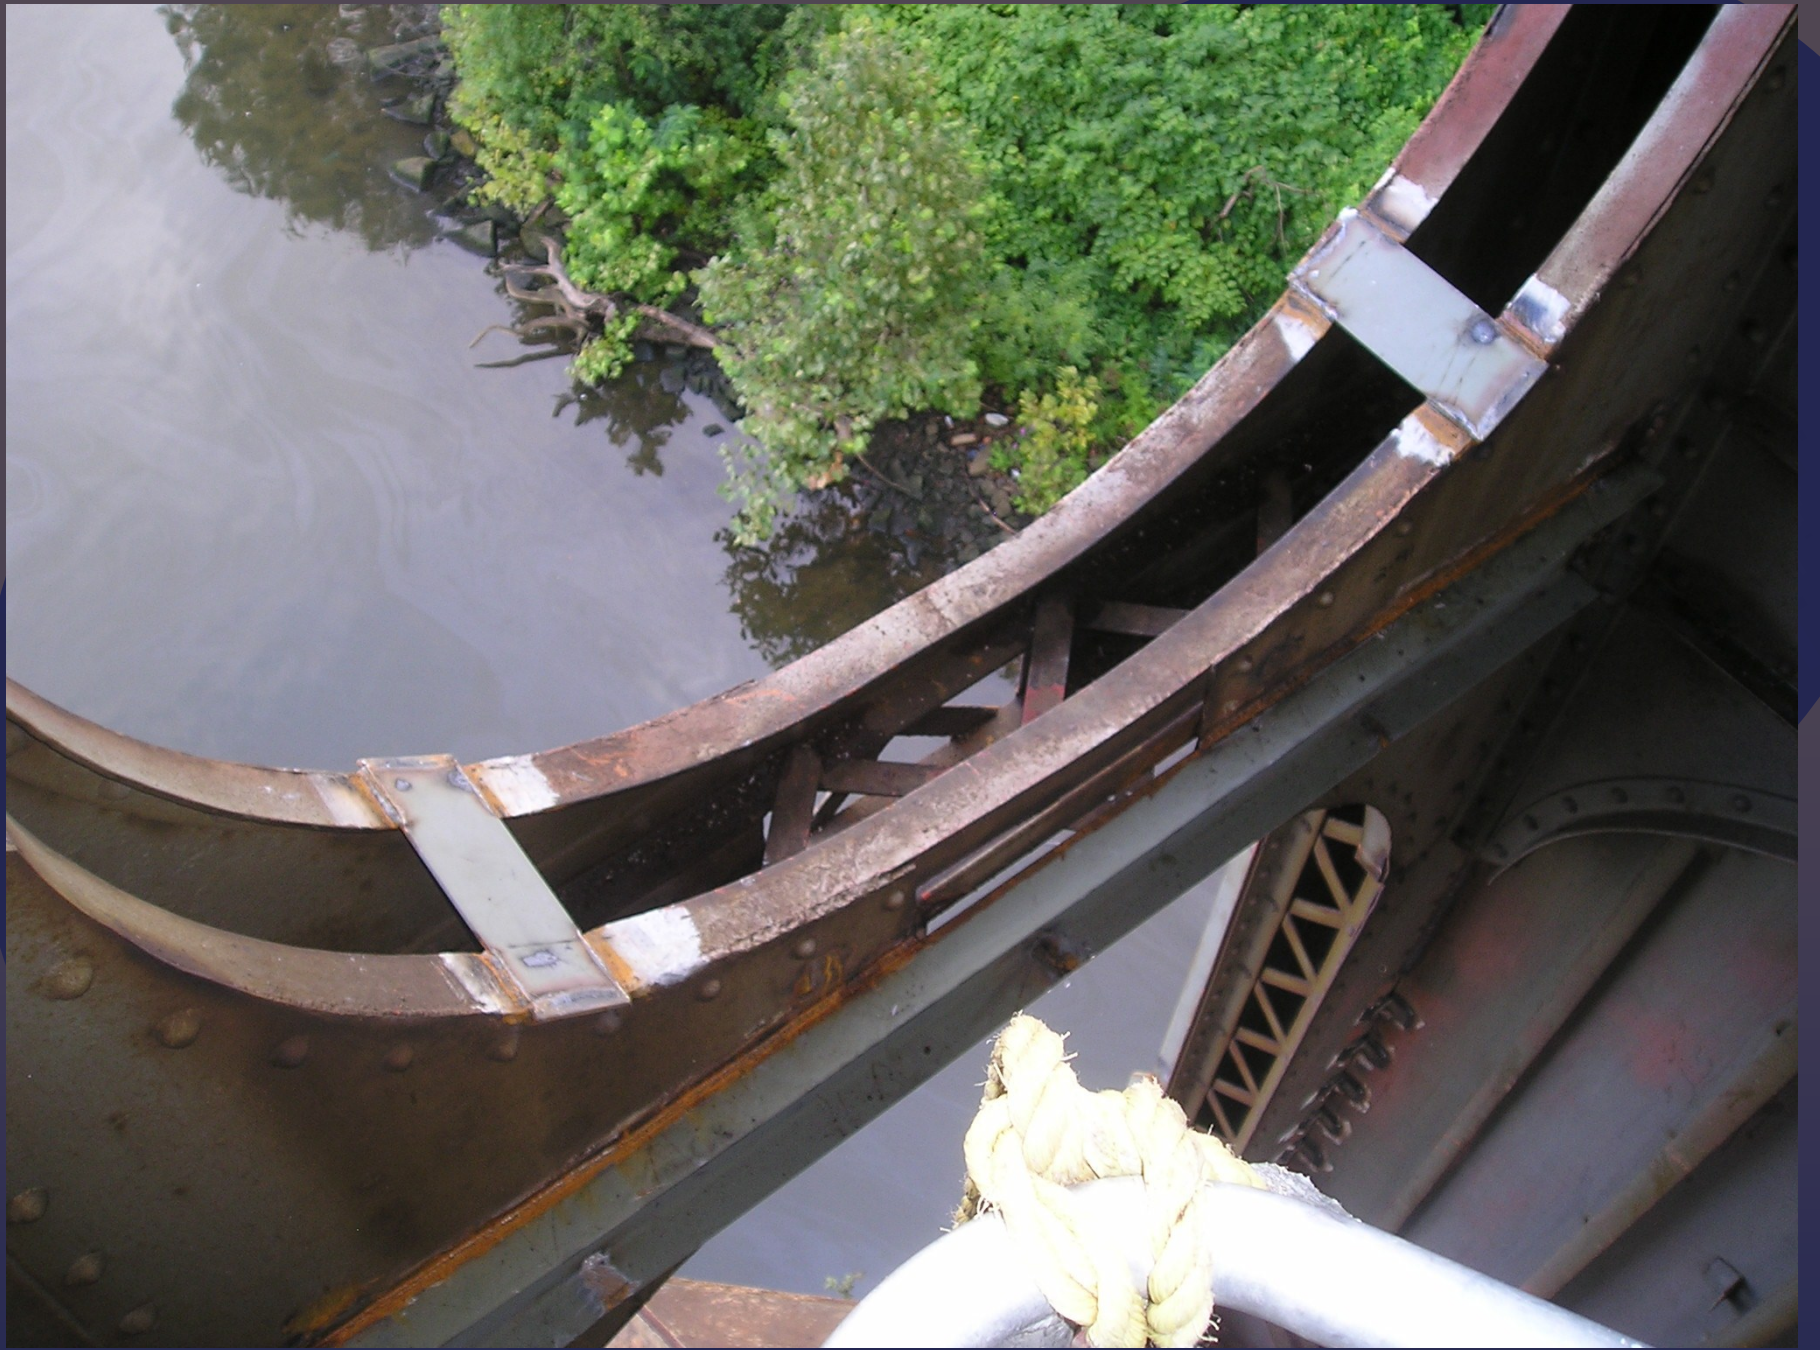
# Strut repairs to the towers

Strut repairs

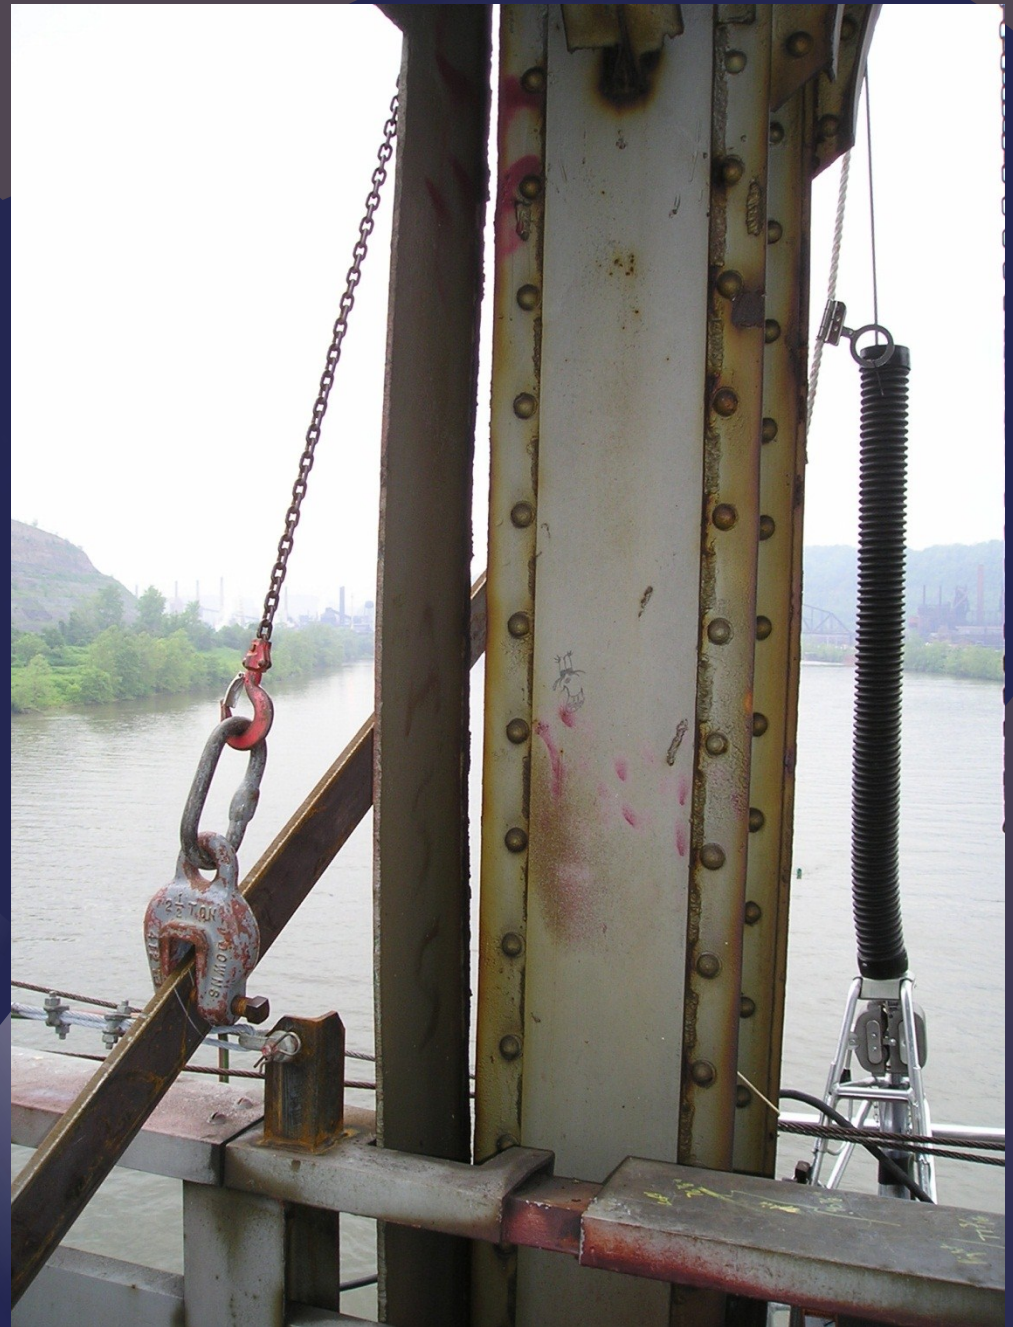
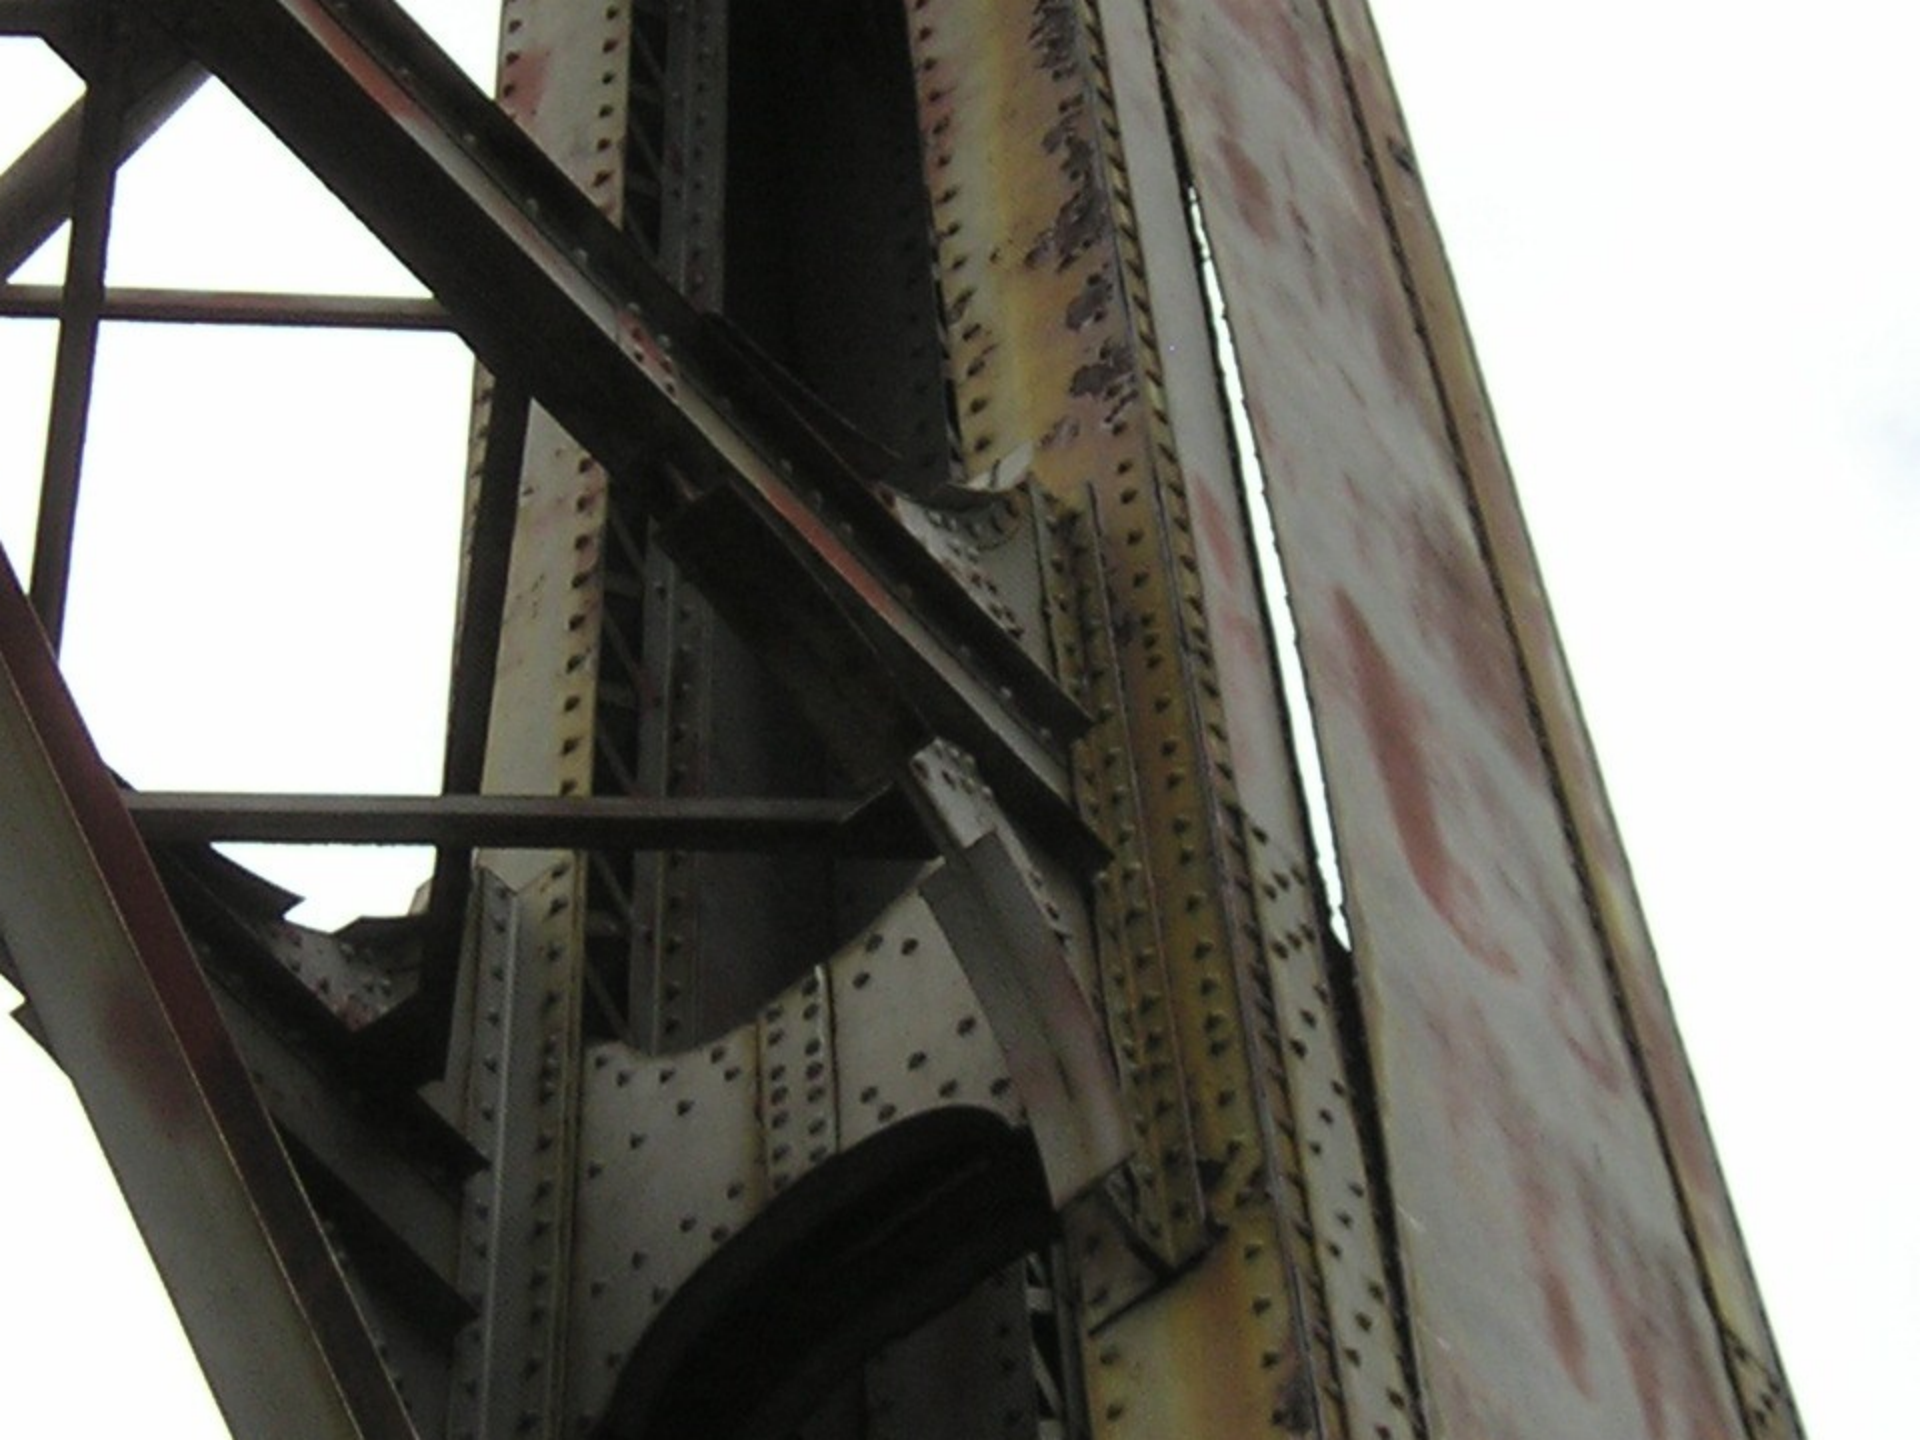
Attach tower plates to  
structure legs by welding  
or clips.

685 clips

1000 lf of weld

Three choices of repair:

Weld on interior of tower leg

Place 3x3 clip on interior

Weld on exterior of tower leg

New weld on tower plates

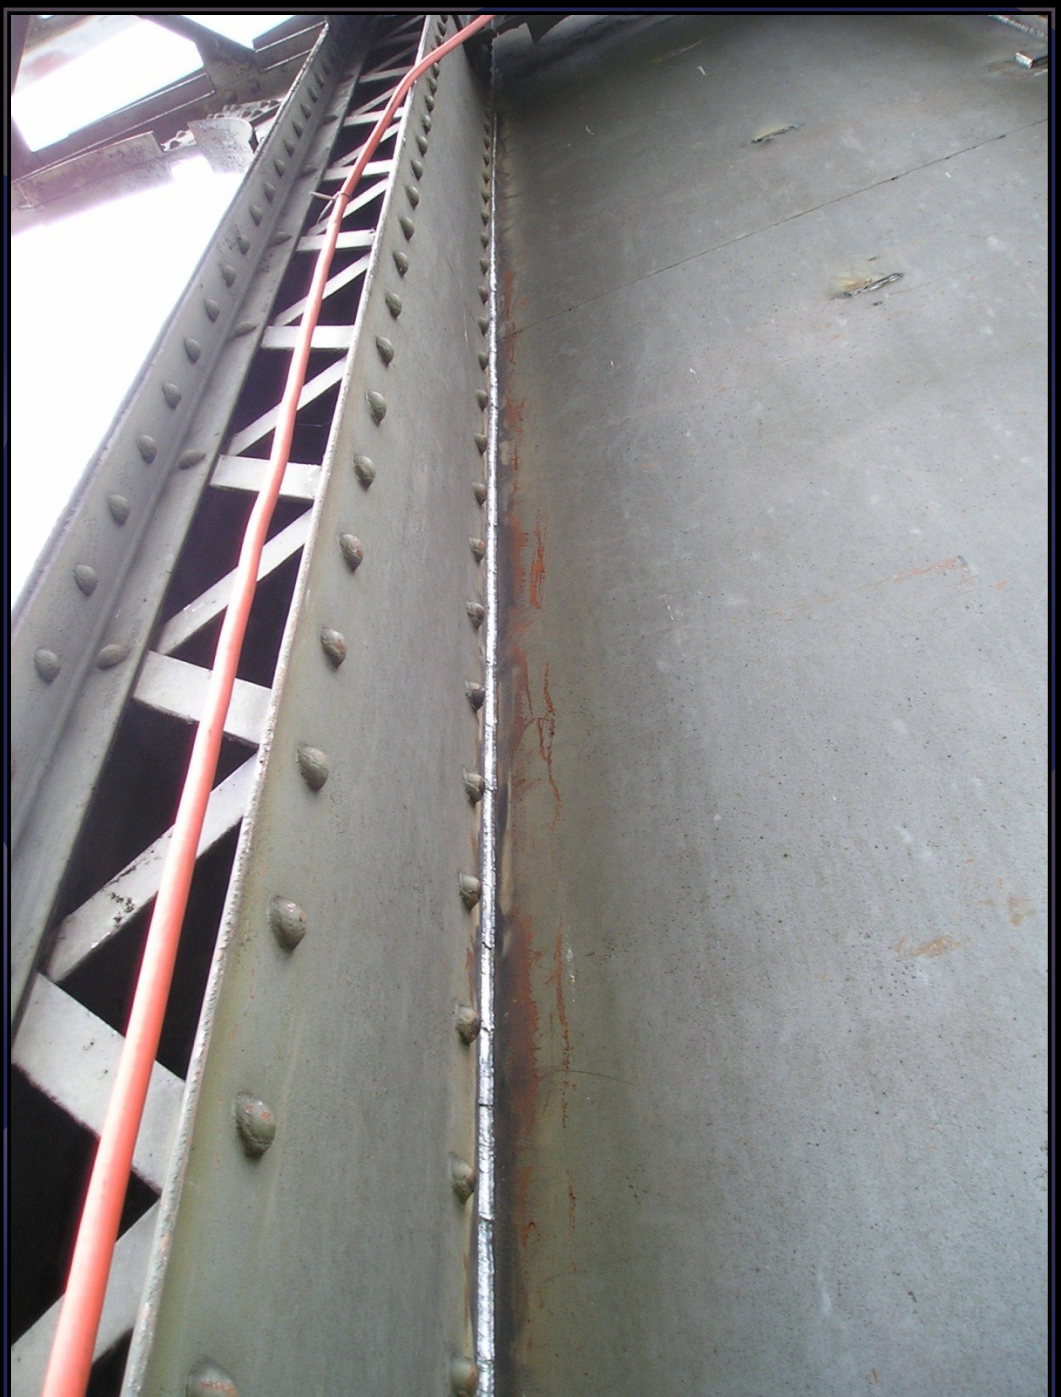
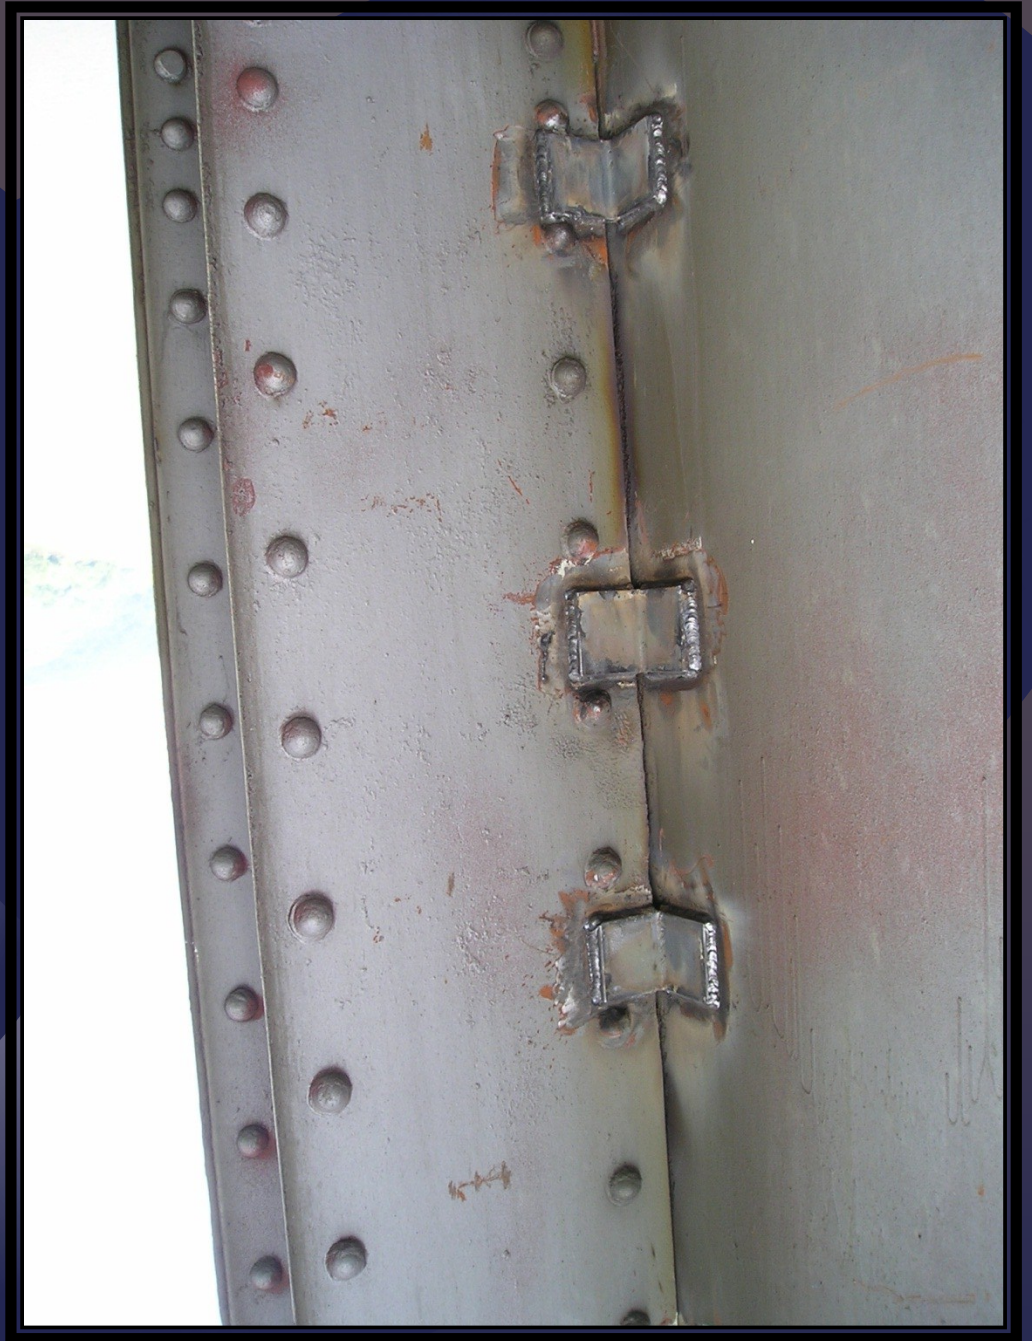
clips
