Waters Investigation Report

*26th Ave. – Blizzard Drive Widen,
Add Lanes (0.49 mi)*

State Project: U354-14-9.23 00 /STP-0014(174)D
Parkersburg, West Virginia

WATERS INVESTIGATION REPORT
26TH AVE. - BLIZZARD DRIVE WIDEN, ADD LANES (0.49 MI)
STATE PROJECT: U354-14-9.56 00 /STP-0014(174)D
FEDERAL PROJECT: N/A

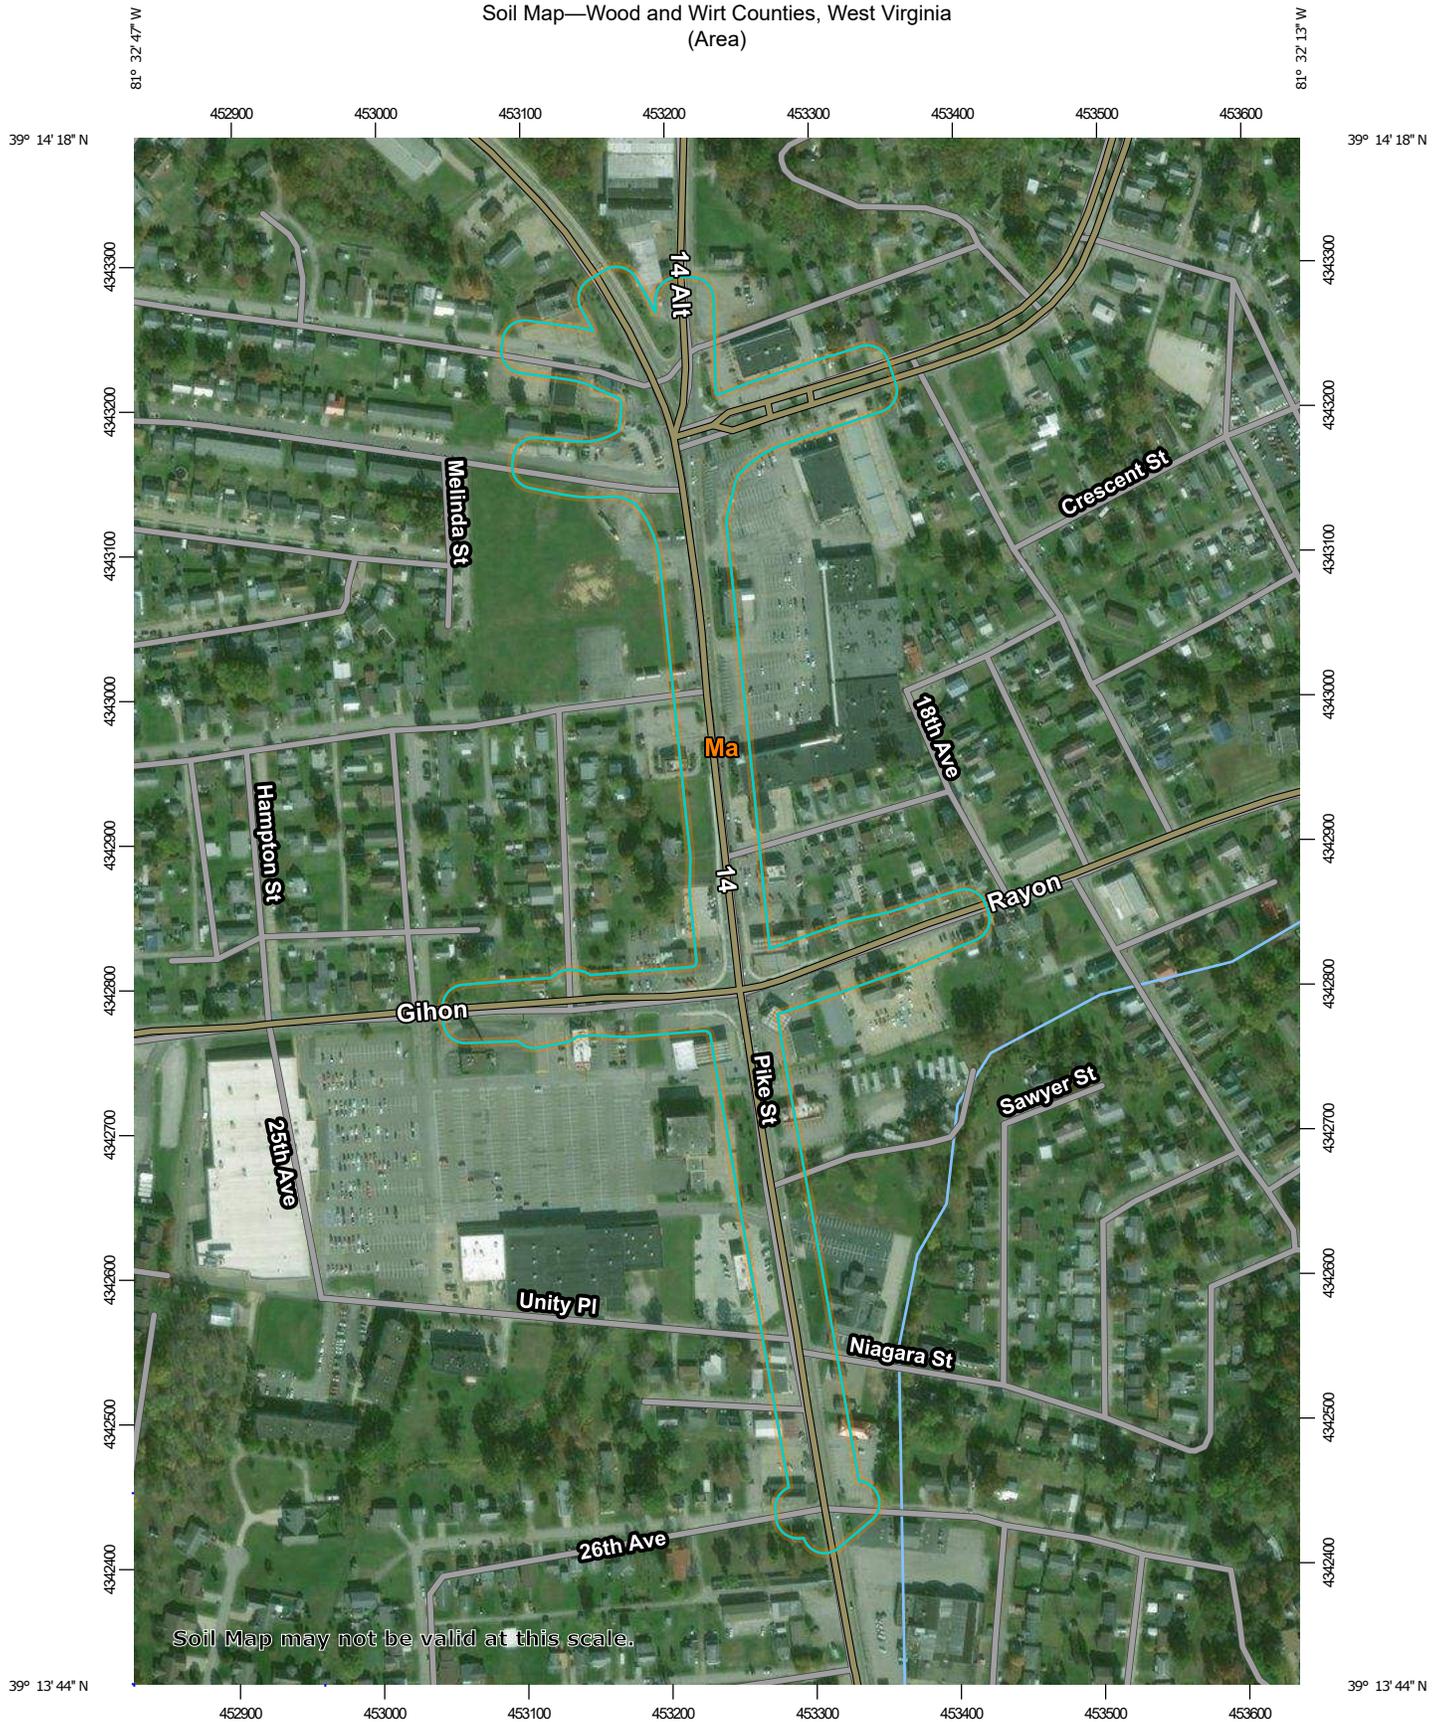
Soil Map—Wood and Wirt Counties, West Virginia
(Area)

Soil mapping and descriptions for the investigation area were obtained for review from the Natural Resources Conservation Service (NRCS) Web Soil Survey (<https://websoilsurvey.nrcs.usda.gov>). Made Land (Ma) was the only soil unit found within the project area. This soil is classified as non-hydric.

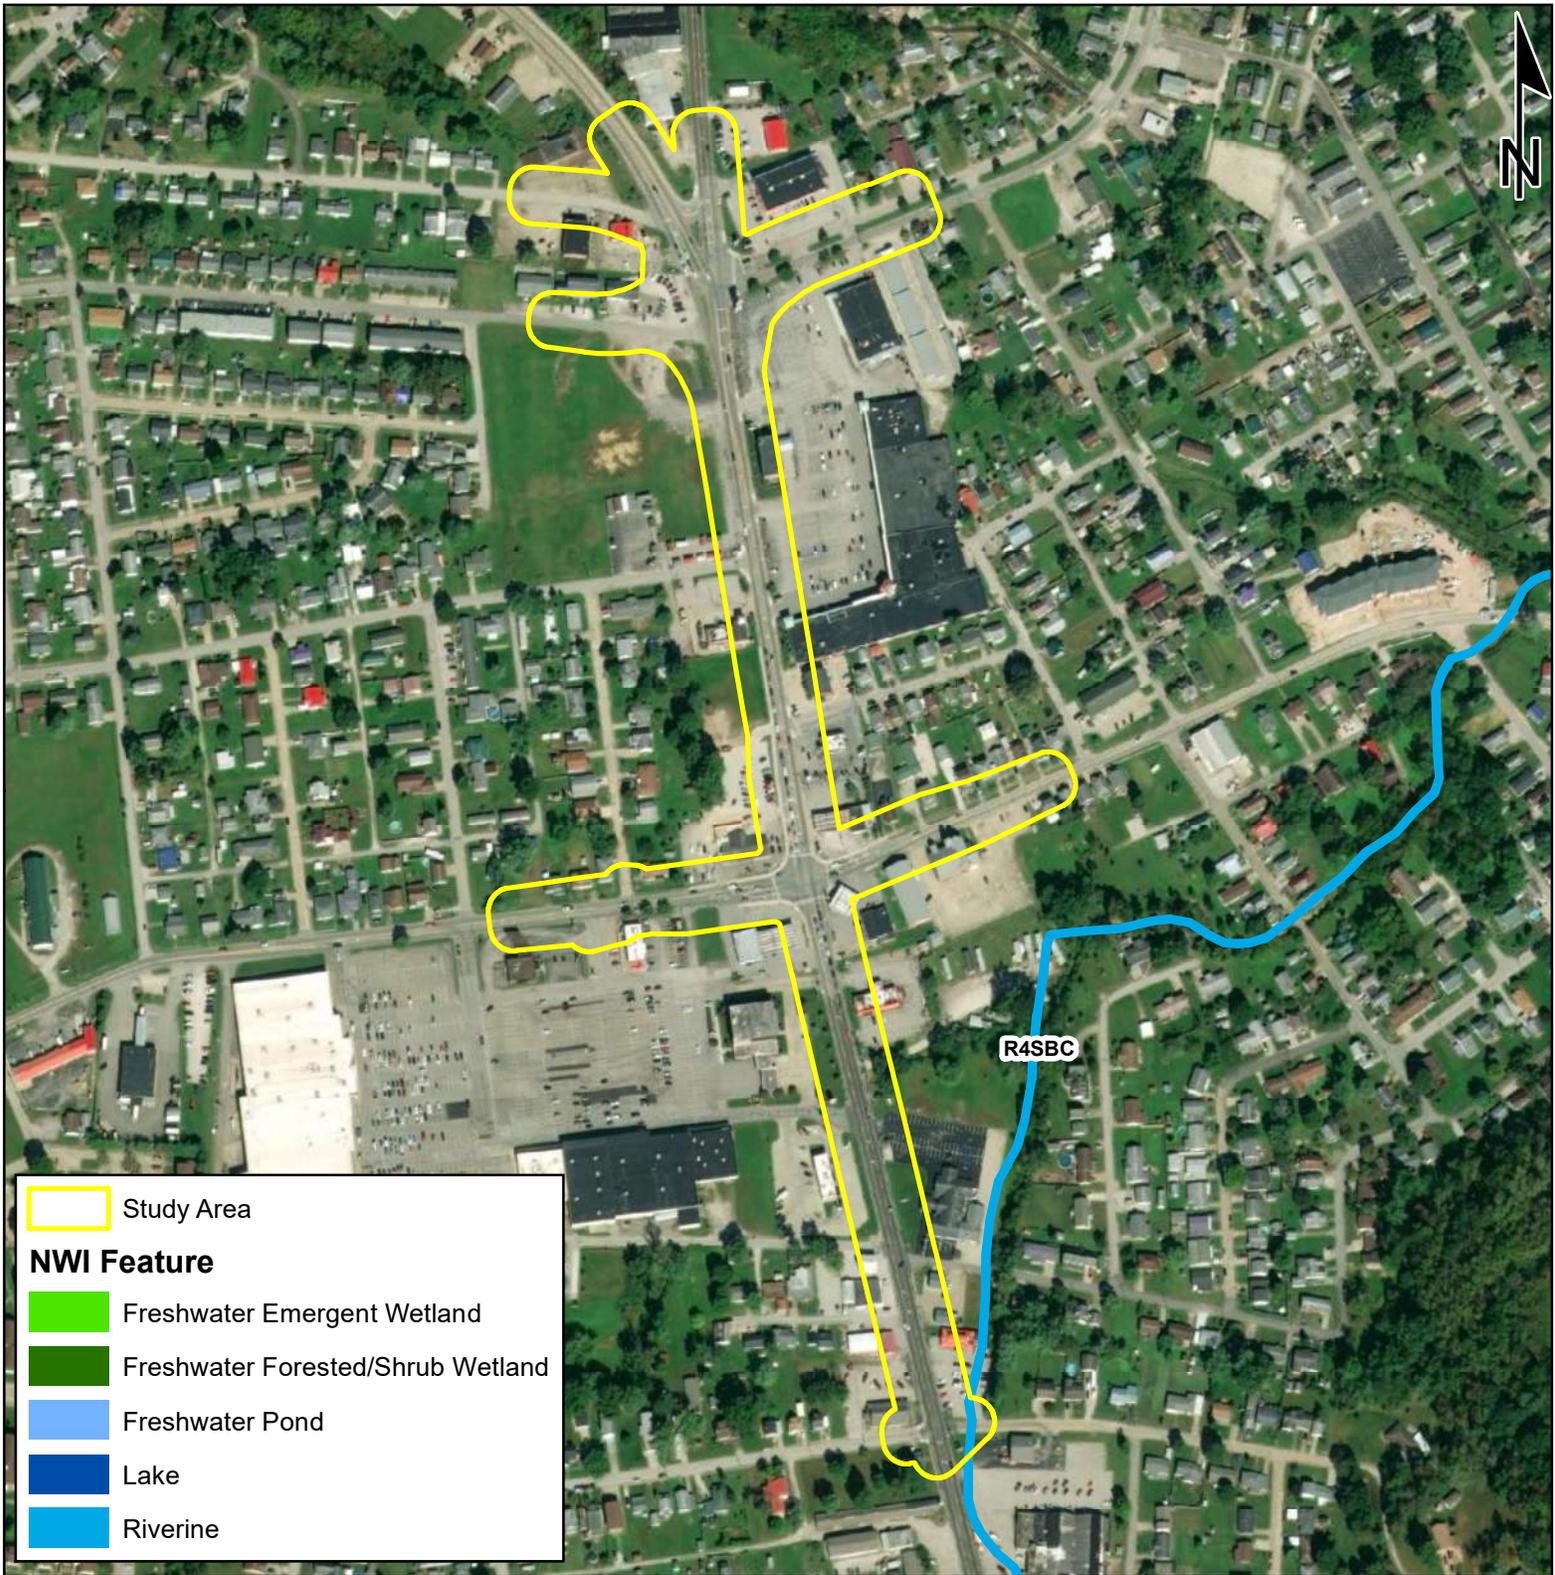
National Wetland Inventory (NWI) Map

National Wetland Inventory (NWI) mapping obtained from the U.S. Fish & Wildlife Service (USFWS) Wetlands Mapper application (<https://www.fws.gov/wetlands/Data/Mapper.html>) depicts one (1) riverine feature within the project area. Wards Run (R4SBC) runs along the southeast side adjacent to the project area. It flows from south to northeast where it meets its confluence with the Little Kanawha River off-site.

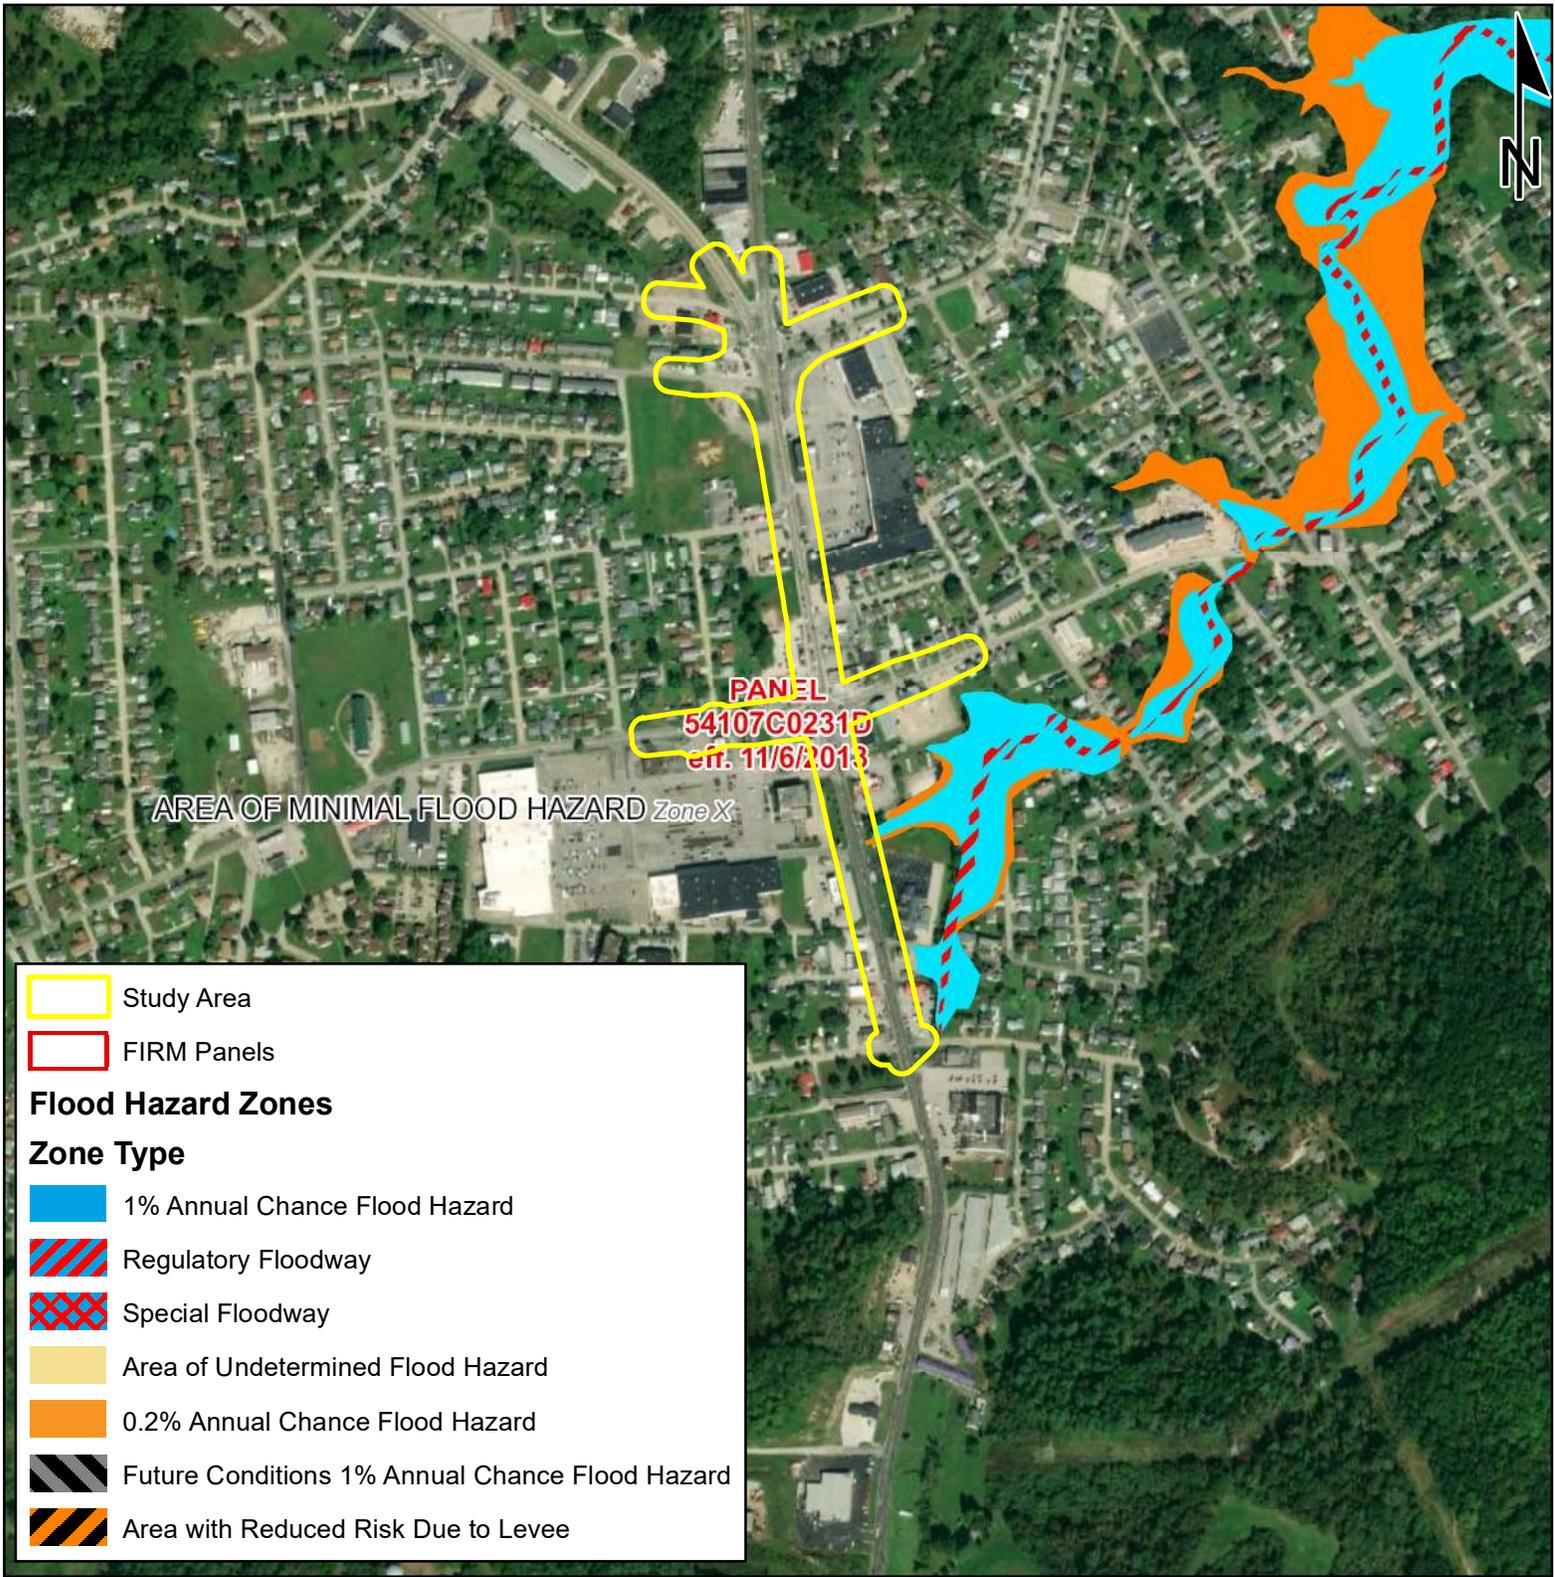
FEMA Flood Hazard Map

The project location appears on Federal Insurance Rate Map (FIRM) panel 54107C0231D. It is shown located primarily within Zone X, indicating that it is in the Areas of Minimal Flood Hazard with a very small area along the south eastern edge of the project falling within Zone AE indicating a Regulatory Floodway, Zone X indicating an area of 0.2% Annual Chance Flood Hazard, and Zone A, indicating an area of 1% Annual Chance Flood Hazard.

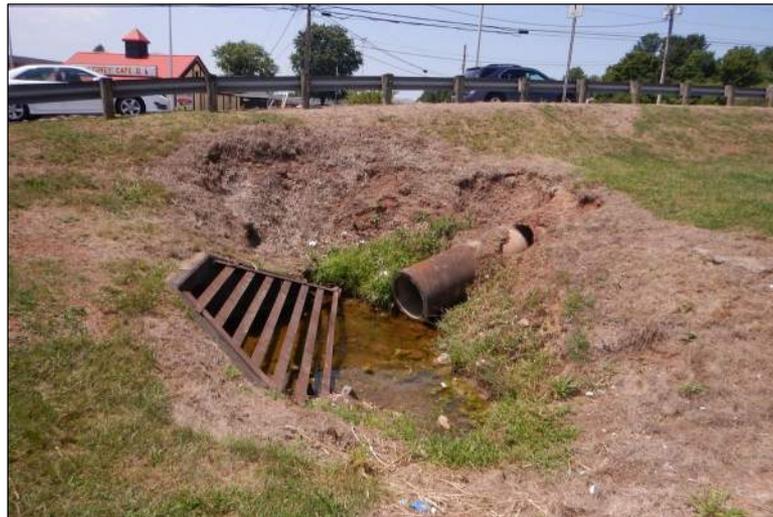
Photo 3: Between Blizzard Drive and WV 14 at a culvert outlet/inlet.

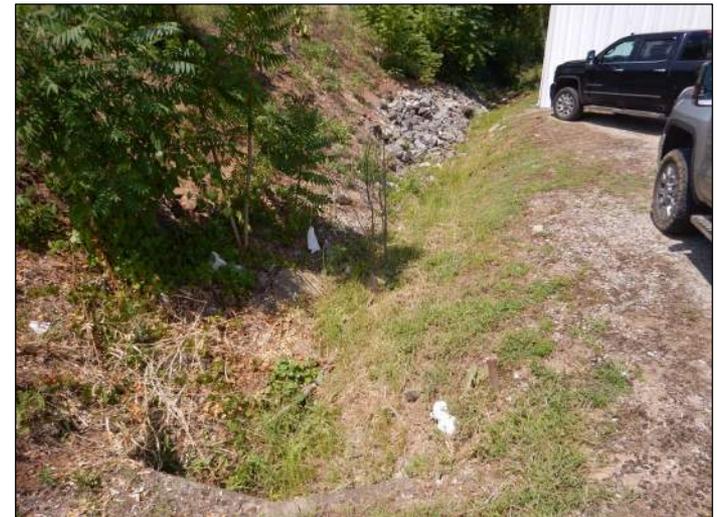
Photo 4: Facing north along a riprap ditch that feeds into the culvert inlet/outlet.

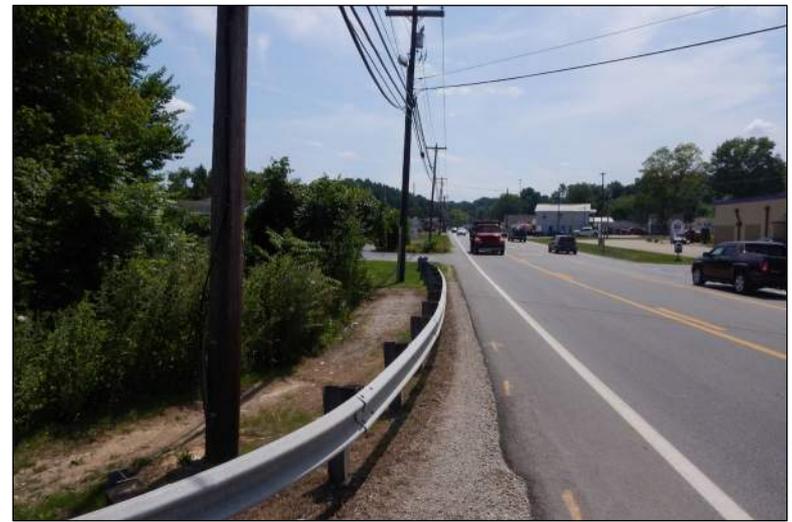
Photo 42: Facing south along the east side of WV 14. Note stream along wooded area.

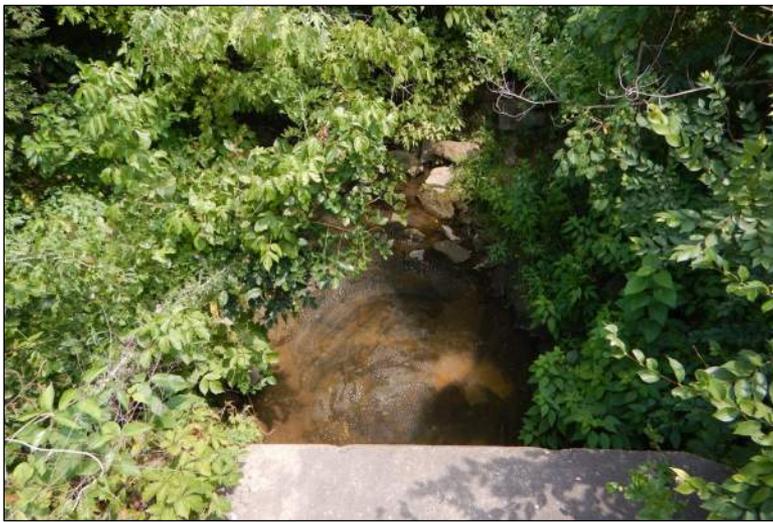
The UNT to Wards Run is an intermittent stream that runs approximately 180 ft. from west to east through the project area. UNT to Wards Run enters a culvert west of the project area and crosses under WV 14 and exits the culvert just east of WV 14. Approximately 135 ft of Wards Run is currently culverted within the project area with approximately 45 ft of stream within the project area not culverted. At this location, it has an average estimated OHWM width of 8.5 ft. and an average estimated OHWM depth of 0.75 ft. with a sand/silt substrate and drains approximately 0.5 mi². UNT to Wards Run was assessed using the WWSWVM. The Habitat Assessment Field Data Sheet - High Gradient Streams scored a total of 55 points while Functional Capacity Index for Hydrology is 0.13, Biogeochemical Cycling is 0.25, and Habitat is 0.20. The WWSWVM Index is 0.390. The UNT to Wards Run flows into Wards Run off-site which then flows into the Little Kanawha and therefore, it is likely a Jurisdictional Water of the U.S.

Photo 45: Facing east at the outlet of UNT to Wards Run.

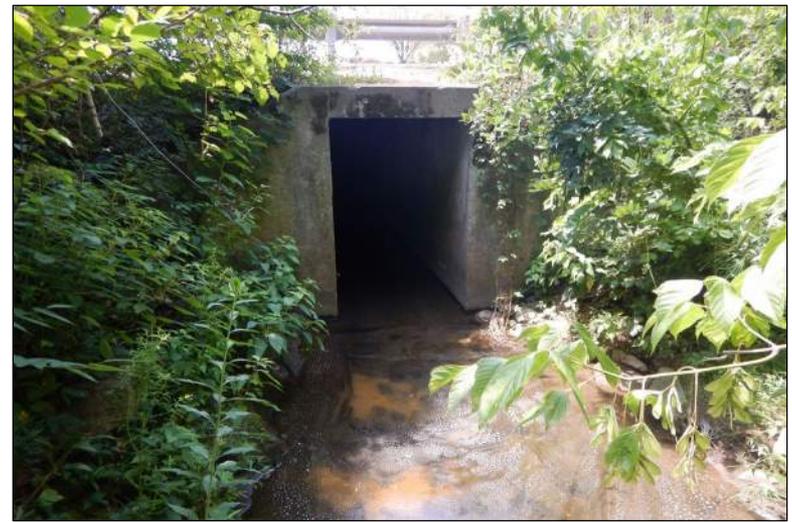
Photo 46: Facing west at the outlet of UNT to Wards Run.

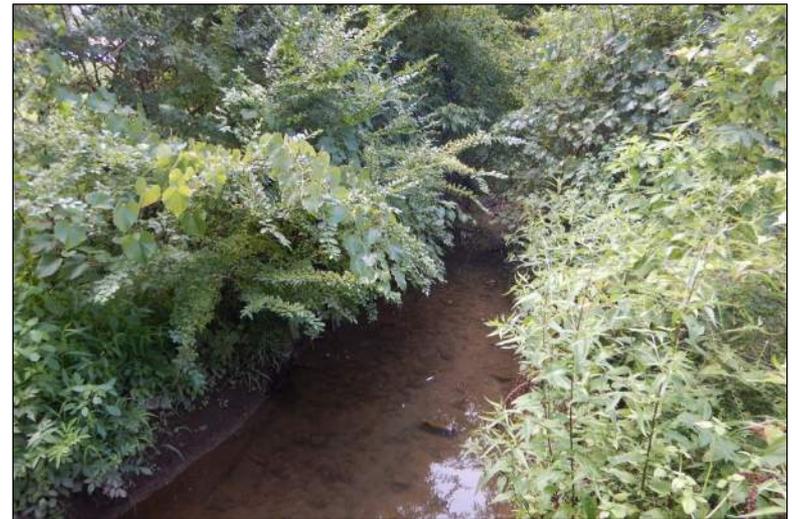
Photo 48: Facing west and upstream along UNT to Wards Run.

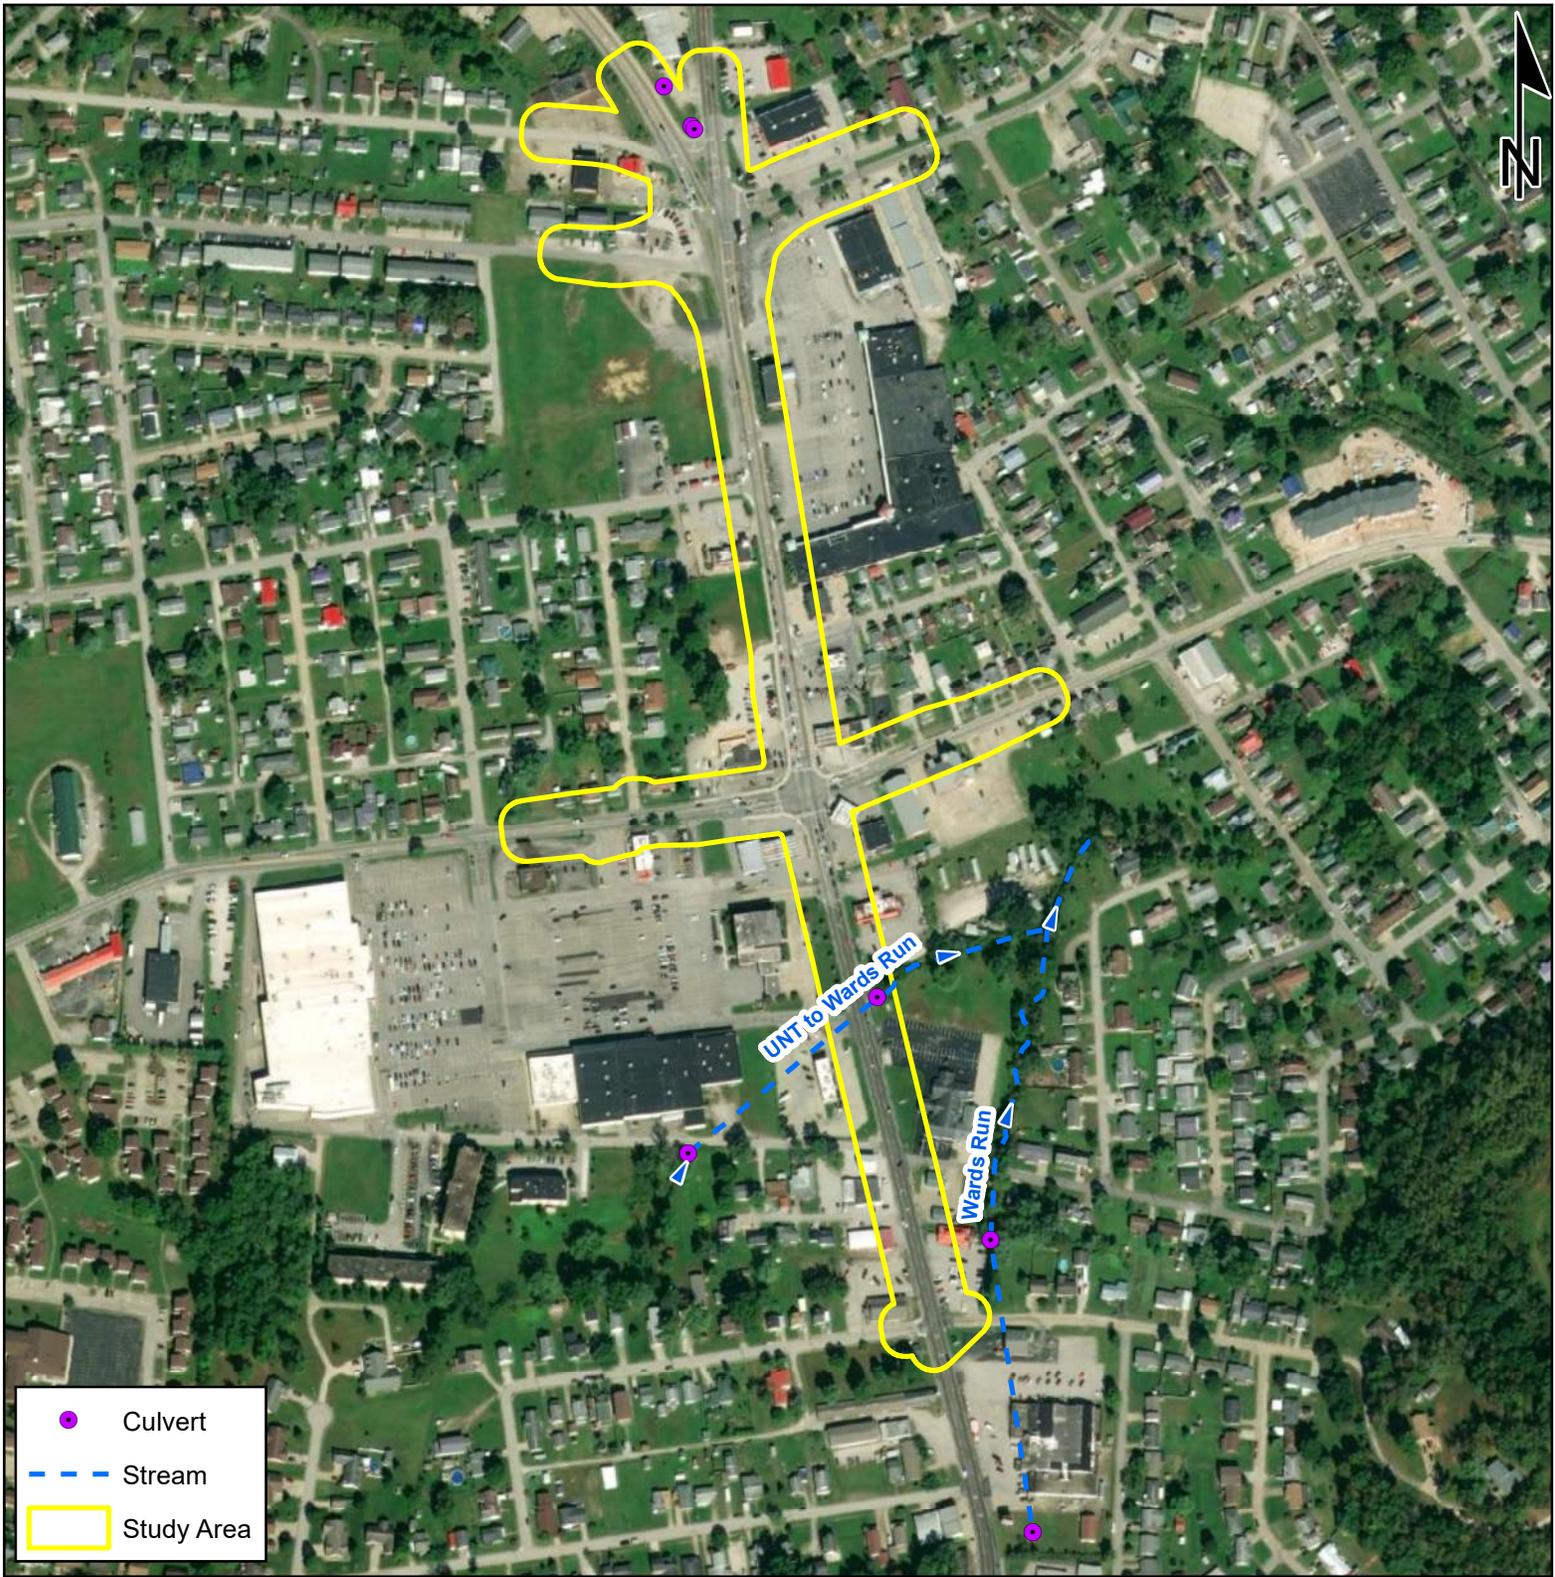
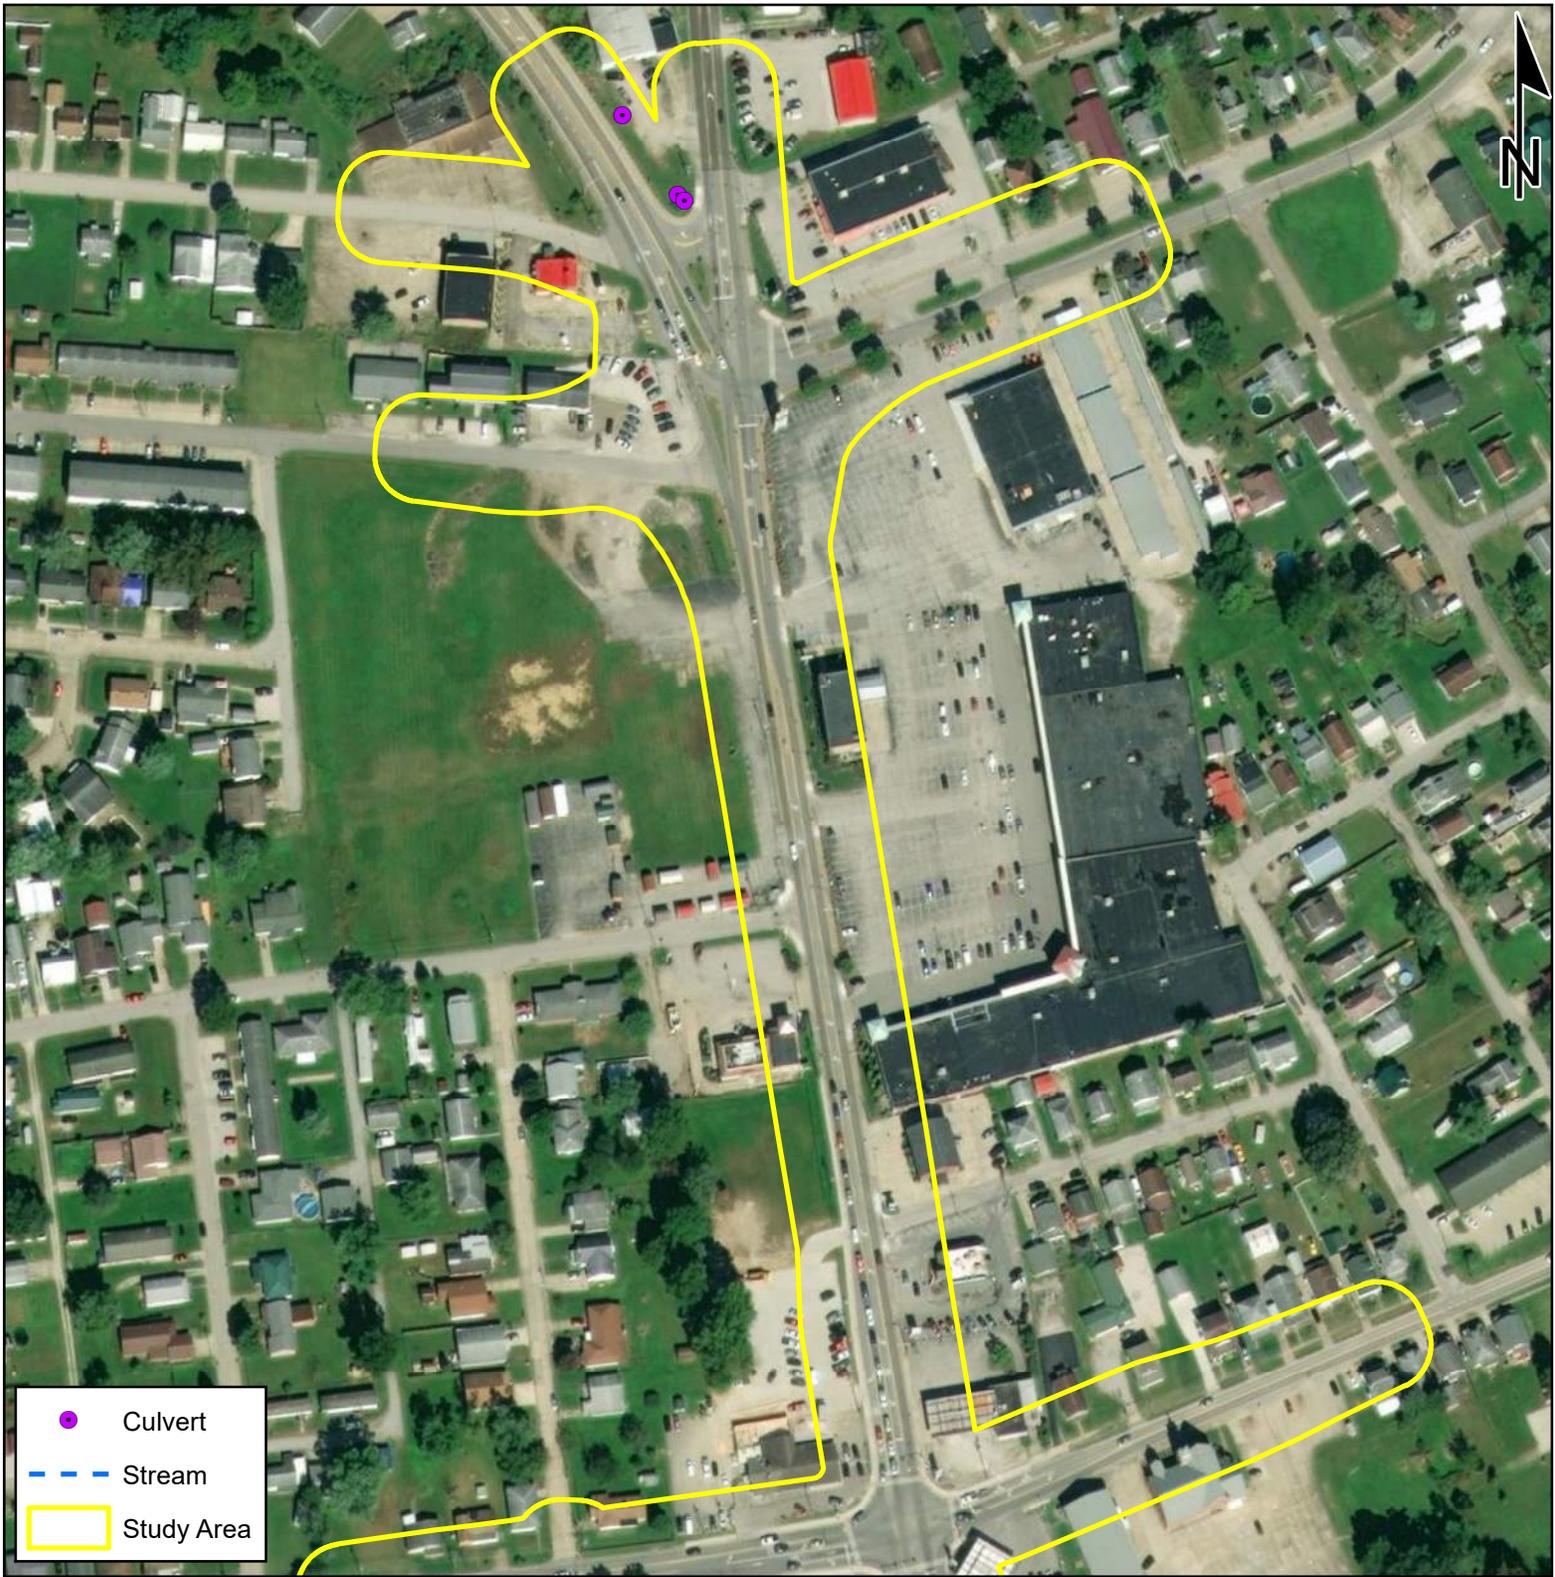
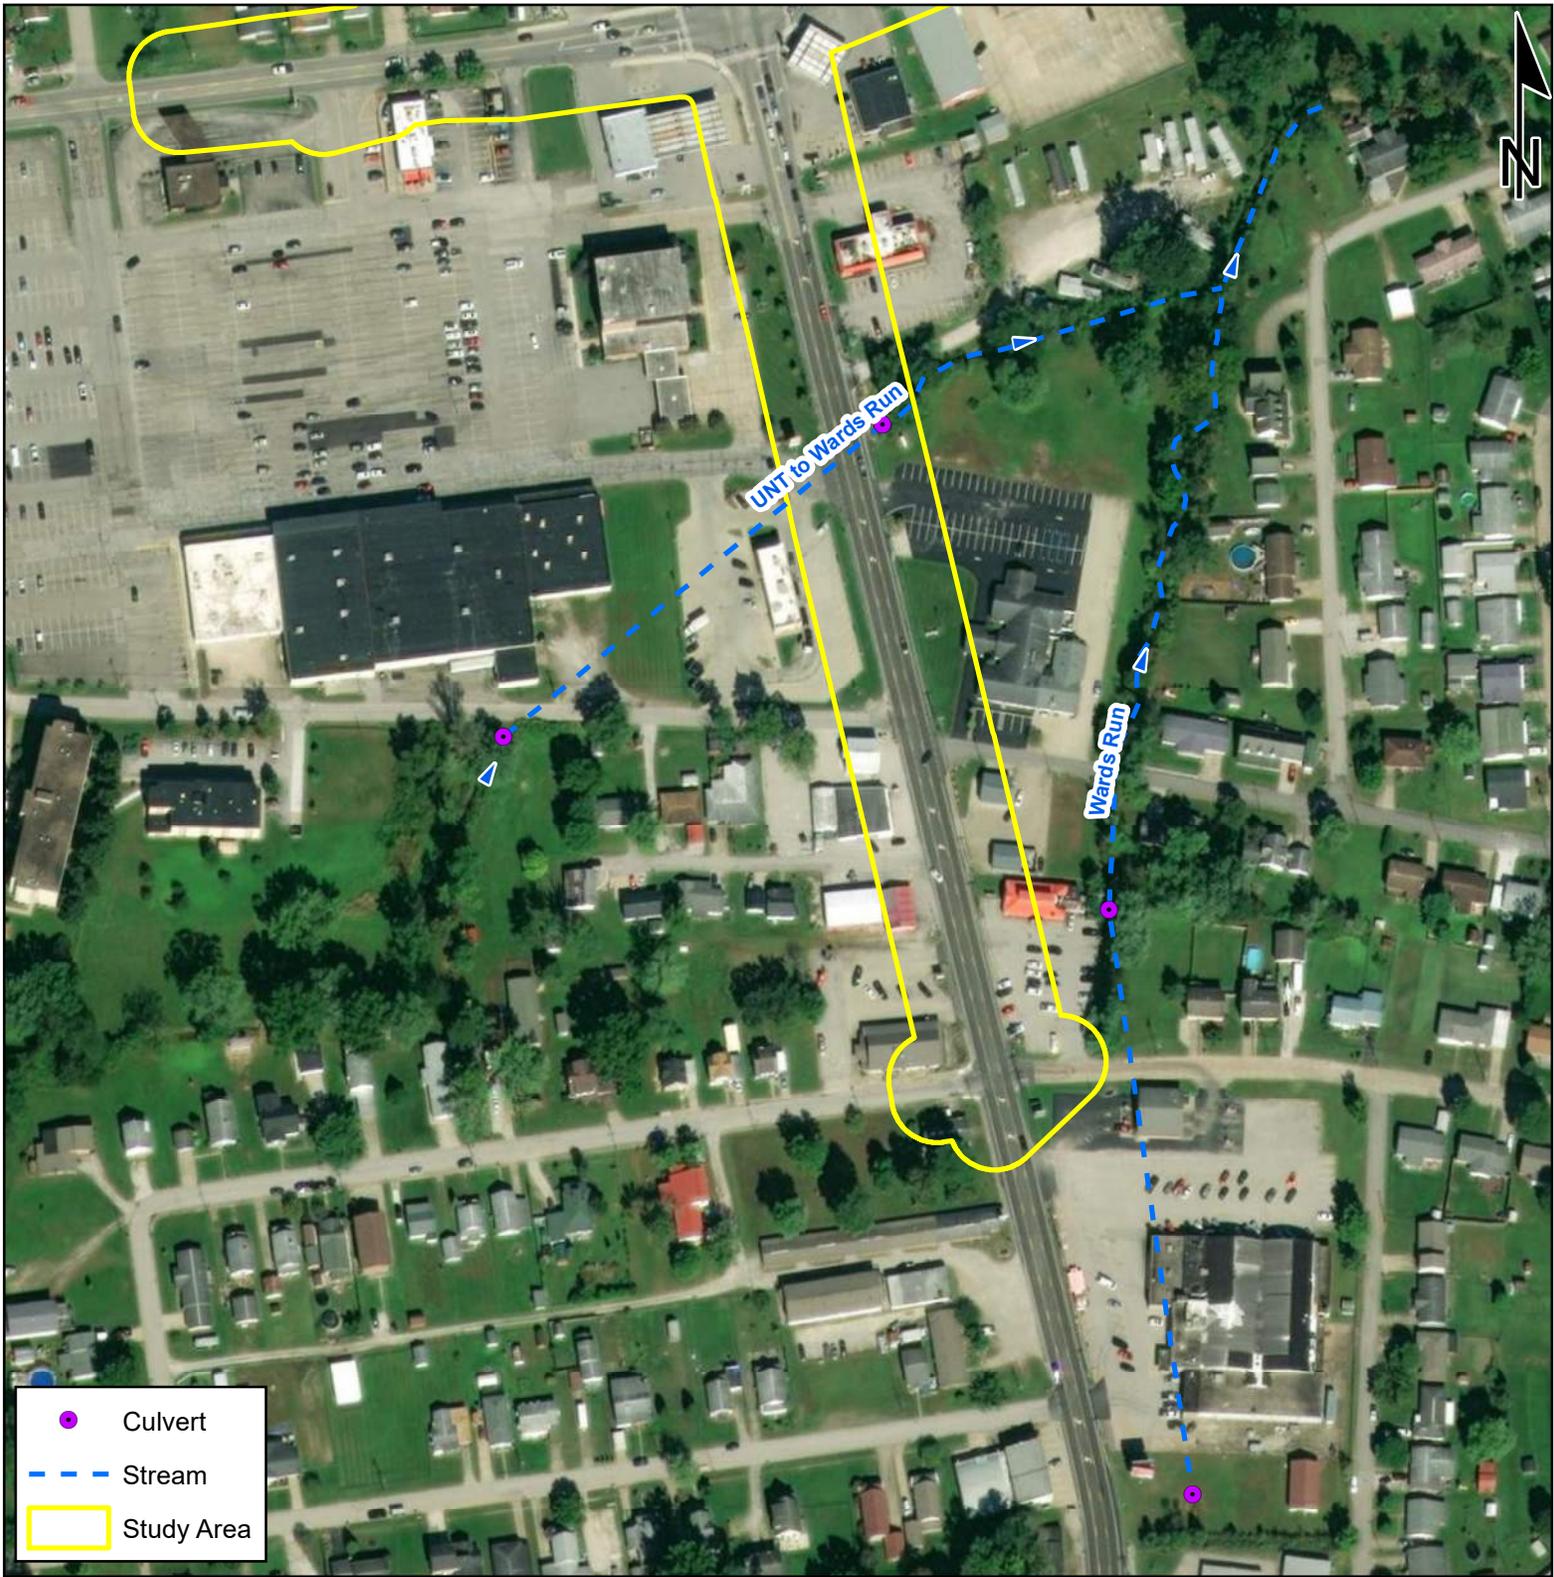
Water Resource Delineation Map

Based on the findings of this Waters Investigation, B&N concludes that a total of **180 l.f.** of potentially jurisdictional stream resources are located in the investigation area, as summarized in **Table 2** above. Water Resource Documentation are included in **Attachment 9**.
