# FINAL DESIGN STUDY REPORT

## *Cairo Bridge*

*State Project S343-31-9.82 00*

*Cairo, Ritchie County, West Virginia*

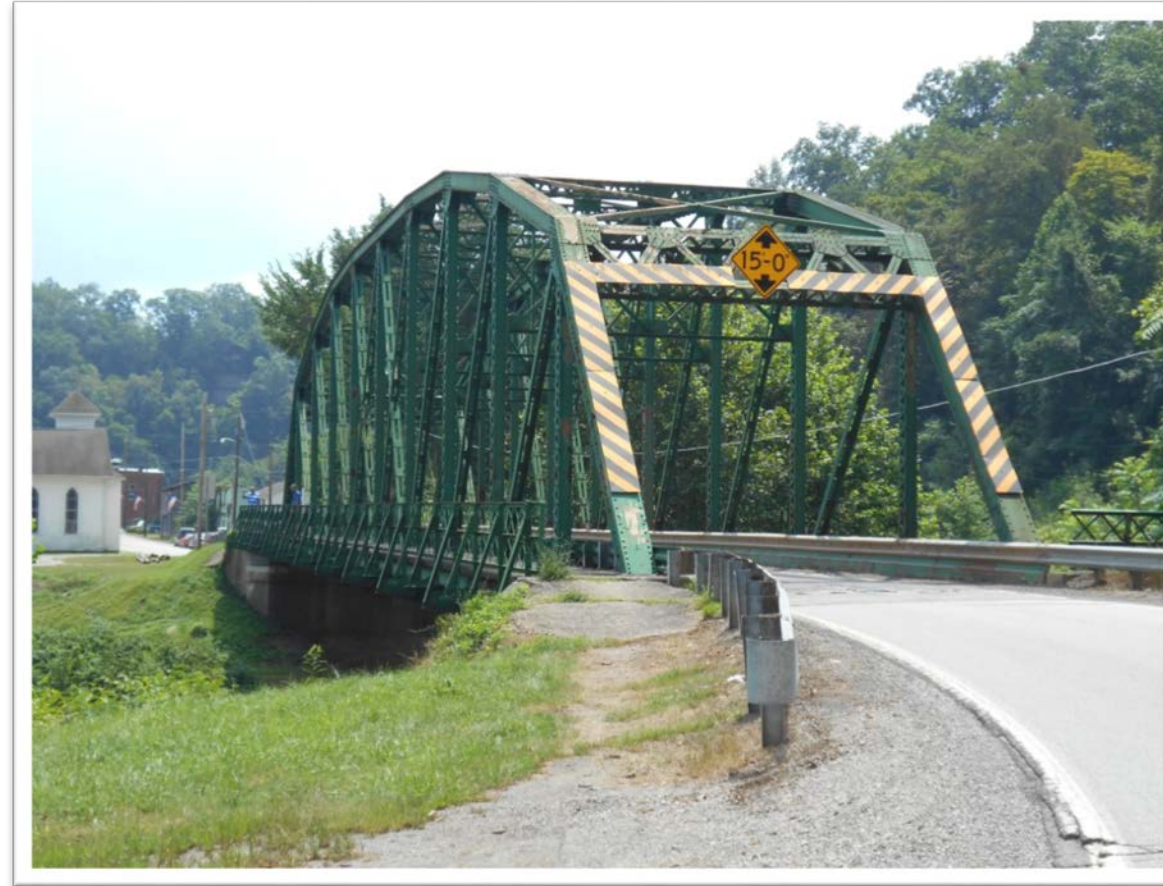
The existing bridge has an 18'-5" wide roadway and is limited to 15'-0" vertical clearance (see cover photo). The current ADT of 750 vehicle per day on WV Route 31. The substandard width does render the bridge functionally obsolete for a two-lane, two-way bridge, and combined with load posting, restricts use by truck traffic. For this reason, the bridge is hindering substantial economic development in the oil and gas industry, and WVDOT predicts that the ADT and ADTT will both increase dramatically when this obstacle is removed.
