WEST VIRGINIA DEPARTMENT OF TRANSPORTATION  
DIVISION OF HIGHWAYS  
MATERIAL CONTROL, SOILS AND TESTING DIVISION

MATERIALS PROCEDURE

METHOD OF TEST FOR DETERMINING THE  
CONDITION OF CONCRETE BRIDGE DECKS

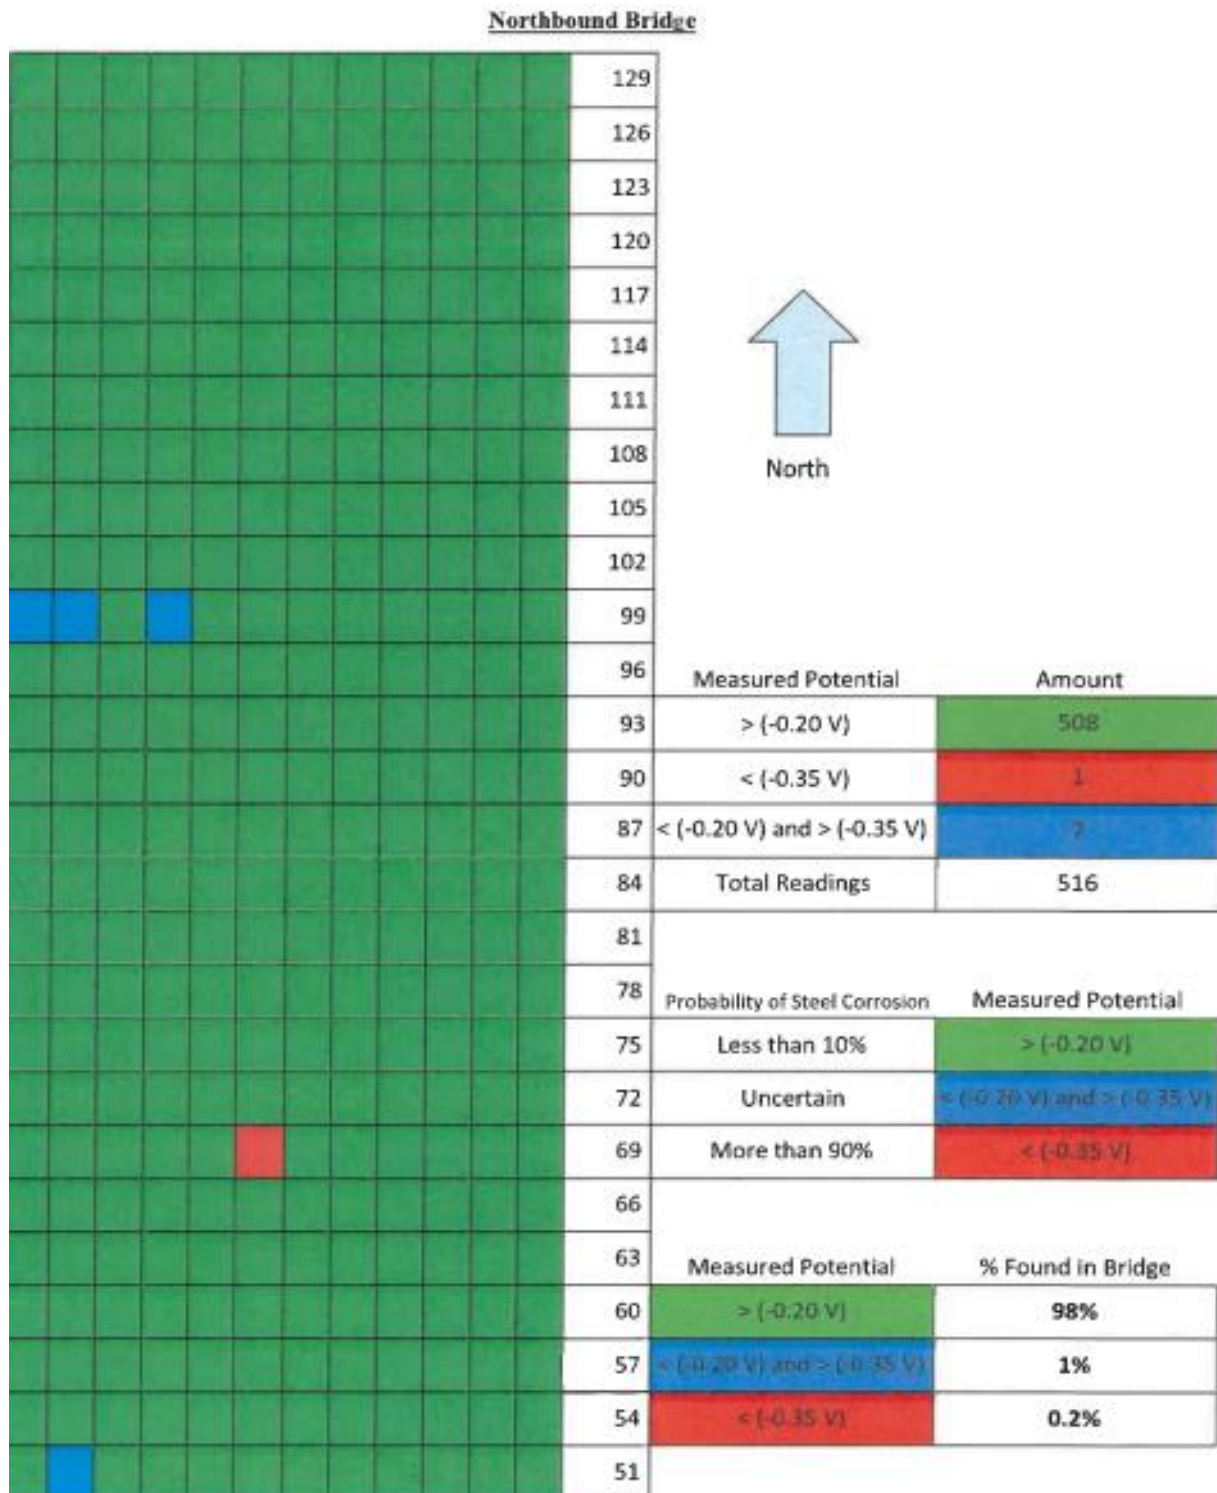
Corrosion Potential Map

- 5.3.10. Take potential readings every 3 ft. by 3 ft. over the entire bridge deck. The sponge contacting the electrode must be kept moist during the entire test.

- 5.3.11. Record the results of each reading on the grid paper in Attachment 4.
  - 5.3.12. Results generated shall be presented according to Section 9 of ASTM C876.

- 6.2.4. Potentials greater than -0.20V indicate a 90% or higher probability of no corrosion taking place at the time of measurement.
  - 6.2.5. Potentials in the range of -0.20V to -0.35V are inconclusive.

- 6.2.6. Potentials less than -0.35V generally indicate a 90% or higher probability of active corrosion taking place at the time of measurement. Refer to Attachment 8 for example.

4.7.4 See Attachment No. 9 for the plotted corrosion potentials found on the bridge decks.
