5TH STREET BRIDGE PURPOSE AND NEED

The purpose of the 5th Street Ritter Park Bridge Project (including 8th Street Bridge) is to replace two bridges crossing Fourpole Creek in the City of Huntington, WV with bridges that meet current design standards.

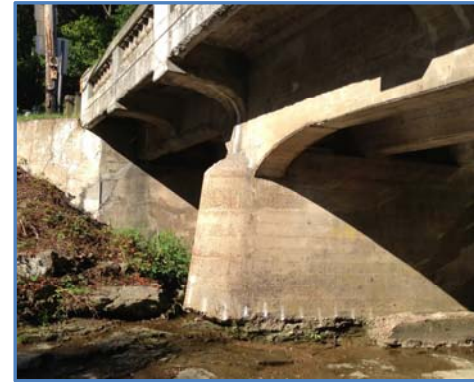
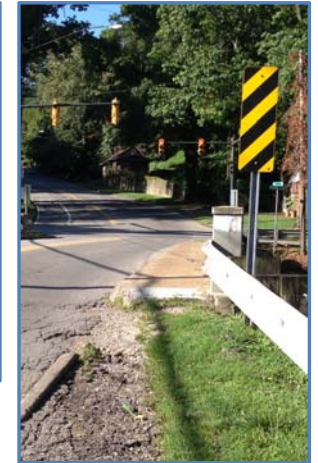
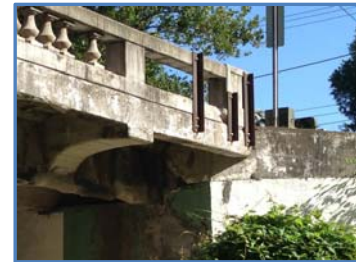
- The bridge is in poor condition
- Railing has deteriorated and lost balusters
- Travel lanes are narrow (10 feet)
- Roadway has no shoulders
- High traffic volume (11,200 vehicles per day) for the roadway's existing capacity
- Sidewalks are cracked and narrow (4 feet); 5 feet is recommended width for Americans with Disabilities Act compliance.

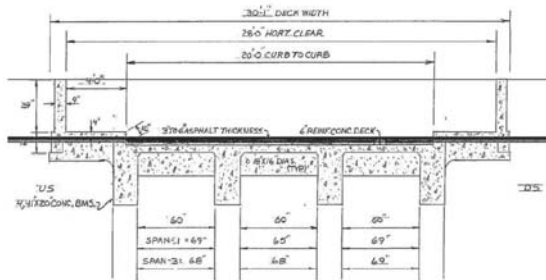
5th Street Bridge Cross Section from the 1995 Inventory Inspection Report (Revised 2007)

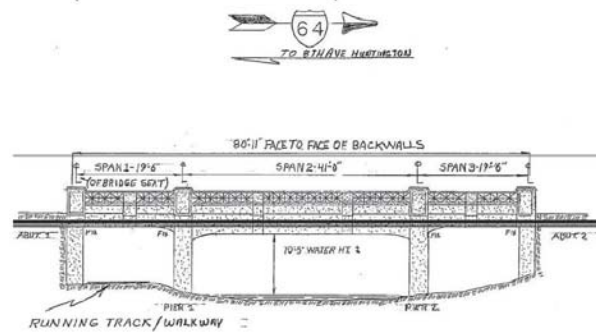
5th Street Profile from the 1995 Inventory Inspection Report (Revised 2007)
