8TH STREET BRIDGE PURPOSE AND NEED

The purpose of the 5th Street Ritter Park Bridge Project (including 8th Street Bridge) is to replace two bridges crossing Fourpole Creek in the City of Huntington, WV with bridges that meet current design standards.

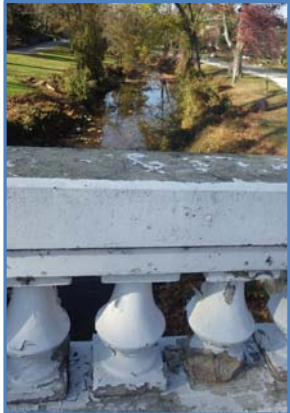
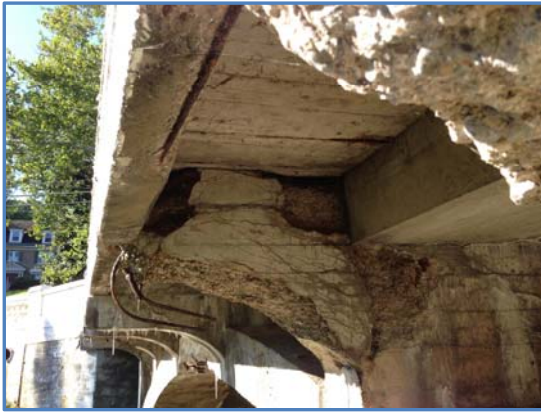
- The bridge is in poor condition
- Railing has deteriorated and lost balusters
- Reinforcing steel is exposed
- 3-ton weight limit posted in 2015; School Board has approved detour to avoid using posted bridge
- Sidewalks are cracked and narrow (4 feet); 5 feet is recommended width for Americans with Disabilities Act compliance
- Roadway has no shoulders

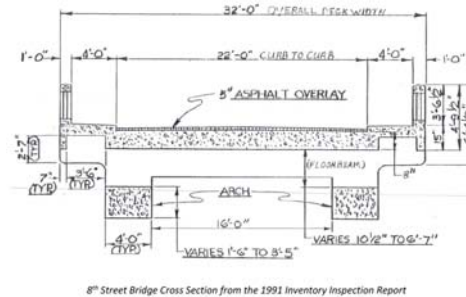
8th Street Bridge Cross Section from the 1991 Inventory Inspection Report

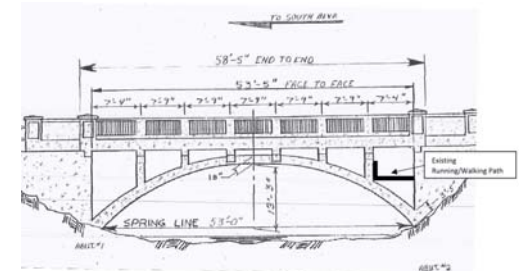
8th Street Profile from the 1991 Inventory Inspection Report
